Citizen Concern Response Memorandum W2A-10
February 2, 2006

GeoInsight Project 3871-002

Re: Bouchard Barge B120 Oil Release
Buzzards Bay, Massachusetts

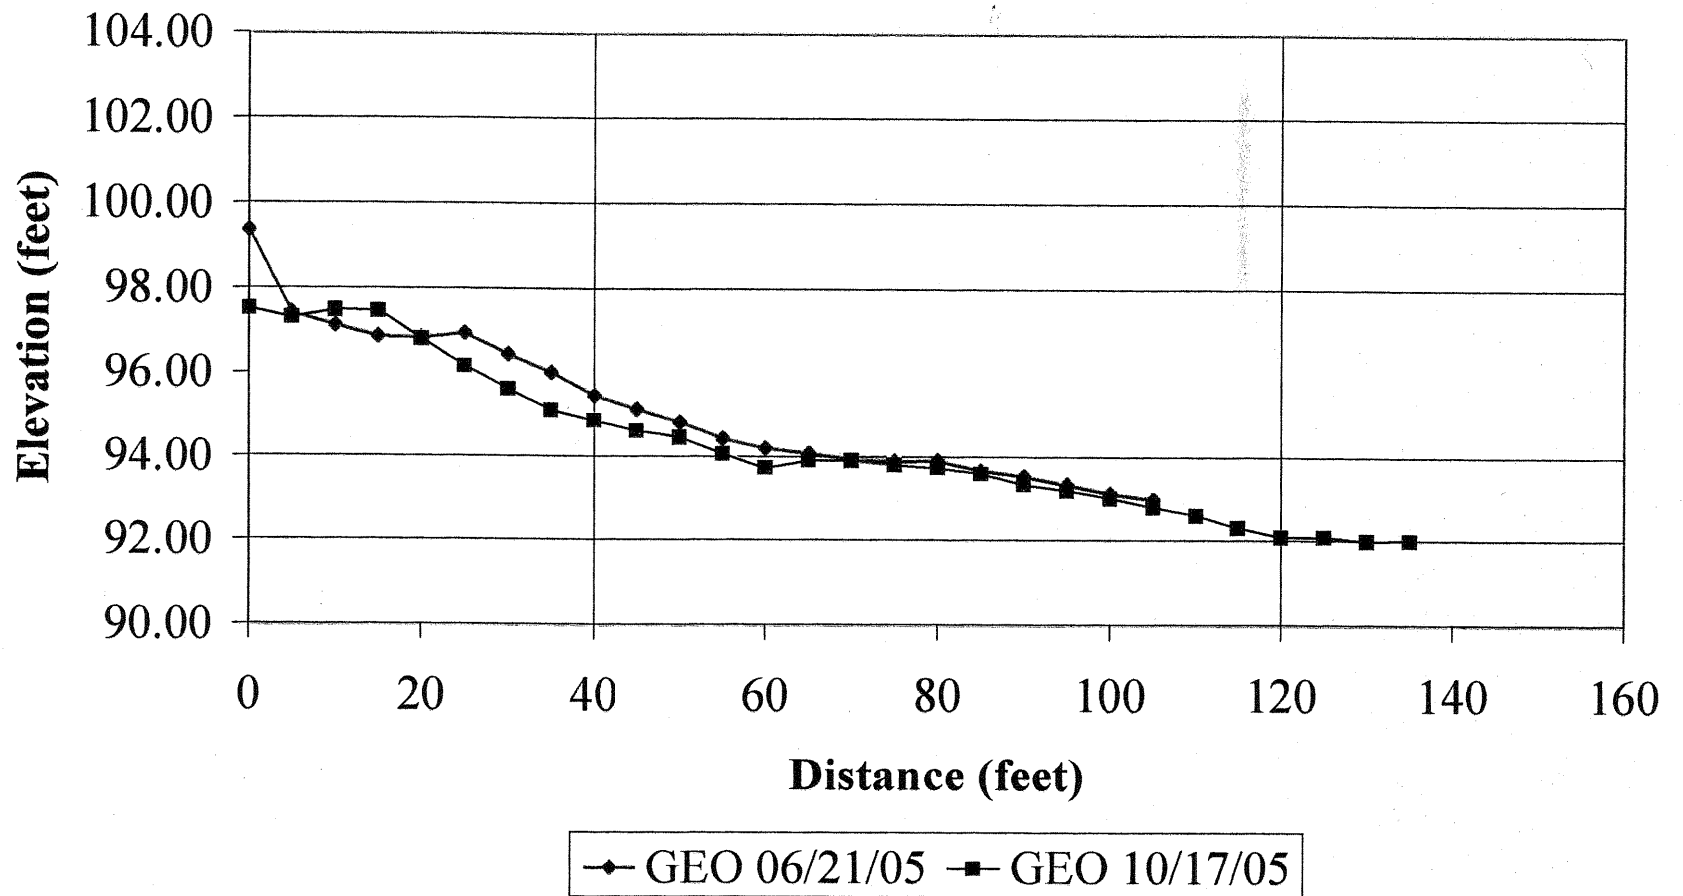
**Figure 2 - W2A-10 (Brower Beach)
Transect H1**

The H2 and H3 shoreline profiles (Figures 3 and 4, respectively) do not show large changes in shoreline profiles. The H1 profile (Figure 2) shows some changes in shoreline elevation, with some sand accretion near the start of the survey at the dune line and some sand erosion seaward of the dune line. However, the overall profile of the beach is generally consistent between the two survey events.

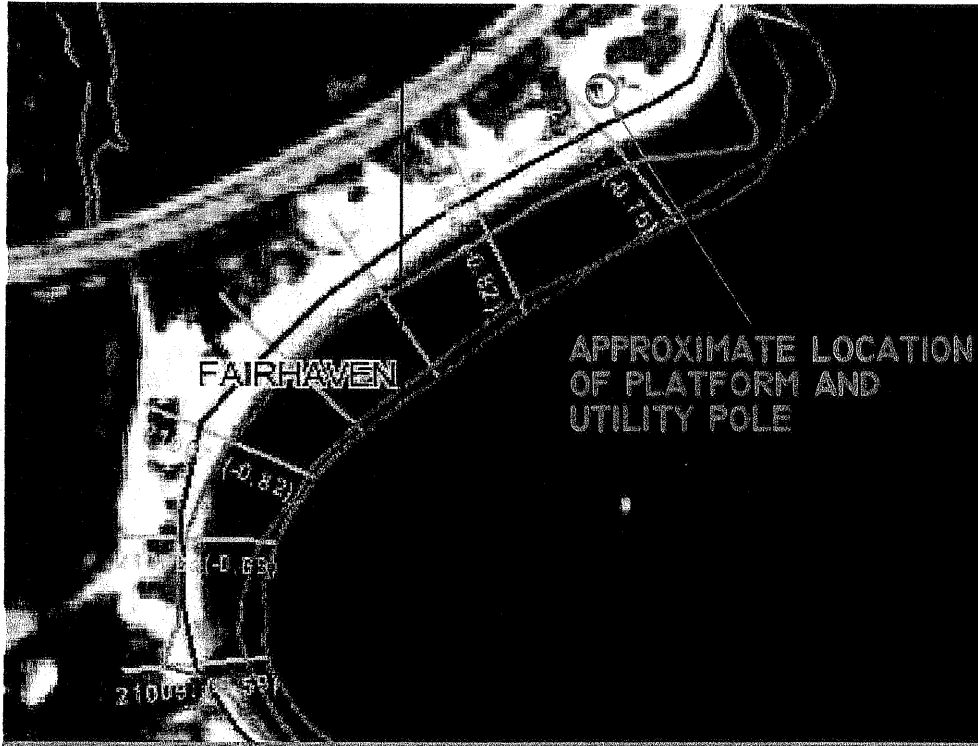
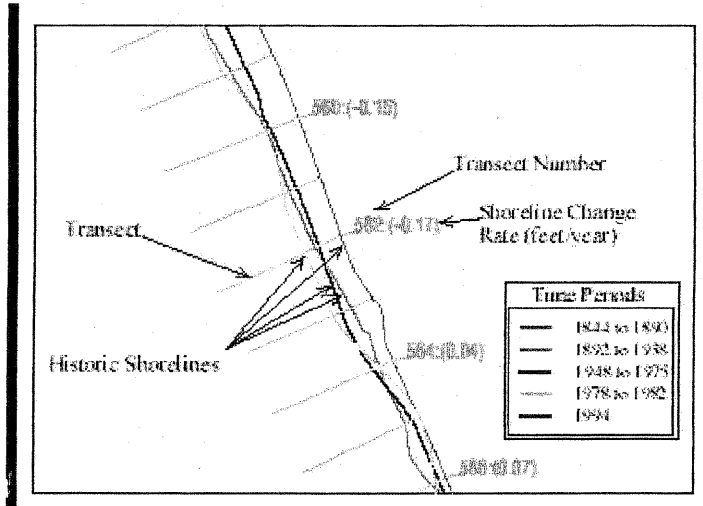
Massachusetts Coastal Zone Management (MACZM). A total of seven shoreline transects, identified as transect numbers 21003 to 21009, are present in the general area and the locations of these transects are shown on Figure 6. Transects 21003, 21004, and 21005 are located in the primary area of concern. The published annual shoreline change rates at the individual transect locations are summarized below:

The data from the MACZM Shoreline Change Project indicate that natural shoreline changes in this general area are resulting in long-term net erosion, ranging from a long-term net average of 0.59 to 0.85 feet per year, at all the transect locations. It is important to note that at the three transects located in the primary area of concern (transects 21003, 21004, and 21005), the MACZM Shoreline Change Project indicates that the annual rate of erosion between 1978 to 1994 has accelerated from previous rates to between 2 and 3 feet per year, which is greater than the annual rate of erosion that occurred between summer 2003 and summer 2005 (i.e., one foot per year) in the area at issue.
