PARE PROJECT NO. 08216.00

**INSPECTION REPORT
COAL POCKET PIER
NEW BEDFORD WATERFRONT
FACILITIES INSPECTIONS
NEW BEDFORD, MASSACHUSETTS**

MARCH 2009

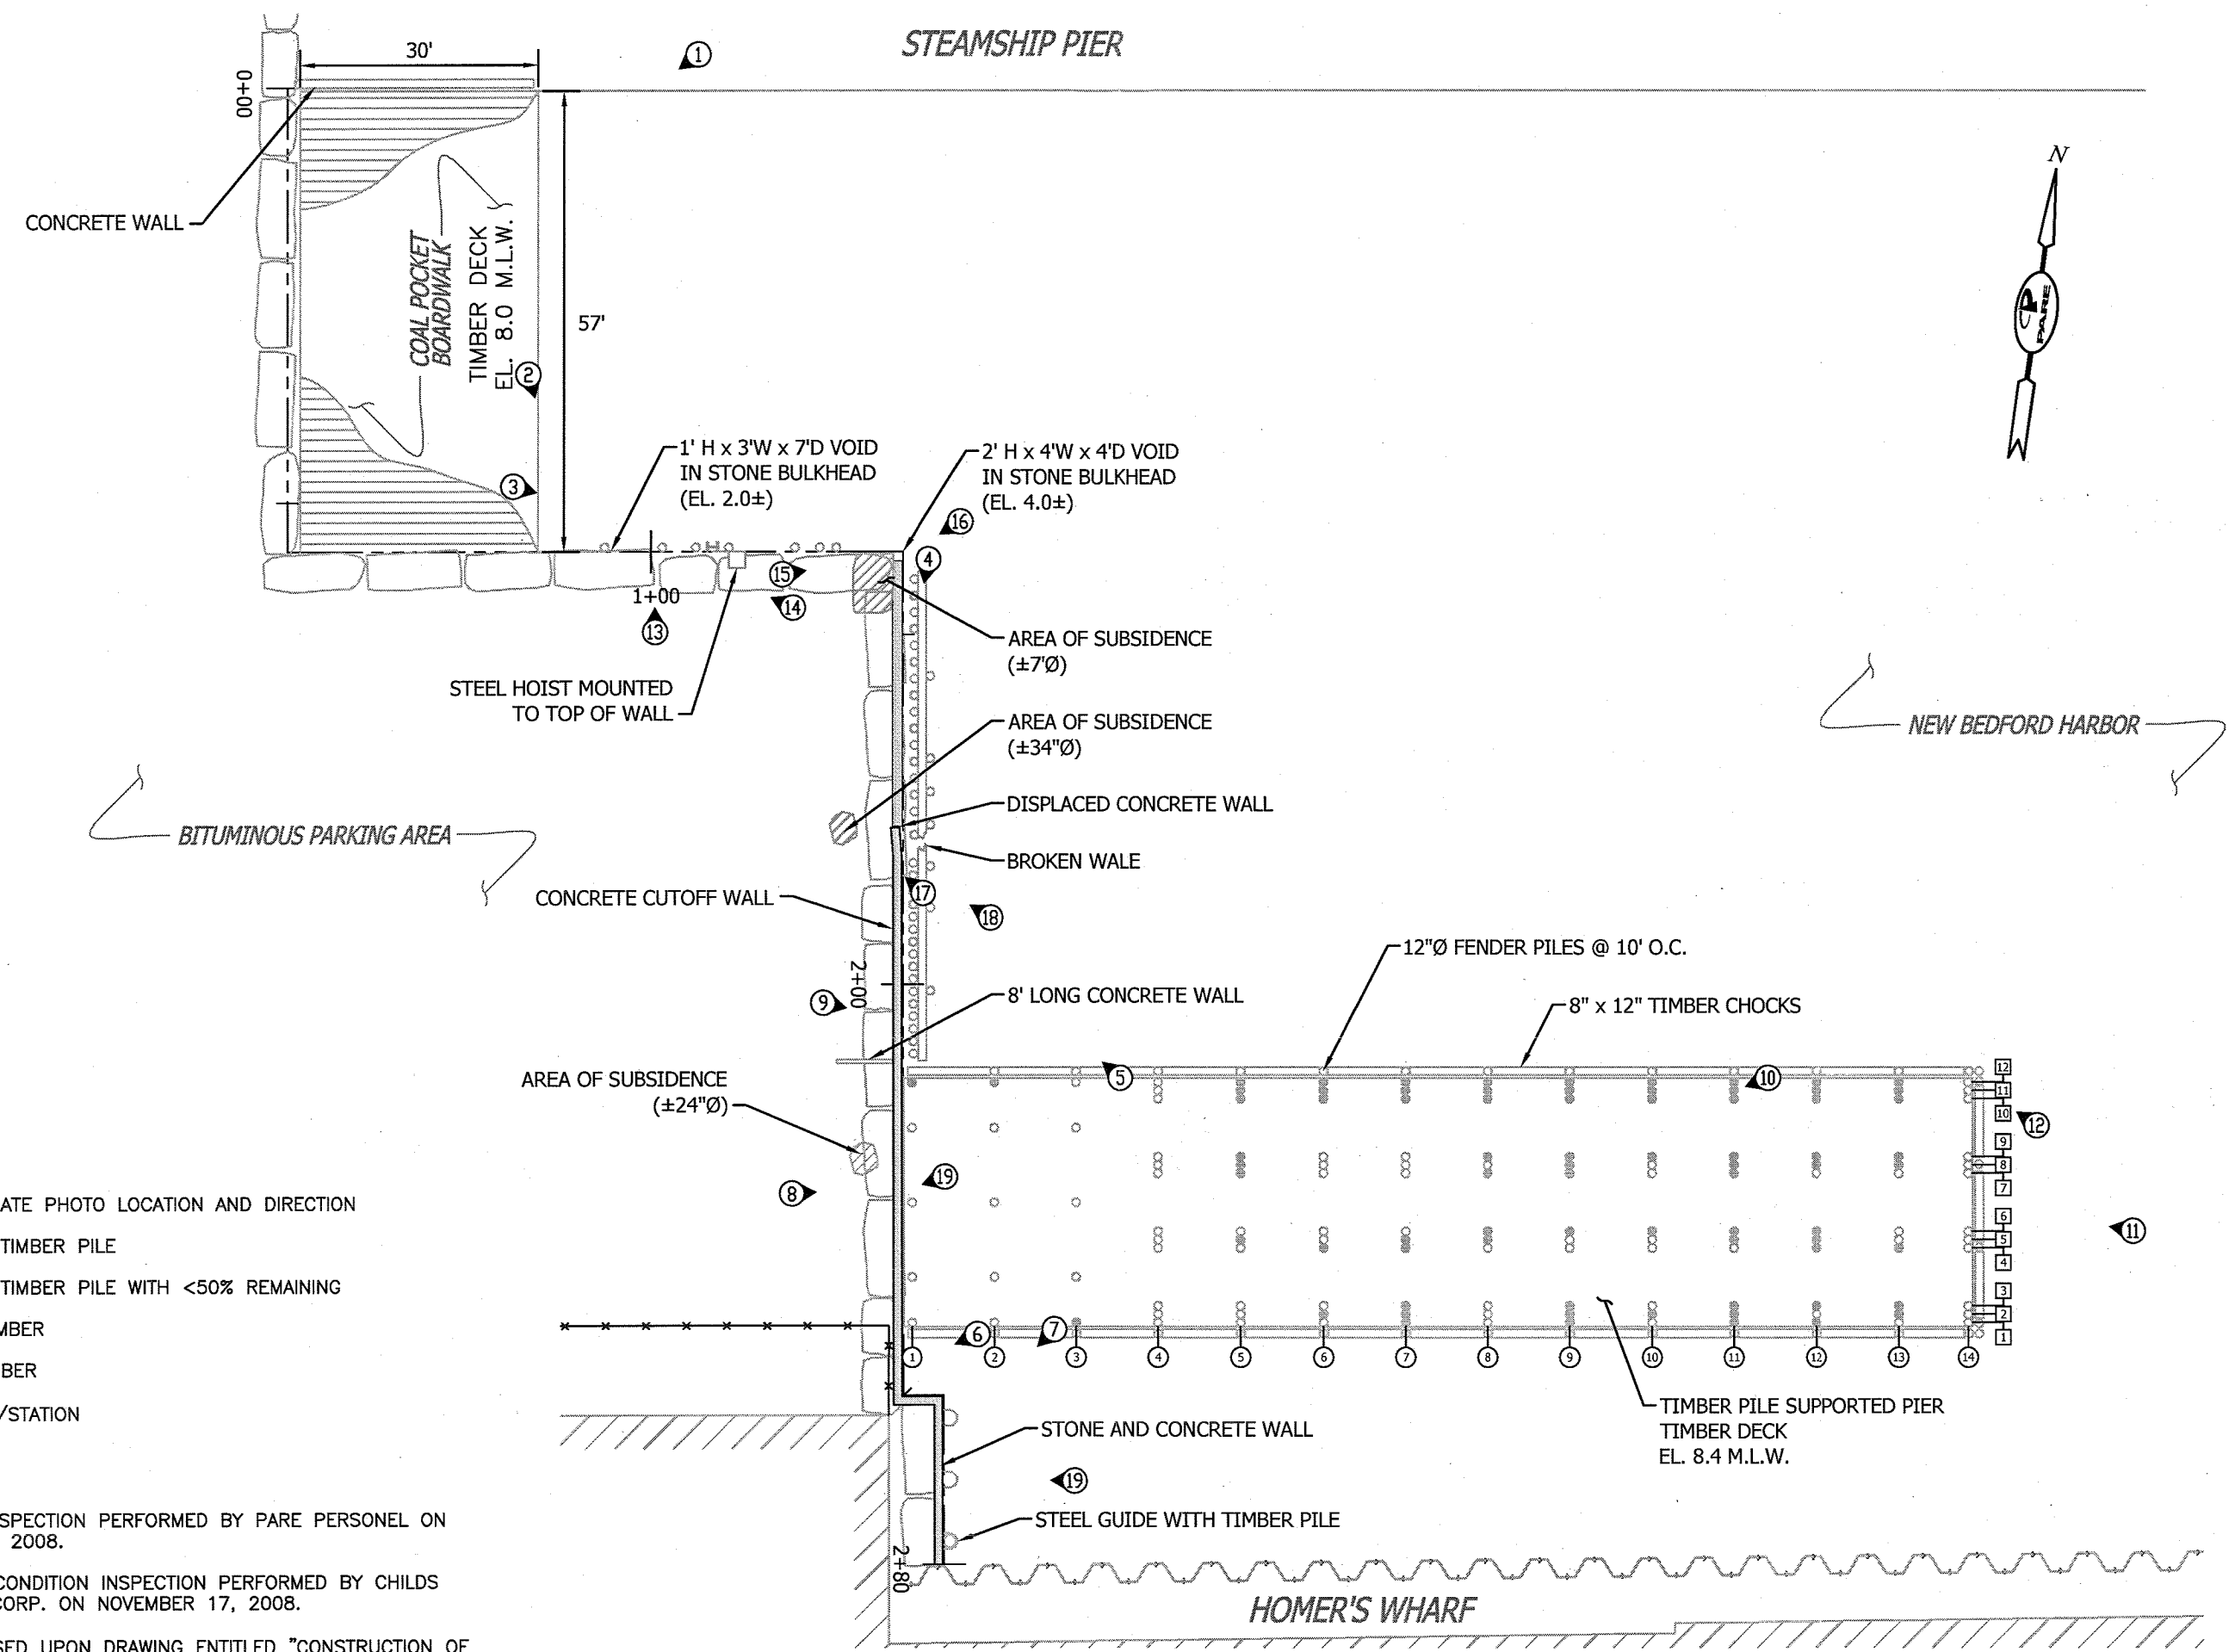
EXISTING SITE PLAN
 FIGURE NO.:
 SHEET NO. 2 OF 1

The portion of the granite block seawall that was observed during the topside inspection was in overall fair to poor condition. During the topside inspection, the wall was observed to have large spaces between stones, possibly the loss of chinking stones. From Station 0+90 to Station 1+40, a timber cap sits atop the stone bulkhead. The cap was observed to be in fair condition with rot developing in areas. From Station 1+40 to Station 2+80, approximately the top 3-feet of the stone bulkhead has been replaced with a concrete cutoff wall that was built on top of the stone bulkhead. At Station 1+75, the concrete cutoff wall was observed to be displaced approximately 4 inches (Photo 17, 18). This condition may have occurred due to movement of the stones below. The stone and concrete bulkhead from Station 2+10 to 2+80 was observed in overall fair condition with no observed voids or areas of subsidence. Three steel pile guides were bolted to the face of the concrete cutoff wall from Station 2+50 to 2+80 with only 1 timber pile remaining. Subsidence areas were observed along the length of the wall as discussed in Section 3.5 and as indicated on Figure 2 - Existing Site Plan.

The bituminous pavement was observed to be in generally poor condition. A number of large cracks have developed in the surface. Areas of subsidence behind the stone seawall were typical, with several large areas as indicated on the Site Plan. Near Station 1+00 to 1+25, several smaller areas of subsidence were observed in the bituminous deck behind the wall (Photo 13, 14). There is a void in the stone bulkhead near this location, and is likely the cause of this subsidence. A 7-foot wide area of subsidence was observed along the bituminous deck at the corner of the bulkhead at Station 1+40. A piece of plywood was placed over the hole (Photo 15). A large void was also observed in the stone bulkhead at this location. An area of subsidence measuring 3 feet in diameter was observed approximately 5 feet behind the edge of the wall at Station 1+75, indicating significant loss of fill material (Photo 17). The concrete and stone bulkhead at this location was observed to be displaced by several inches.

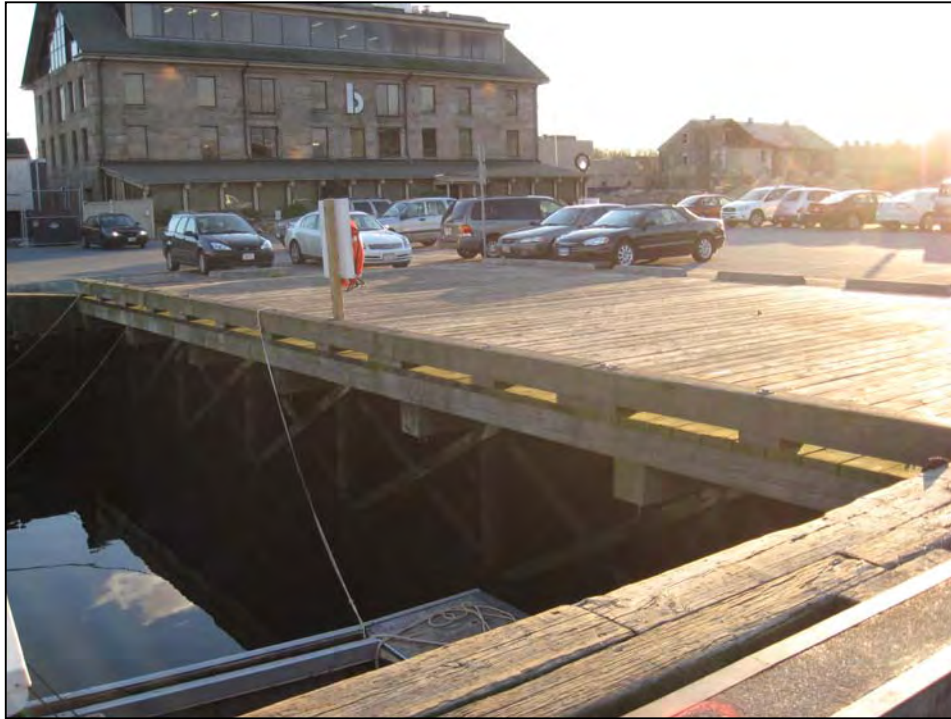
Photo No. 1: Overview of the Coal Pocket Boardwalk.

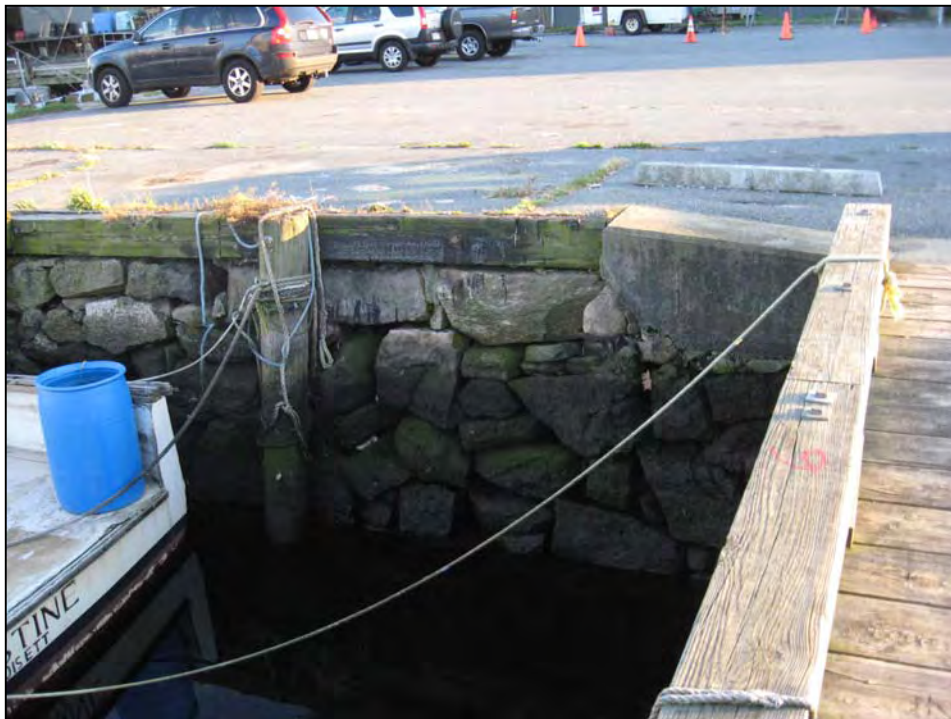
Photo No. 2: Typical stone bulkhead near Station 0+90.

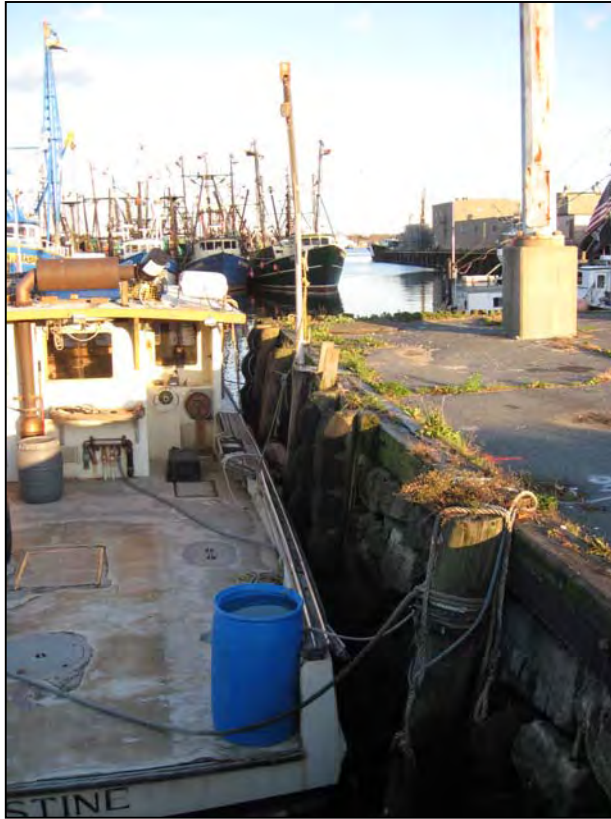
Timber fender piles were observed along the face of the granite block seawall, and may serve the purpose of retaining the stone wall. The piles were noted to be in overall fair condition, with evidence of marine borer attack. Piles were observed to have reduced diameters from 12 inches to approximately 8 inches.

Photo No. 3: Timber fender piles with docked vessel along the stone bulkhead from Station 0+86 to Station 1+33.

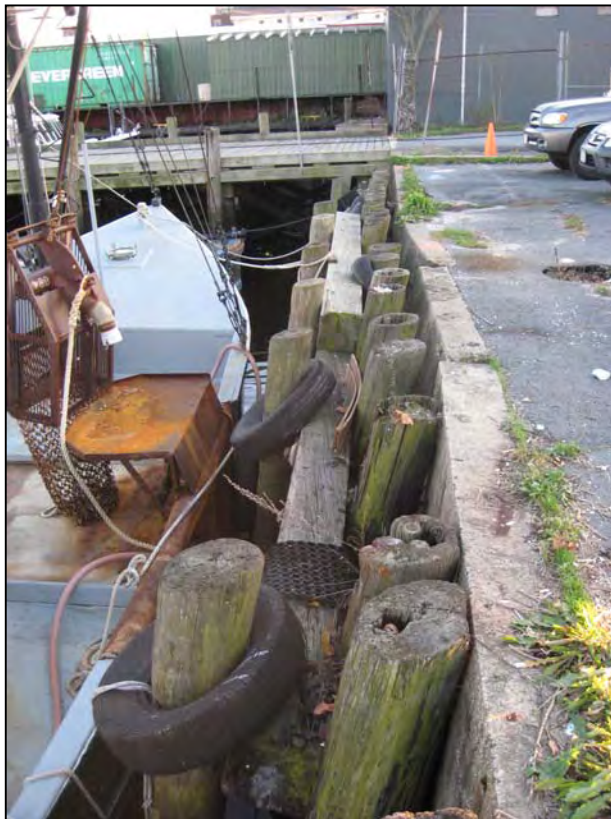
Photo No. 4: Timber fender system with docked vessel along the stone bulkhead from Station 1+33 to Station 2+10.

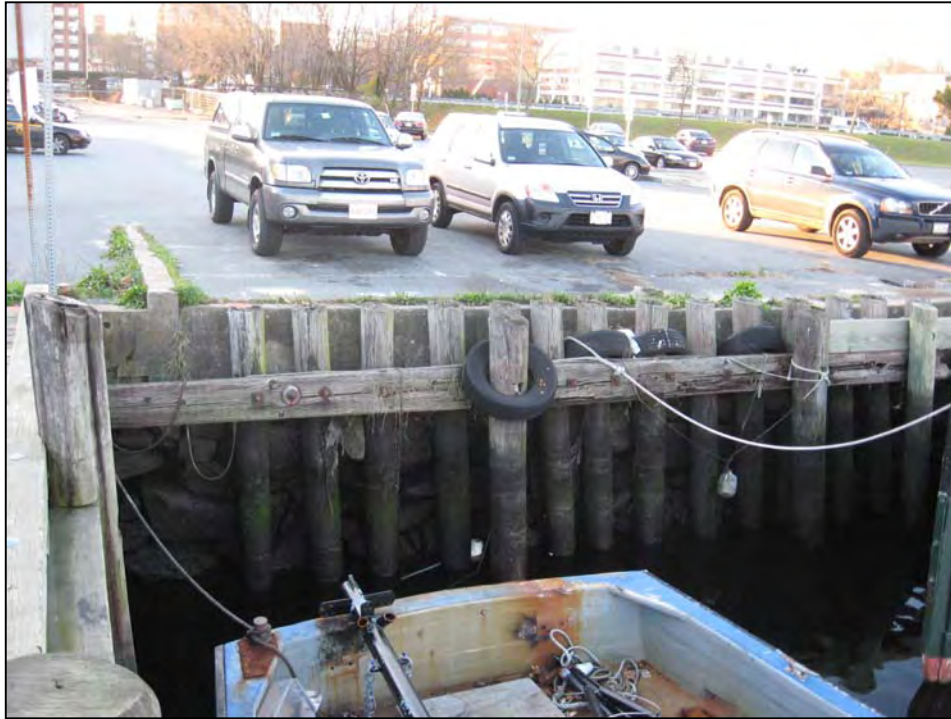
Photo No. 5: Timber fender system with docked vessel along the stone bulkhead from Station 1+70 to Station 2+10.

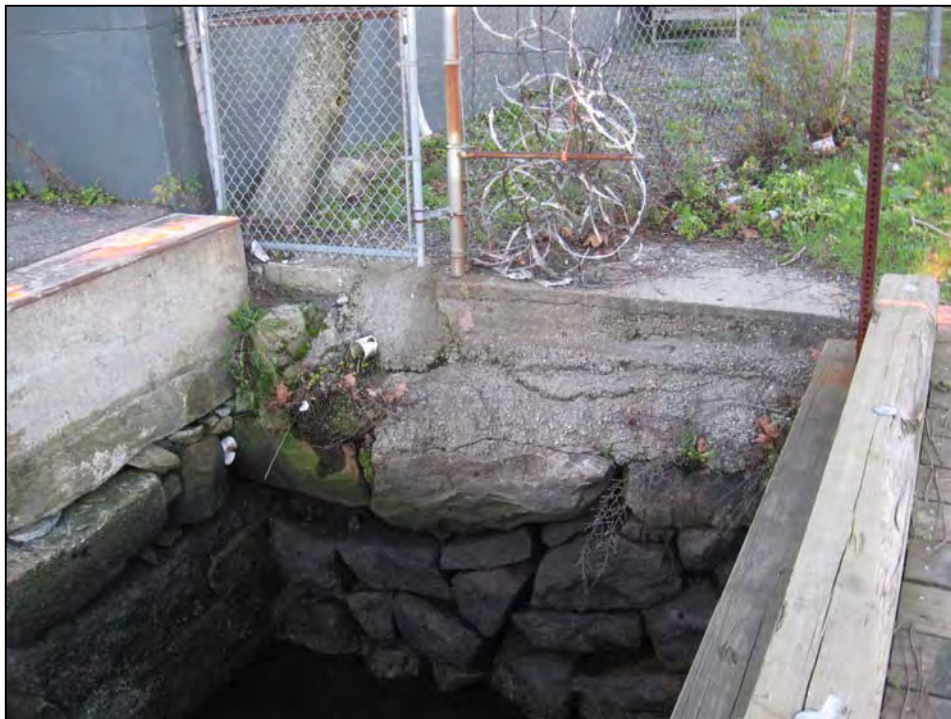
Photo No. 6: Stone bulkhead and concrete fill from Station 2+40 to Station 2+50.

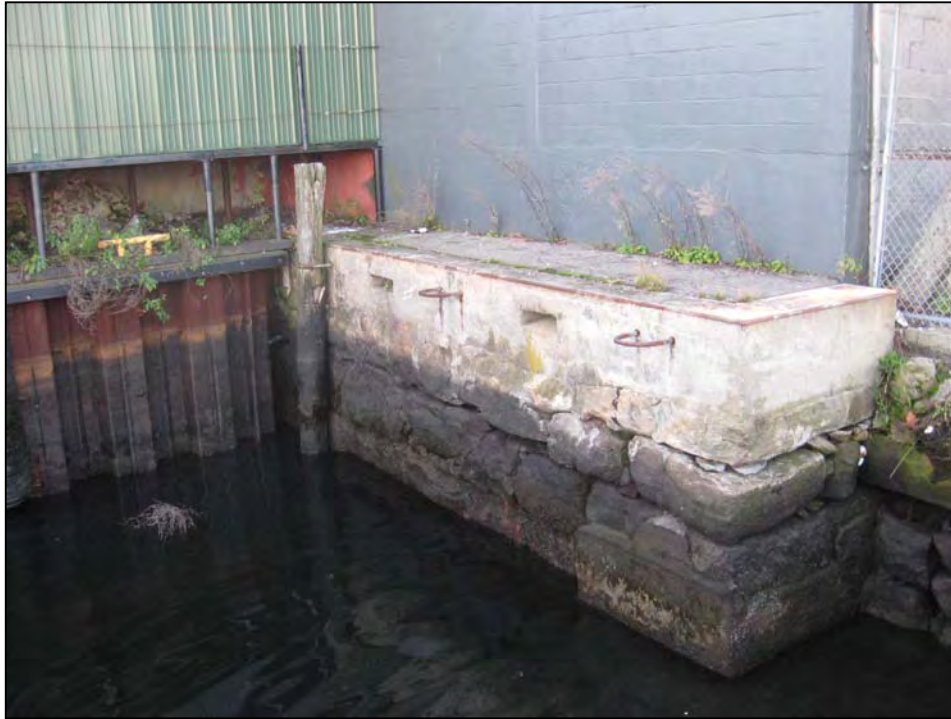
Photo No. 7: Stone bulkhead and concrete fill from Station 2+50 to Station 2+80.

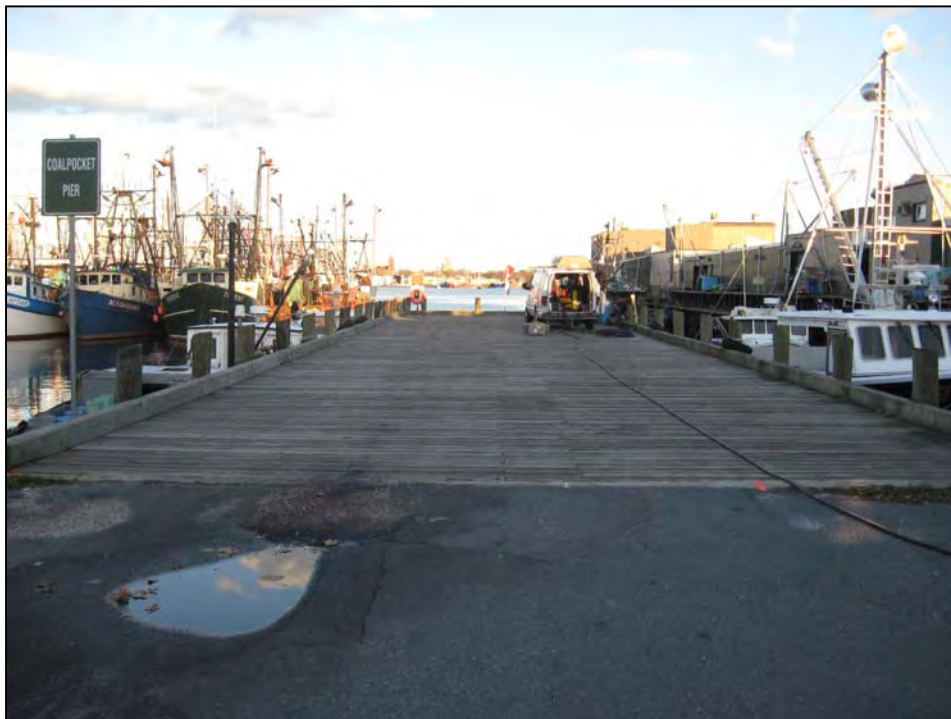
Photo No. 8: Overview of the 30' wide timber pile supported pier.

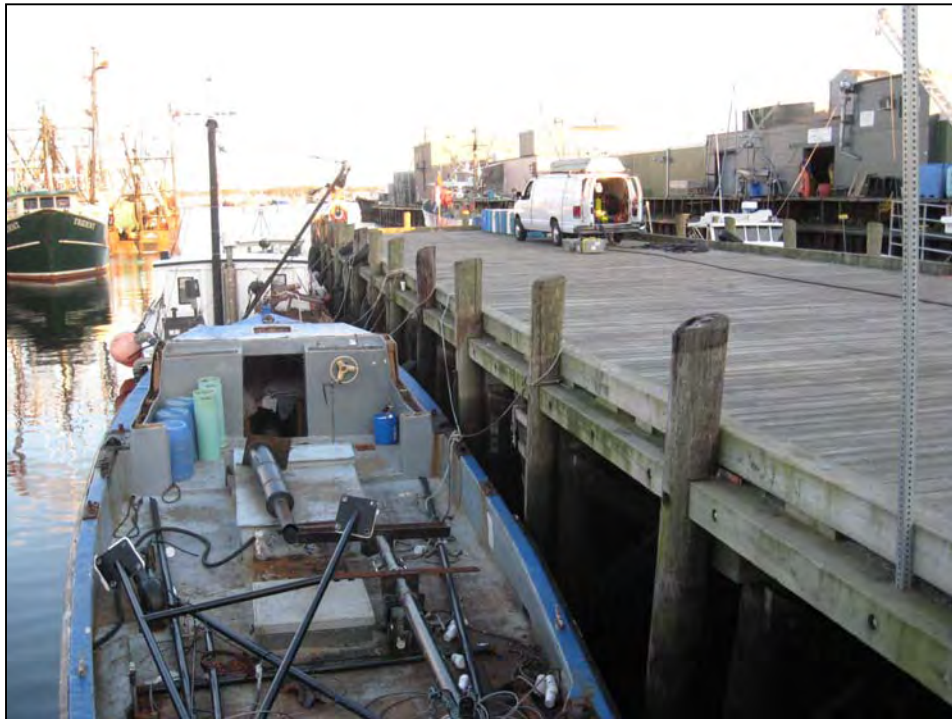
Photo No. 9: Overview of the fender system with docked vessel along the timber pier.

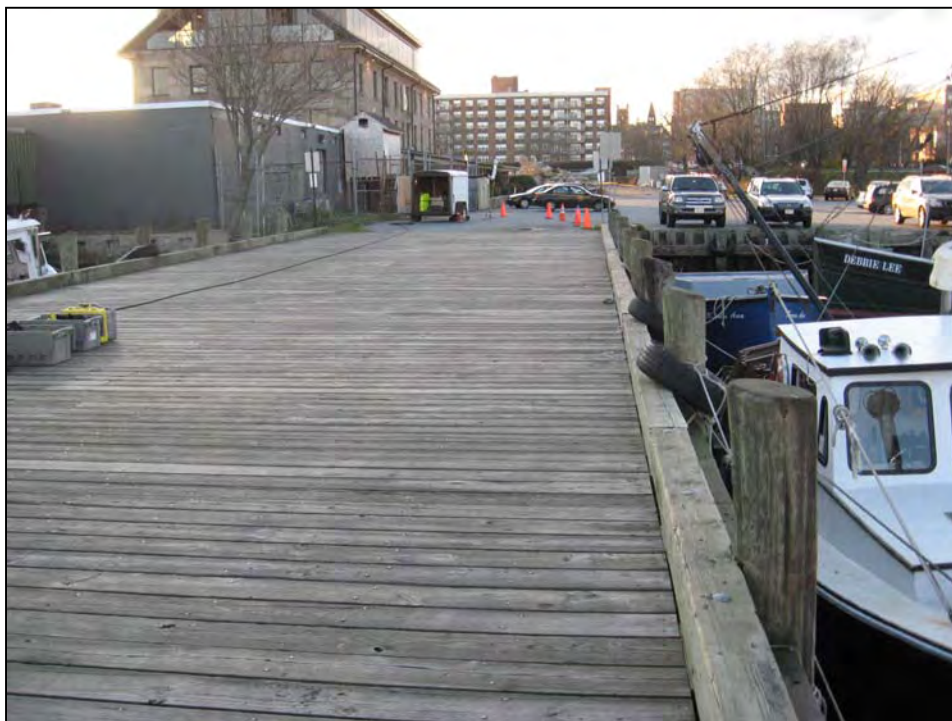
Photo No. 10: Overview of the timber decking along the pier.

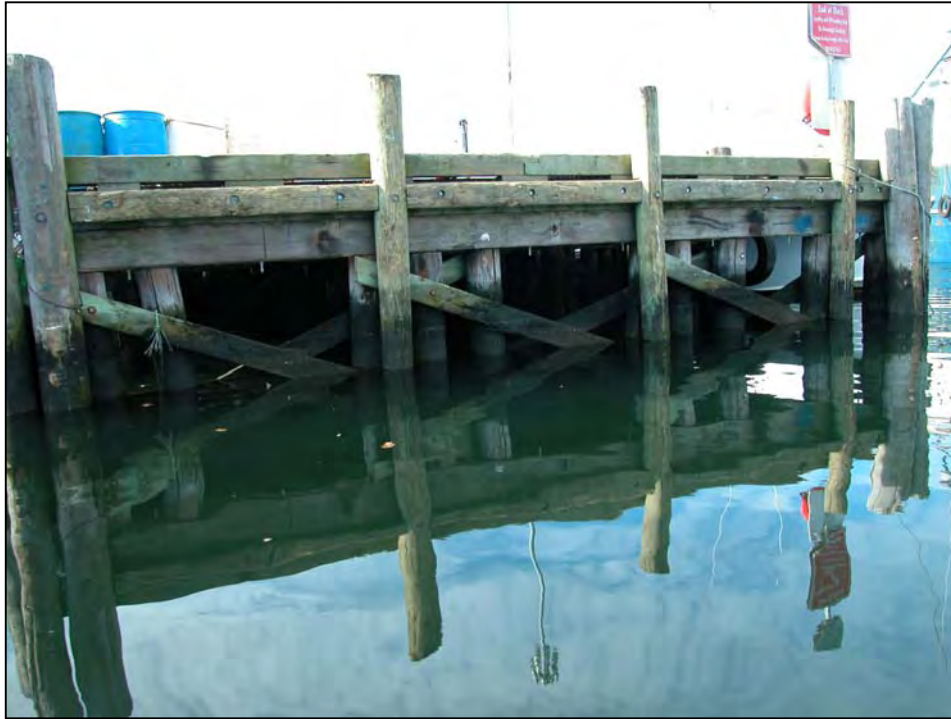
Photo No. 11: Overview of the end of the timber pier and timber fender system.

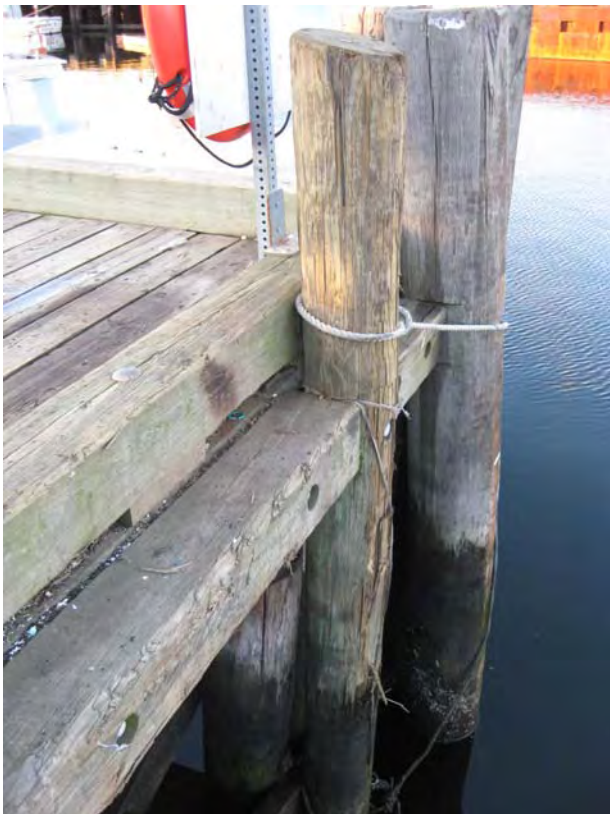
Photo No. 12: Typical wearing of the fender face at the end of the timber pier.

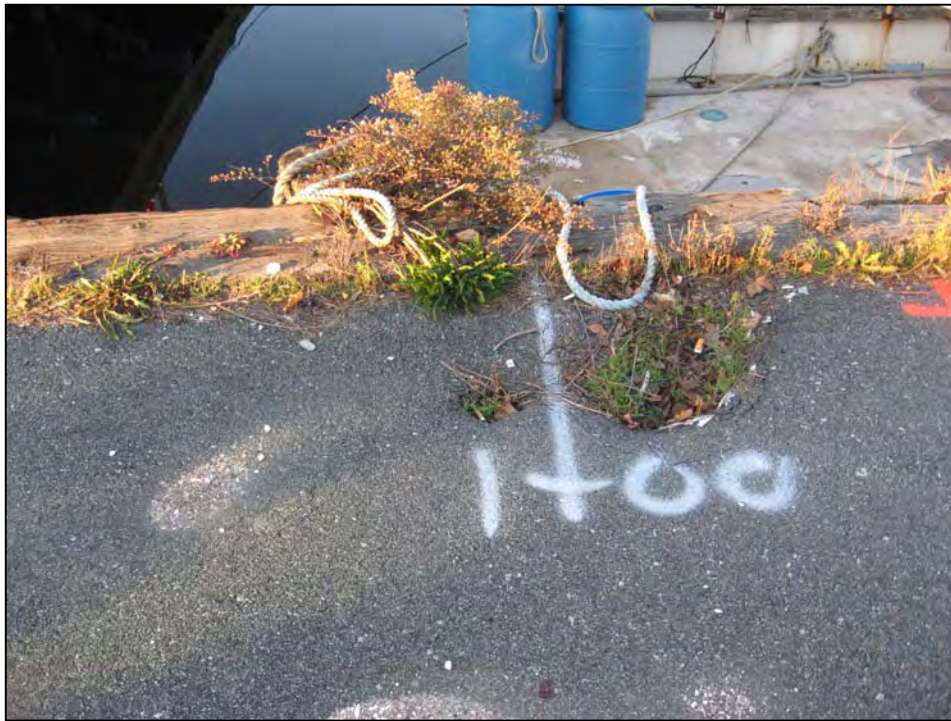
Photo No. 13: Area of subsidence behind the bulkhead wall. Note: Void observed in stone bulkhead in underwater inspection report.

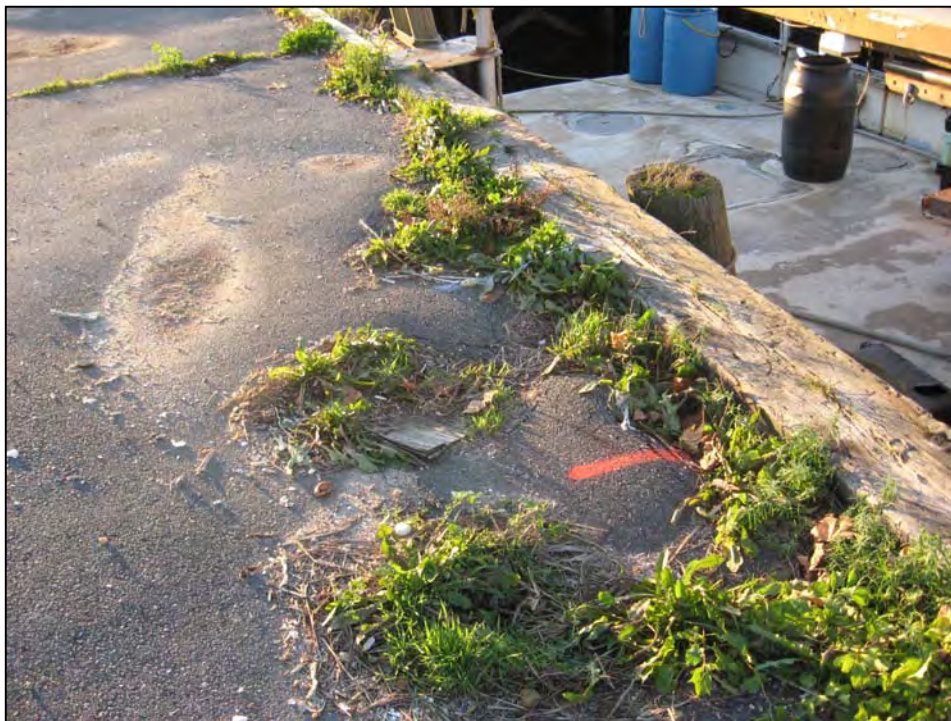
Photo No. 14: Areas of subsidence behind the bulkhead near Station 1+25.

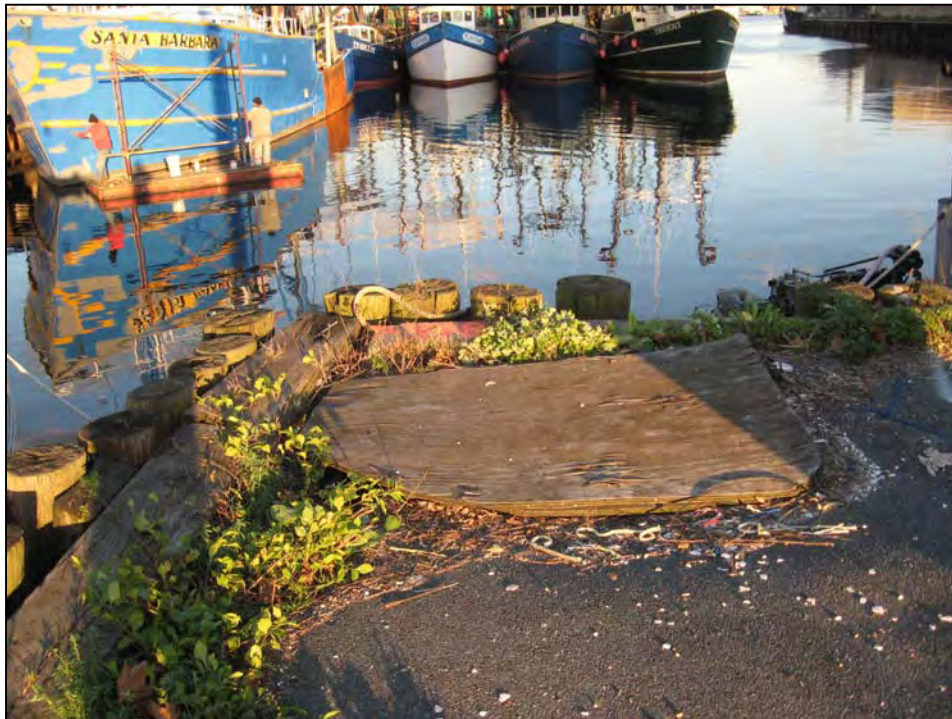
Photo No. 15: Plywood sheet covering 7' wide area of subsidence at Station 1+40.

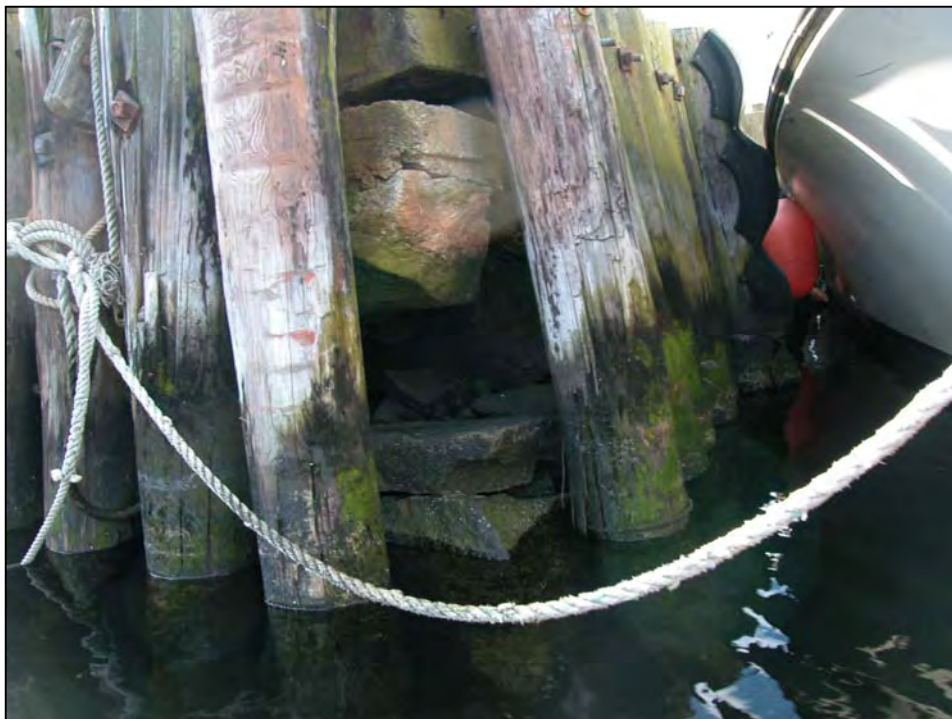
The existing granite block seawall was observed to be in generally poor condition, with large voids observed in the wall, and associated subsidence of the retained fill behind the wall. Without remedial action, the wall will continue to deteriorate, with continued loss of material through the wall.

Photo No. 16: Large void with missing stone in bulkhead wall at Station 1+40.

This item consists of the rehabilitation of the existing stone wall from Station 90 to Station 2+80. Rehabilitation will include the excavation behind the wall, repairing of voids in the stone, and placement of a geotextile against the back of the wall prior to backfilling and replacement of the pavement. Rehabilitation will also include necessary repairs to the existing timber fender pile system in front of the wall.

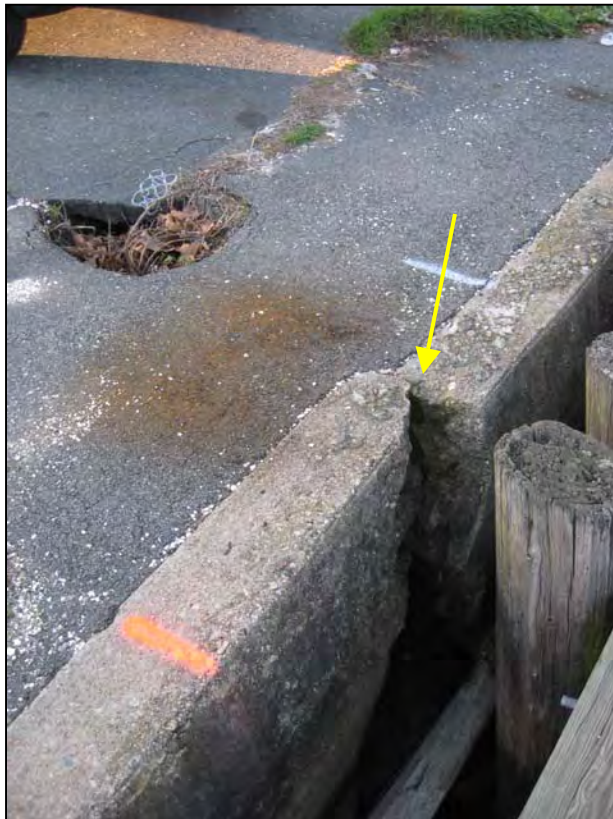
Photo No. 17: Area of subsidence (34" diameter) at Station 1+76. Note the displacement of the concrete wall.

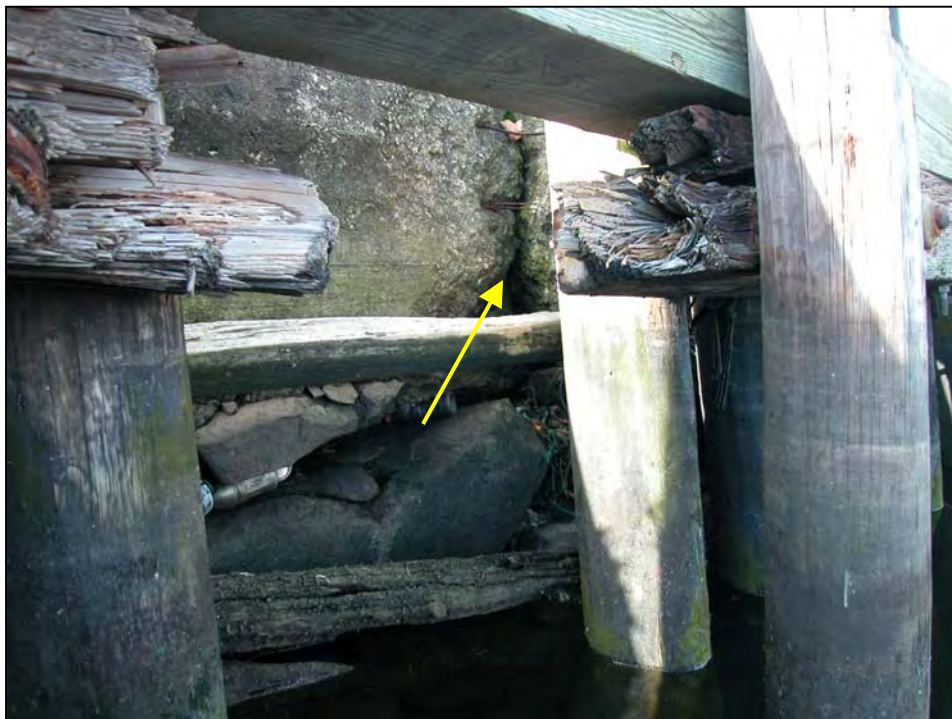
Photo No. 18: Displacement of the concrete wall with exposed reinforcement at Station 1+75.

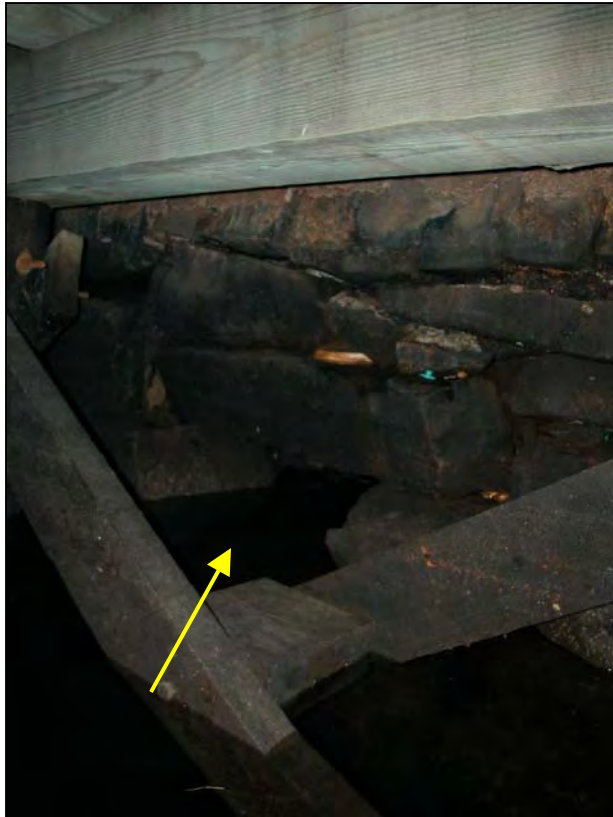
Photo No. 19: Void observed in the stone bulkhead at Station 2+20 beneath the timber pier

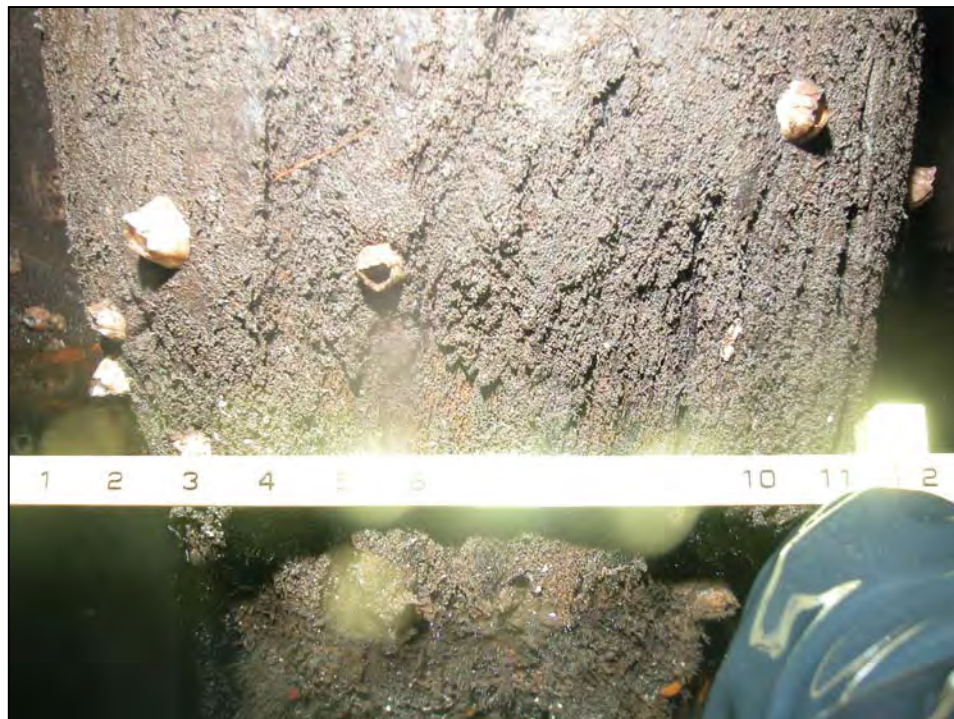
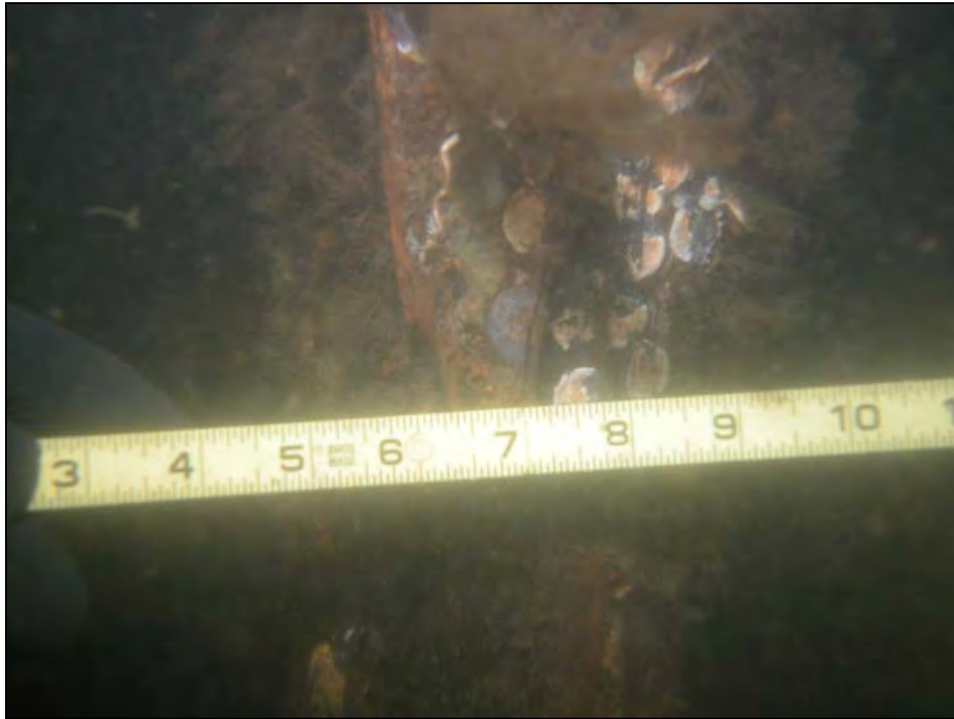
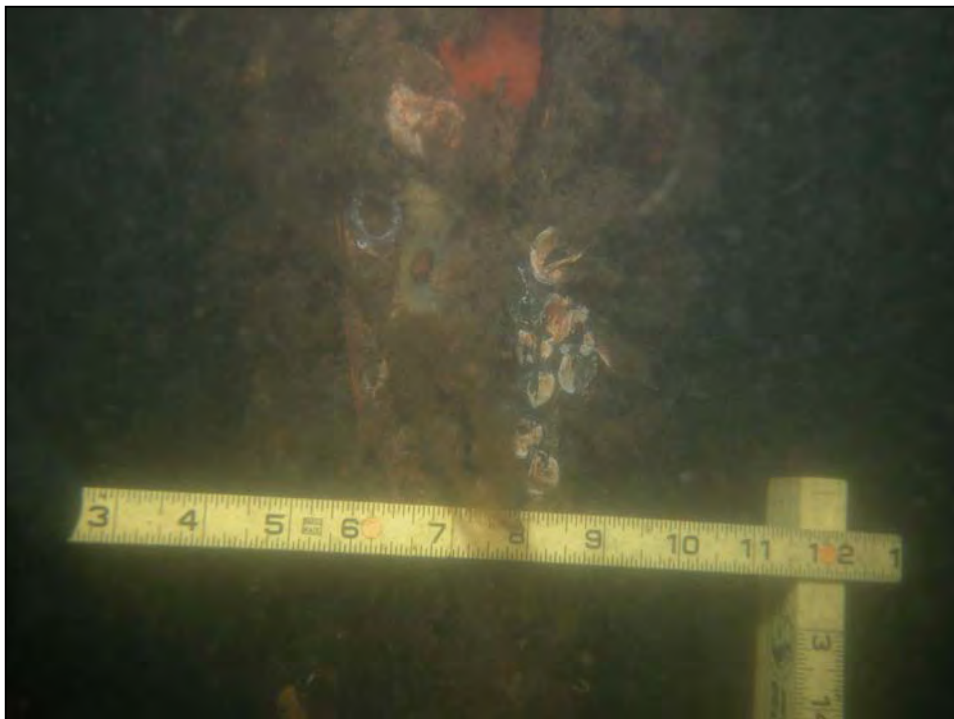
Based upon the visual inspections, the timber support piles of the Coal Pocket Pier are in generally poor condition. The significant section loss of the timber support piles beneath the pier due to rot and marine borer attack has reduced the pier load capacity to approximately 30% of its original capacity. The timber above the waterline is considered to be in fair condition. The pier is at or near the end of its useful life, and major rehabilitation or replacement is warranted. The posted reduced allowable loading of the timber pier should be continued until repairs can be carried out.

Photo No. 20: Typical underwater view of the timber pile section loss beneath the timber pier. (Photo by Childs Engineering Corp.)

This item consists of the removal and replacement, or sistering, of the severely deteriorated timber piles supporting the Coal Pocket Timber Pier. Providing “fish plates” or concrete jackets as means of repair has been ruled out at this location, as the location of the deterioration is at the mudline, and would require costly labor intensive work below the mudline.

The proposed work will consist of the removal of the timber decking, removal and replacement of approximately 75 timber piles, and refastening of the timber bracing and decking. In addition, the remaining 60 timber piles, with at least 6 inches of pile diameter remaining, should be wrapped along the underwater component to arrest further marine borer damage.
