**INSPECTION REPORT
CO-OP / FISHERMAN'S WHARF
NEW BEDFORD WATERFRONT
FACILITIES INSPECTIONS
NEW BEDFORD, MASSACHUSETTS**

MARCH 2009

EXECUTIVE SUMMARY

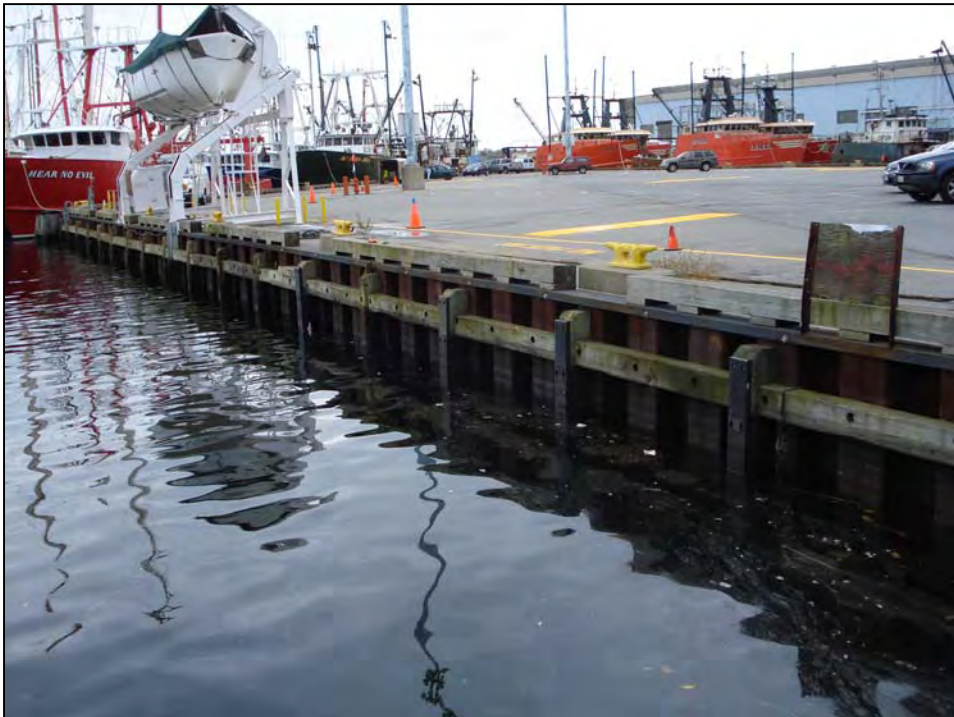
| Location | Station | Deficiency | Description |
|---|---|---|---|
| Underwater | 0+20 - 0+30 | Lower Wale | Fastening studs broken |
| Underwater | 0+40 - 1+73 | Lower Wale | Missing lower wale |

Photo No. 2: Steel Sheetpile bulkhead from approximately Station 0+20 to Station 1+73.

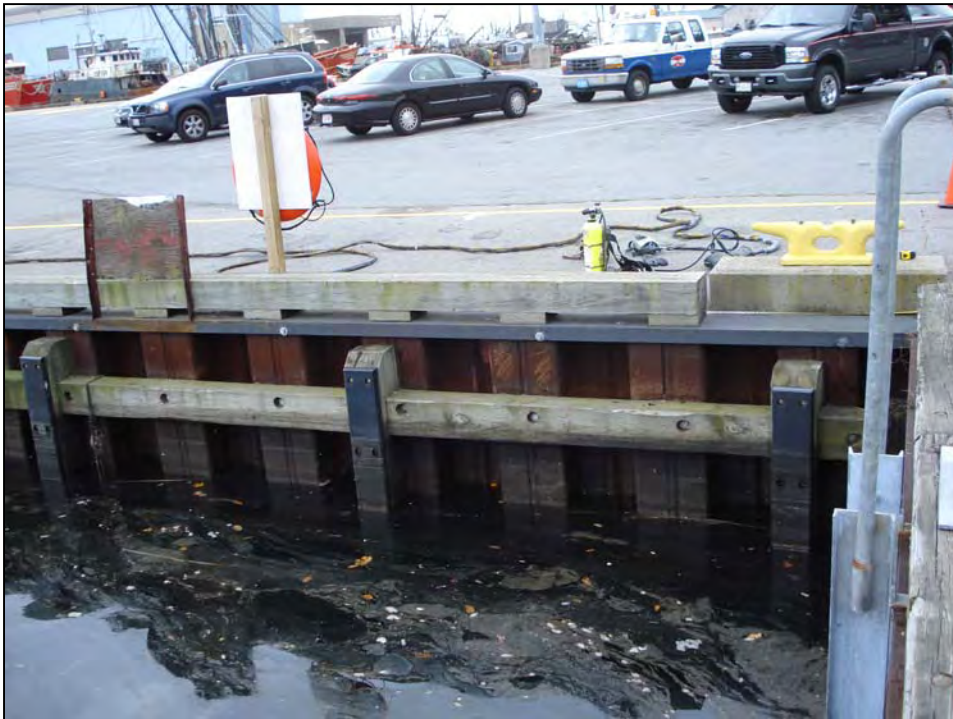
Photo No. 3: Typical overview of the timber fender system with UHMW rubber rails.

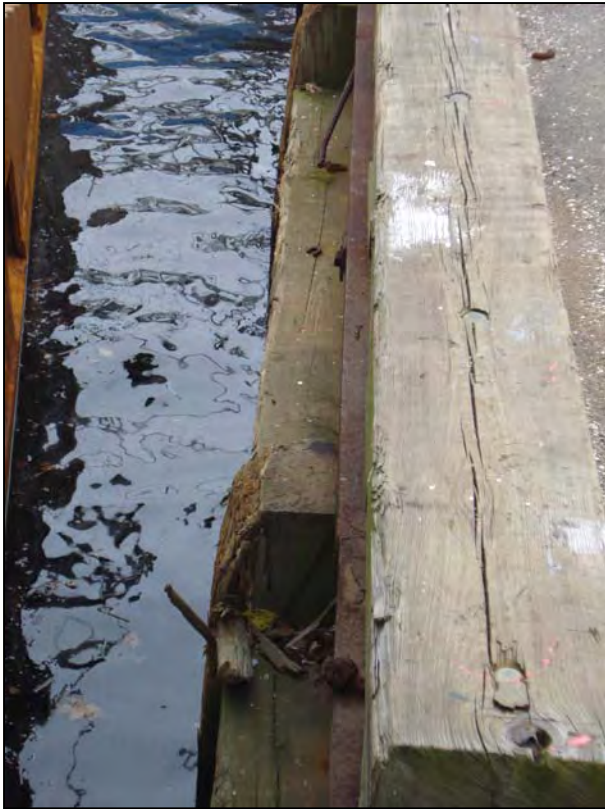
The timber vertical fenders were observed to be in overall good to fair condition, with the exception of several areas that were observed to be in poor condition. Typical deficiencies consist of rotting of the timber, wearing of the tops of fenders and fender faces, and impact damage causing splintering and splitting. A majority of the UHMW rub rails were observed to be missing or loose. Typically, the square top edge of the UHMW rub rail was observed to get caught on the rub rail on the docking vessels, causing them to be snagged and dislodged. The table below indicates specific locations of missing and loose rub rails.

Photo No. 5: Typical worn fender pile with missing UHMW rub rail.

A. Repair and Rehabilitate the Existing Timber Fender System

This item consists of the removal and replacement of damaged, missing and excessively worn components of the timber fender system. This item also includes the replacement of the older fender system from Station 8+80 to 10+44,

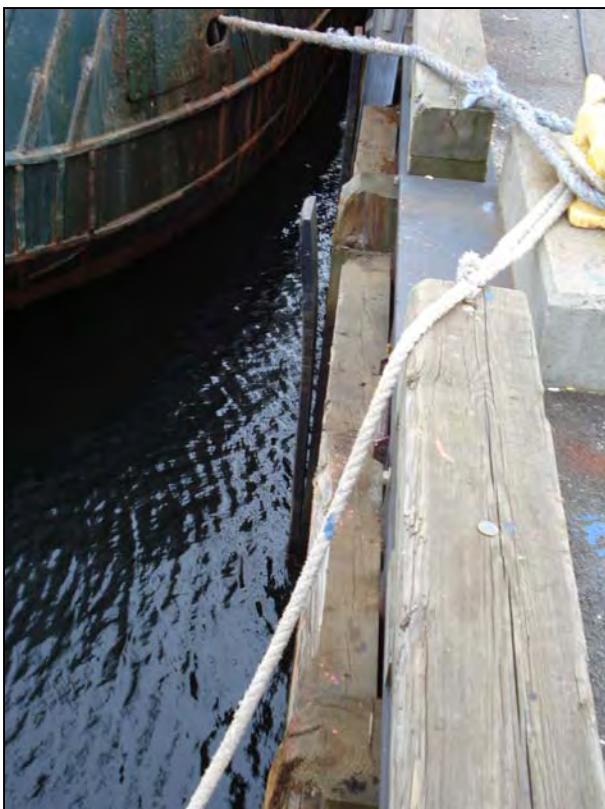
Photo No. 6: Typical loose UHMW rub rail.

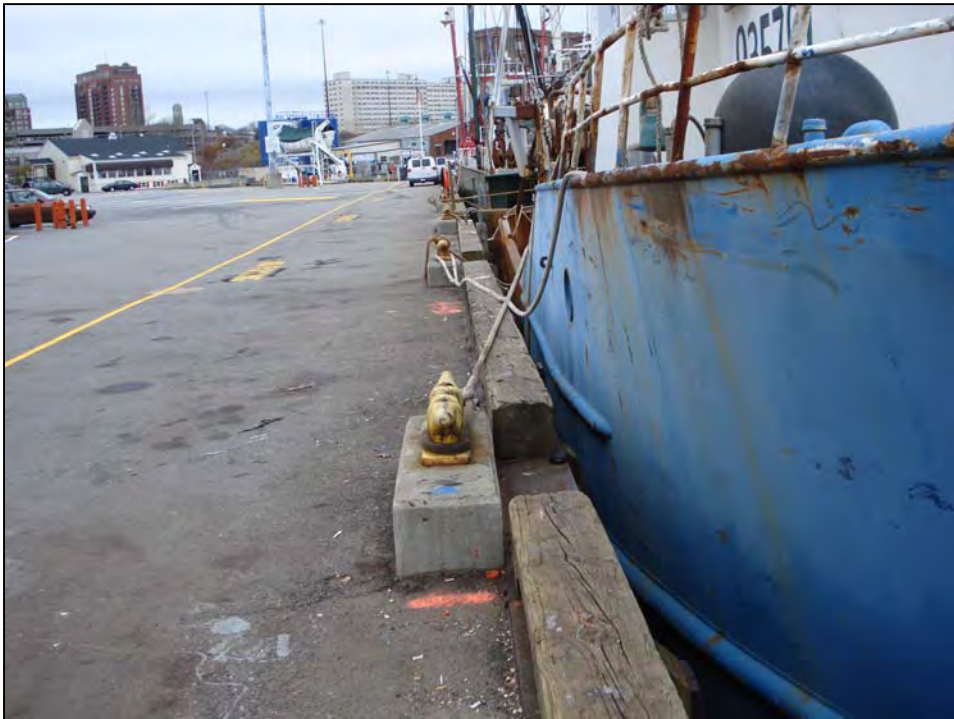
Photo No. 7: Overview of the Wharf and fender system from Station 5+09 looking northwest.

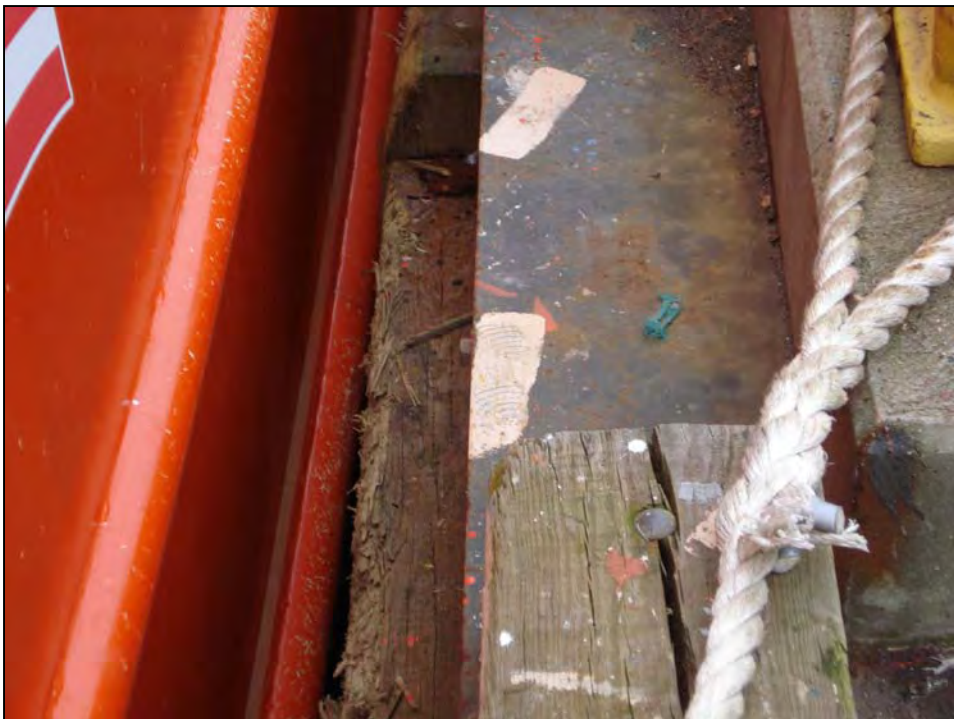
Photo No. 8: Worn fender pile in contact with a docked vessel.

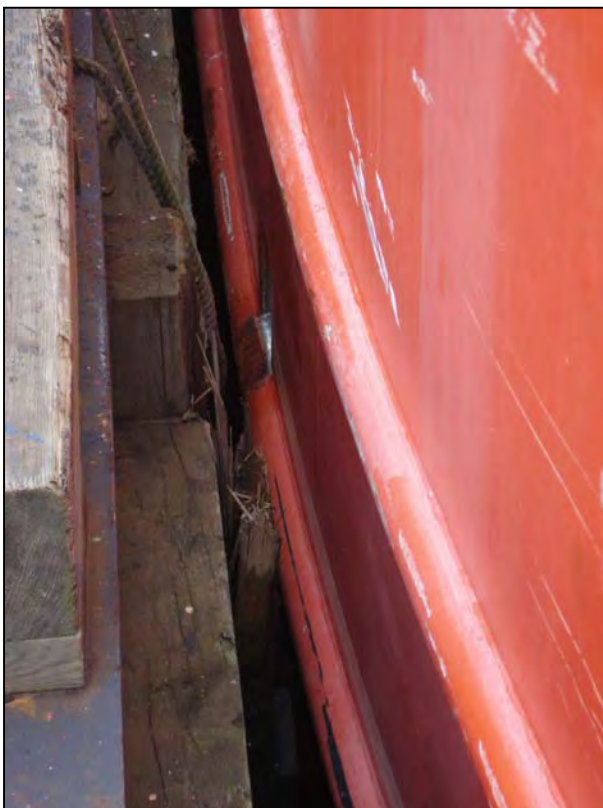
Photo No. 10: Top of a splintered and broken fender pile.

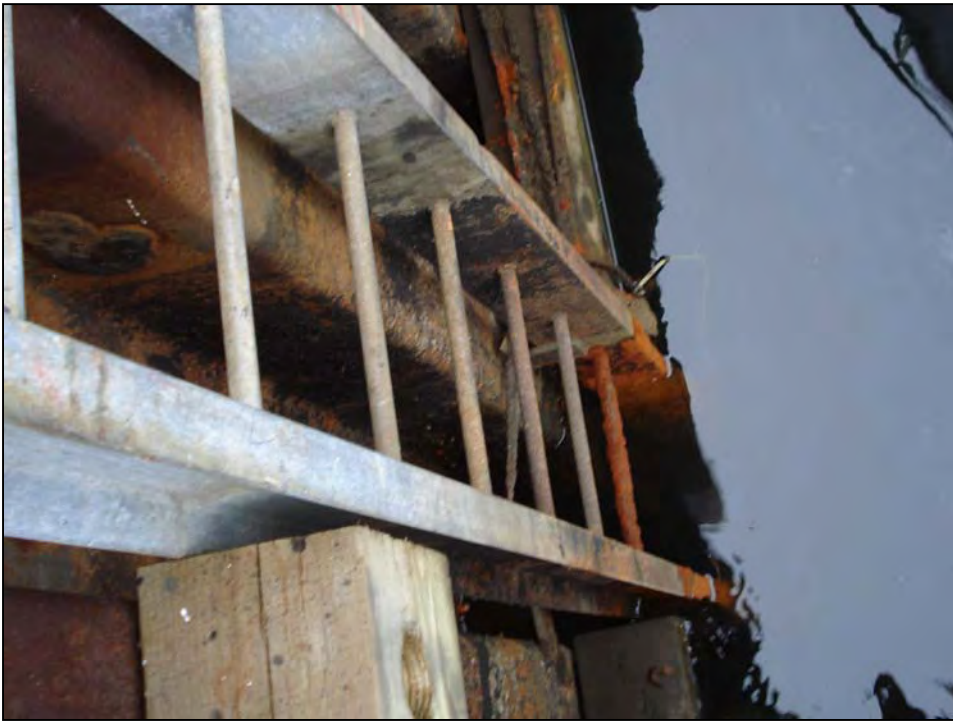
Galvanized steel ladders are located at approximate 100 foot intervals around the bulkhead to provide access to and from the deck to the water below. Overall the ladders were observed to be in fair condition. Some of the ladders are in good condition above mean high water, while others have been damaged during impact with vessels causing damage to the rungs and buckling of the upright members. All of the ladders were observed to be corroded below mean high water rendering them unusable during times of low water.

Photo No. 11: Typical access ladder with corroded rungs.

B. Remove and Replace Access Ladders

This item consists of the removal and replacement of damaged and deteriorated ladders. Also included in this item is the removal of the remaining UHMW facing. The opinion of probable construction cost is approximately \$24,000.

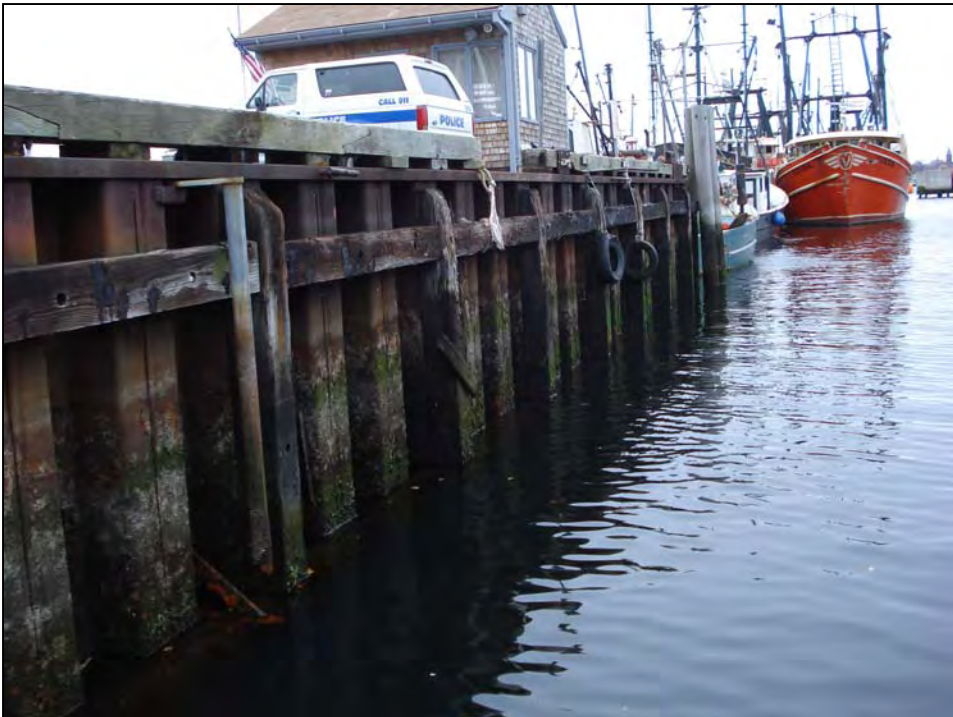
At Station 8+80, the fender system transitioned to an older fender system. The older fender system protects the steel sheetpile bulkhead from Station 8+80 to Station 10+44. It is comprised of 10 inch by 10 inch timber vertical fenders at 10 feet on center with 10 inch by 10 inch timber chocks. An 8 inch by 12 inch timber curb is supported by 3 inch by 12 inch by 12 inch blocks spaced 36 inch on center. The cleats in this area are 32 inch long and are bolted to either the cap channel or a welded steel box on top of the cap

Photo No. 12: Overview of the older fender system from Station 8+84 to Station 10+44.

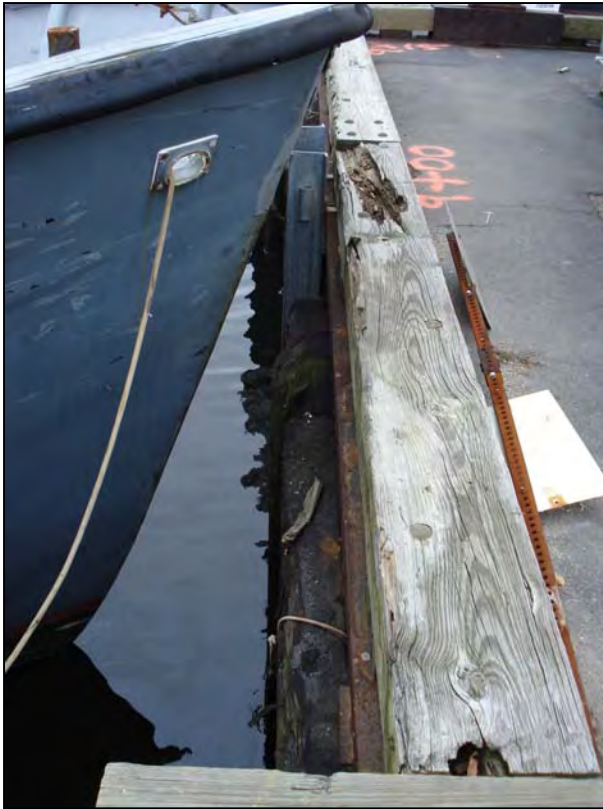
channel. From Station 8+80 to Station 9+30, the vertical fenders and chocks are in fair condition with some signs of rot and wearing on faces. The timber curb was observed to be in poor condition with significant rot from Station 8+85 to Station 9+00. The timber chocks and vertical fenders were observed to be in fair to poor condition primarily because of wear from Station 9+30 to Station 9+80. From Station 9+80 to Station 10+44, the fender system appeared to be in good to fair condition. The older fender system terminates at Station 10+44 at the corner of the timber deck.

Photo No. 13: Older fender system with rotted timber curb and damaged chocks.

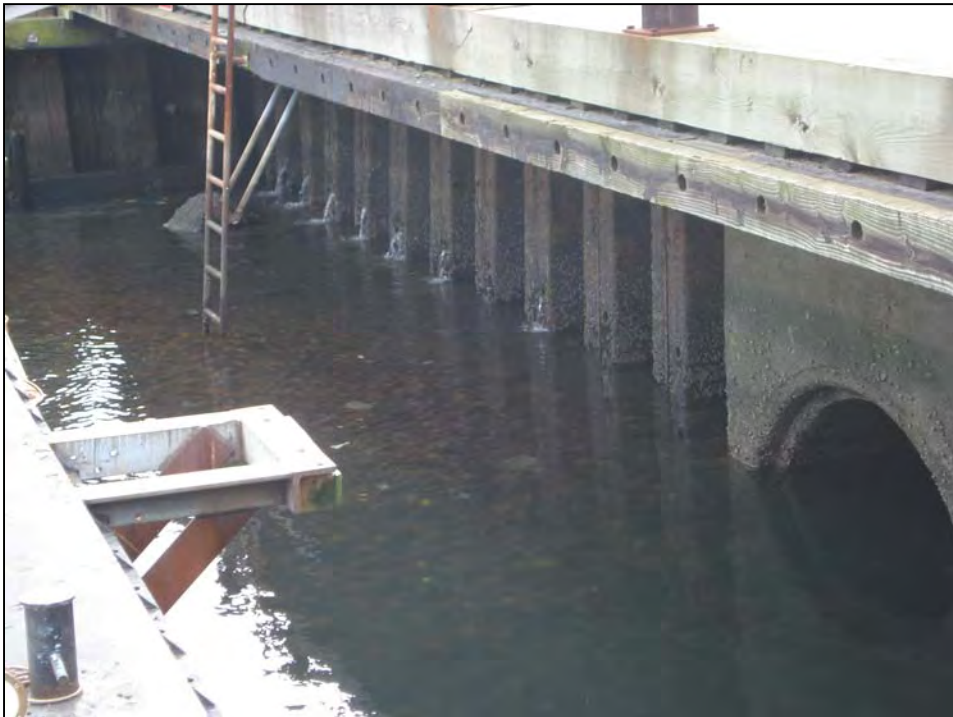
Photo No. 14: Overview of the steel sheetpile bulkhead beneath the timber deck from Station 10+44 to Station 11+21.

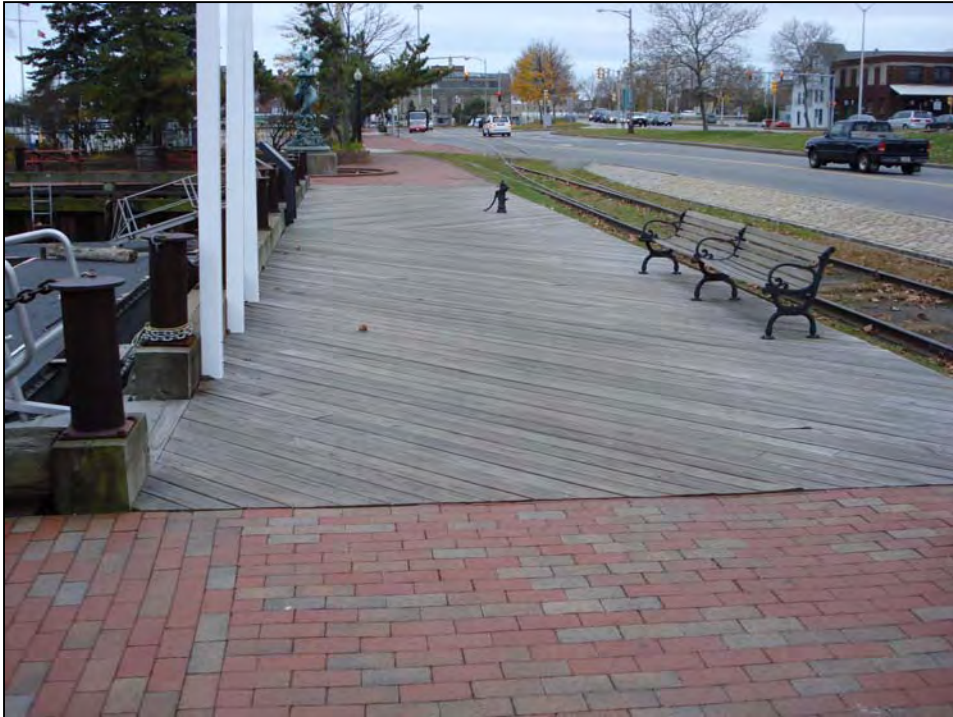
A 16 foot wide timber deck exists from Station 10+44 to Station 11+21 and was observed to be in overall good to fair condition. The timber decking was solid, with no loose boards noted. Some splintering and warping was observed. An existing railroad switch protruded through the deck at Station 10+95. From Station 10+06 to Station 10+44 and from Station 10+51 to Station 11+21, steel bollards with chain are mounted on top of the timber curb. Two gangways extend from the timber deck to floating docks. At Station 10+48 a 30 feet long aluminum gangway with 3.5 feet clear spacing was observed to be in good condition. At Station 11+09, a smaller 15 feet long aluminum gangway with 30 inch clear spacing extended to a floating barge and was observed to be in good to fair condition. Access to this gangway was restricted with the chain connecting two adjacent bollards.

Photo No. 15: Overview of the timber deck from Station 10+44 to Station 11+21.

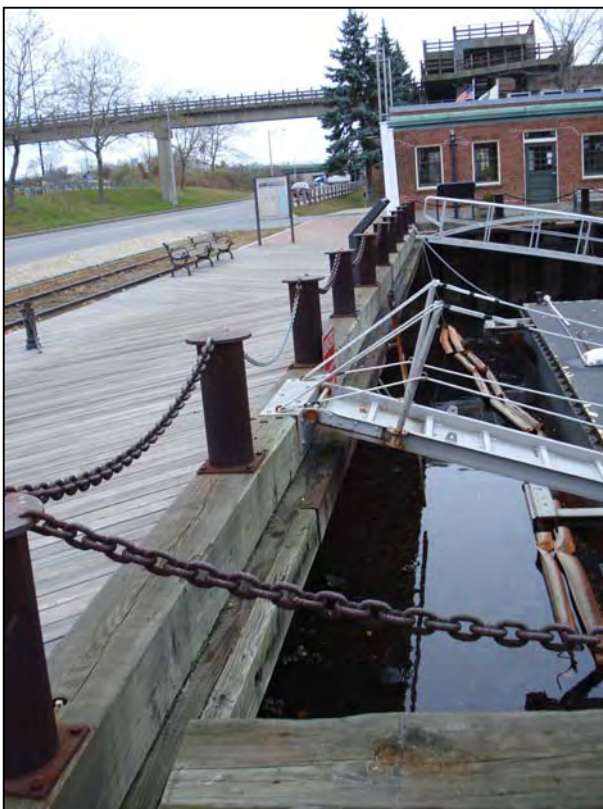
Photo No. 16: Overview of the timber curb with steel bollards along the timber deck.

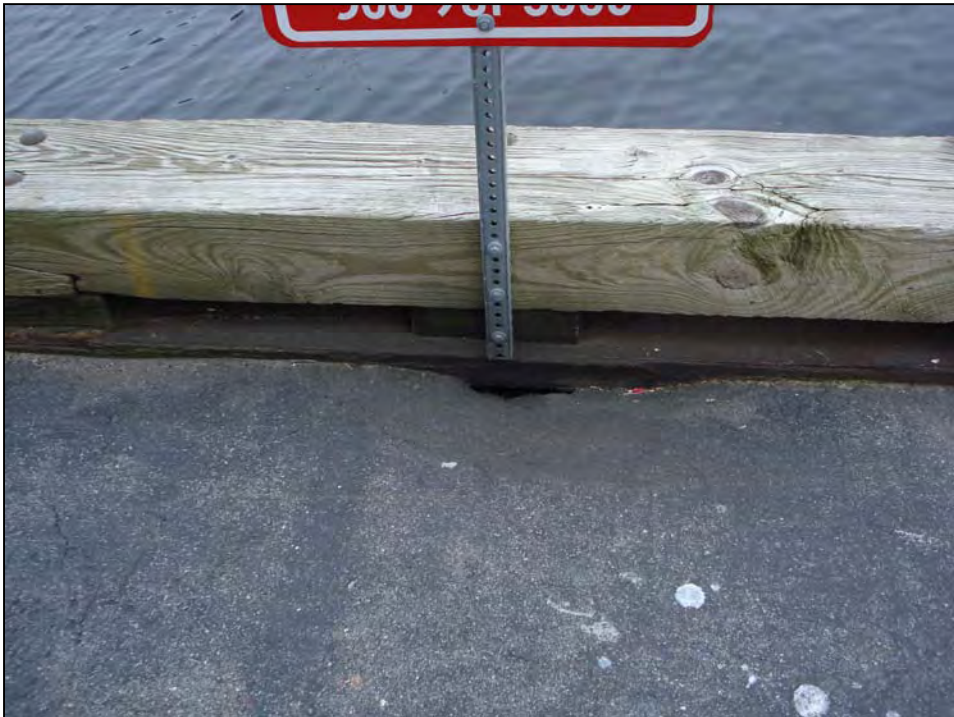
Several areas of local subsidence were observed behind the bulkhead. At Station 1+05, a 12 inch long by 3 inch wide by 3 inch deep area of subsidence was observed with a loss of fill soils and asphalt. At Station 9+00, a 16 inch long by 6 inch wide by 1 inch deep area of subsidence was observed behind the bulkhead. A 24 inch long by 8 inch wide by 6 inch deep area of subsidence was observed at Station 9+34 with a loss of fill material and asphalt, as shown in Photo No. 18 in Appendix A - Photographs.

Photo No. 18: Subsidence behind the steel sheetpile bulkhead at Station 9+34.

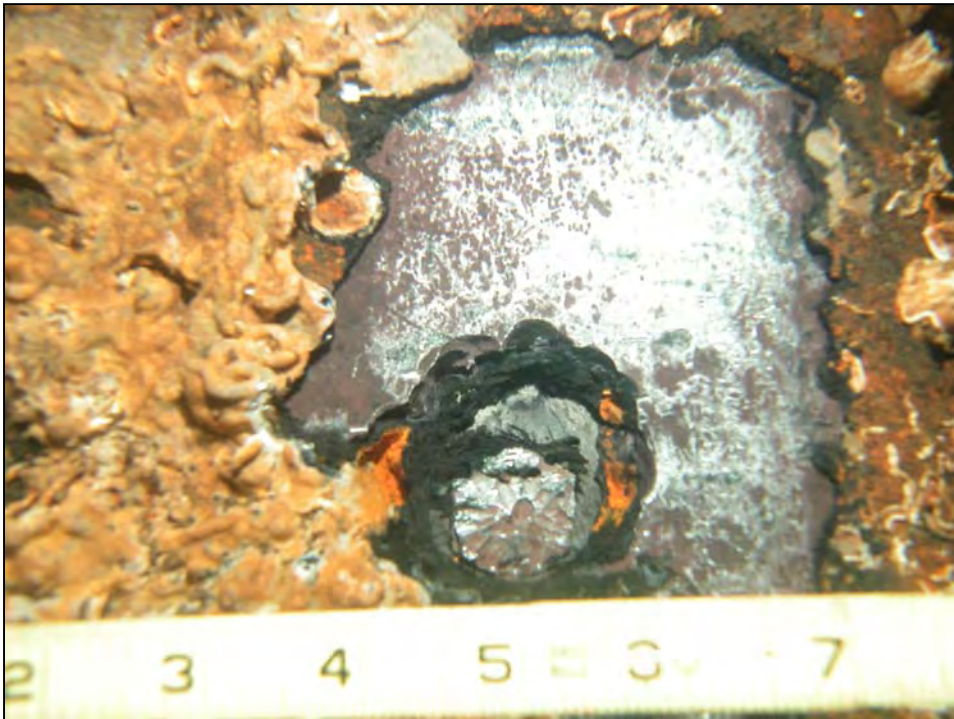
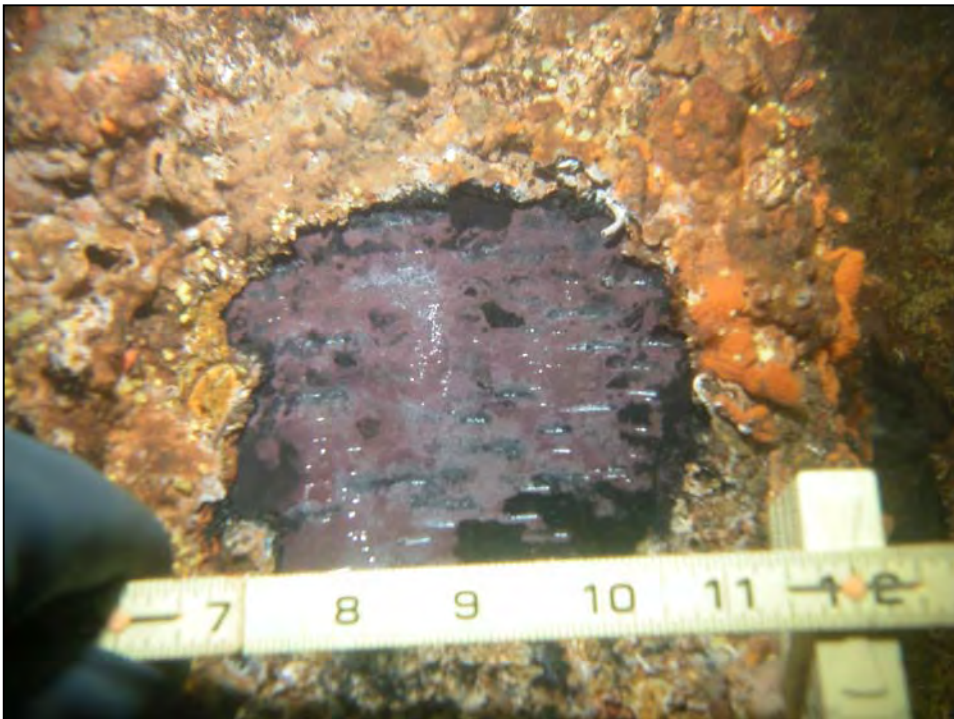
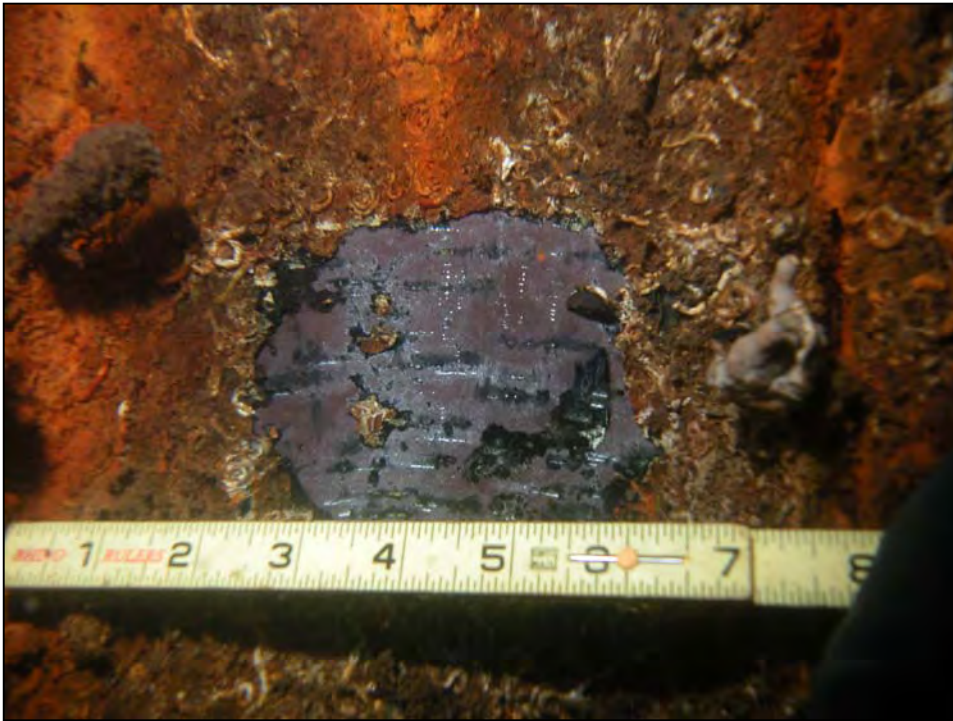
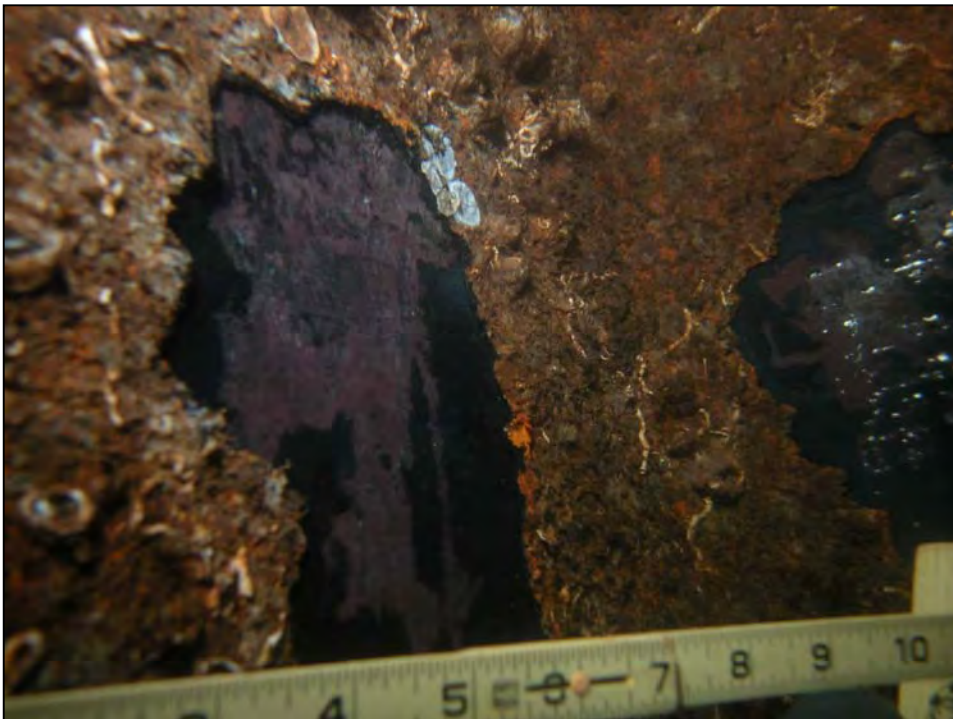
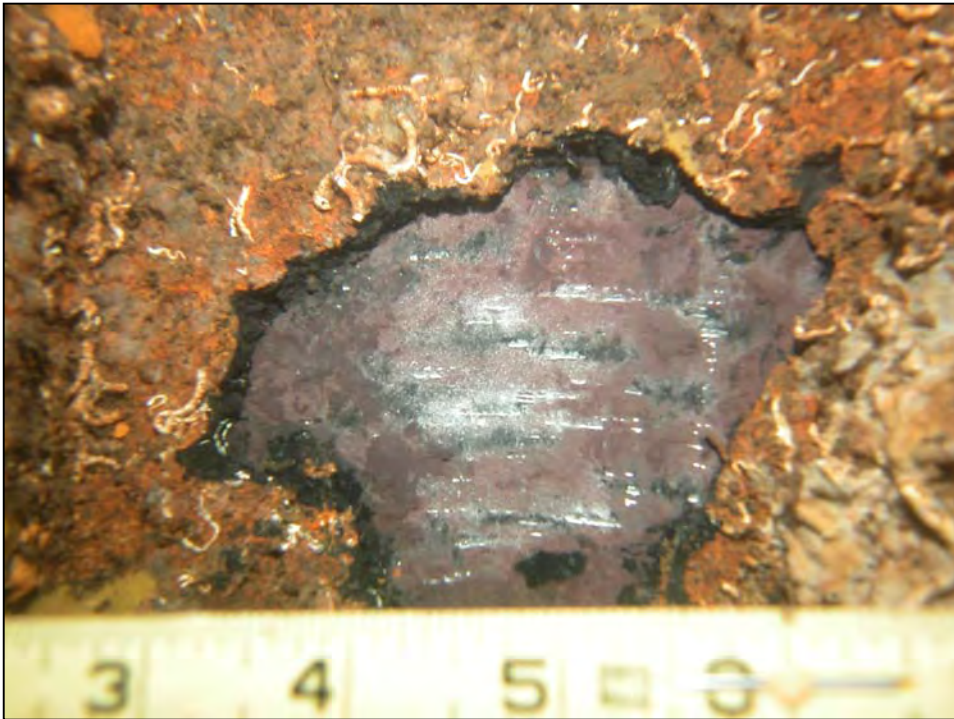
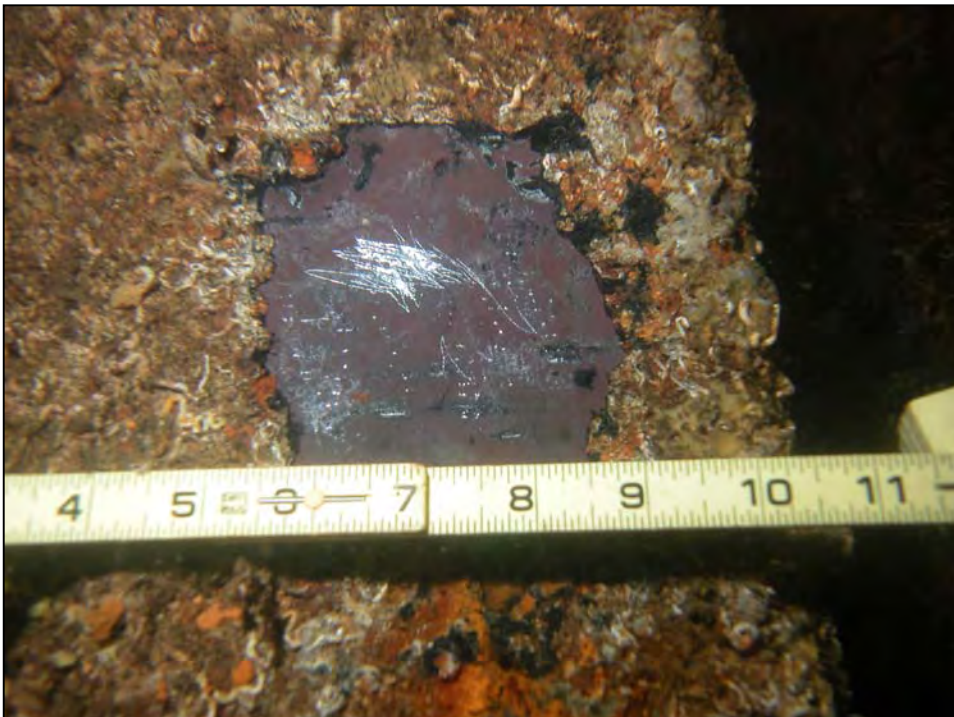
Typically, at Fisherman's Wharf, the steel sheetpile bulkhead was observed to be actively corroding; however there is still significant steel section remaining. The existing coating is failing and there is a layer of black corrosion byproduct built up below the thin layer of marine growth. Corrosion has started to open up holes that were originally drilled through the sheeting for a bolted connection. The holes are typically located at about the MLW elevation. No anodes were found on the wall, consistent with a repair plan dated 1998 which indicates that anodes were to be removed from the wall at that time. The galvanized ladders are severely corroded at the bottom, with the bottom 3 rungs typically unusable. The timber fender system is in fair condition below the waterline. The timber is hard and sound and has some minor abrasion loss. There are some loose connections and missing sections because of corroded hardware. The following table indicates deficiencies observed during the underwater inspection.

Typical UT readings on both the web and flanges displayed reduced thicknesses near mean low water, however the amount of section loss is considered to be minor. Thickness readings on the web indicated average section loss of 7.3% with a maximum reading of 22.3% loss. Using the average section loss and estimating the construction date to 1975, average corrosion rates cause a loss of section of approximately 0.001 inch per year or 0.2%. The minimum thickness reading indicates a section loss of 0.095 inch or 25.3%, corresponding to a maximum section loss of 0.003 inch per year or 0.75%.

Although the coating has played an important role in the corrosion protection of the sheeting, corrosion rates will accelerate if the sheeting is left untreated. Based upon average corrosion rates in the area, if left untreated, the expected life of the sheeting is anticipated to be in the order of 25 years. The installation of coatings and cathodic protection can increase this remaining useful life.

Photo No. 19: Observed steel sheetpile condition underwater (Photo by Childs Engineering Corp.)

This item consists of the installation of a new aluminum anode cathodic protection system, welded to the existing steel sheet piling below mean low water. The cathodic protection system will inhibit steel section loss due to corrosion below the water line. The opinion of probable construction cost is approximately \$146,100.
