PARE PROJECT NO. 08216.00

**INSPECTION REPORT
HOMER'S WHARF
NEW BEDFORD WATERFRONT
FACILITIES INSPECTIONS
NEW BEDFORD, MASSACHUSETTS**

MARCH 2009

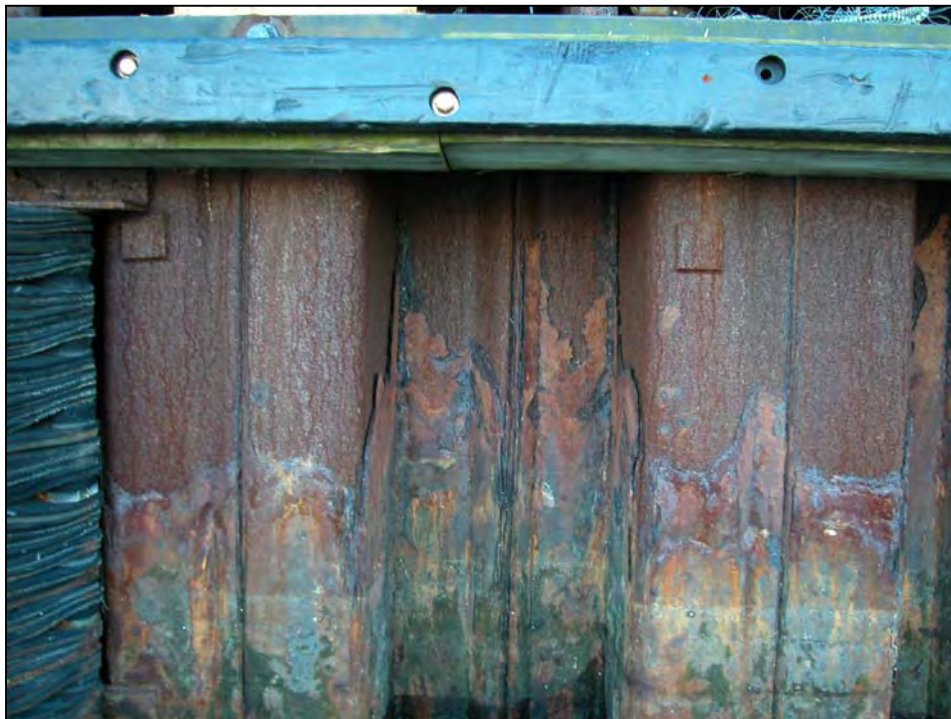
Photo No. 4: Typical condition of the sheetpile bulkhead.

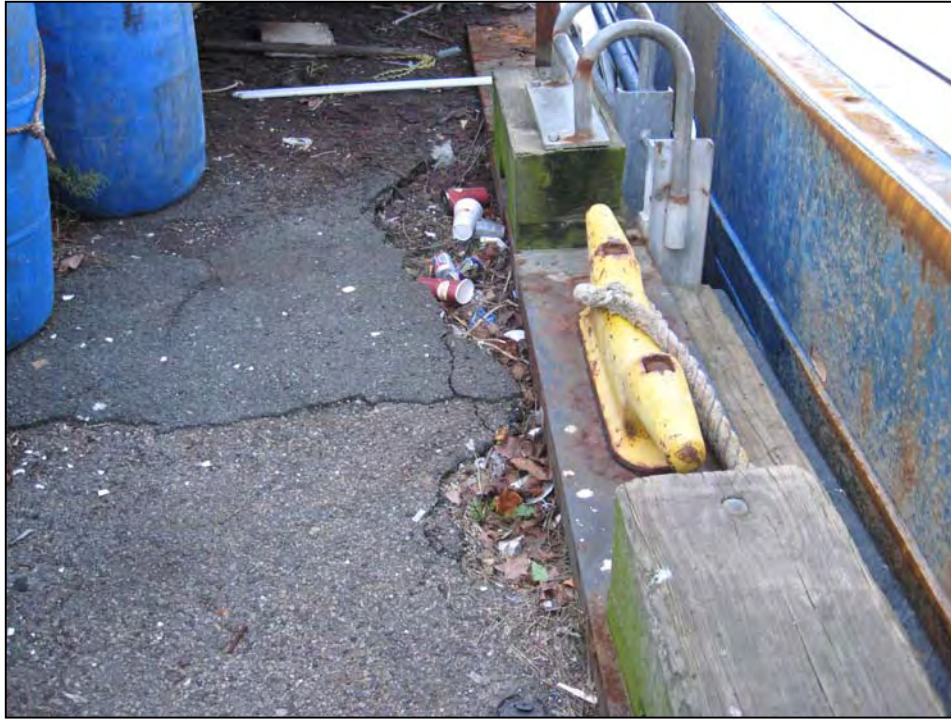
Several areas of local subsidence were observed behind the bulkhead. From Station 2+32 to Station 2+40, a 16-inch wide by 5-inch deep area of subsidence was observed (Photo 5). It appeared as if a hole has been cut through the top of the sheetpile wall at this location for unknown reasons, allowing draining water to remove fill material. At Station 2+95, a 12-inch long by 12-inch wide by 3-inch deep area of subsidence was observed. At Station 7+57, a 48-inch long by 12-inch wide by 1.5-inch deep area of subsidence was observed behind the bulkhead. A 24-inch long by 8-inch wide by 1.5-inch deep area of subsidence was observed at Station 12+12. From Station 11+88 to Station 13+07, a series of small areas of subsidence were observed at approximately 2 feet on center, as shown in Photo No. 17 in Appendix A: Photographs.

Photo No. 5: Subsidence behind the sheetpile bulkhead at Station 2+35 to Station 2+40.

Repair areas of subsidence along the wharf. Repairs are to include patching of the steel sheetpile bulkhead (where applicable) to minimize future subsidence, and backfilling and regrading of existing subsidence. The opinion of probable construction cost for this work is approximately \$45,000.

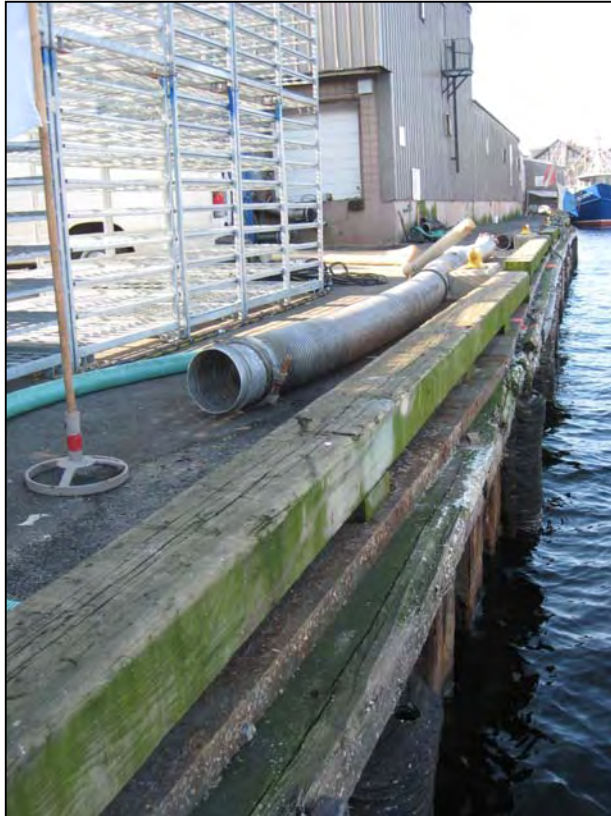
From Station 0+00 to Station 5+91, the timber wale and UHMW rub rails were observed to be in overall good condition. From Station 2+55 to Station 3+20, minor damage was observed along the timber wale and UHMW rub rail. The wale was observed to be displaced at Station 3+00, and only held on by the UHMW from Station 3+10 to Station 3+18. The timber wale and UHMW rub rail were observed to be in good condition from Station 3+00 to Station 5+13 with no major deficiencies noted. The timber wale was observed to be damaged and broken, with the UHMW rub rail missing from the face from Station 5+13 to Station 5+45 and from Station 5+86 to Station 5+91 at the corner of the bulkhead. The rubber tire fenders were observed to be in overall good condition.

Photo No. 7: Timber wale with missing UHMW rub rail. Note the damage to the wale.

Remove and replace damaged and worn timber wale. Failure to repair damaged areas may lead to additional damage to the fender system and structural damage to the pier. The opinion of probable construction cost for this work is approximately \$63,000.

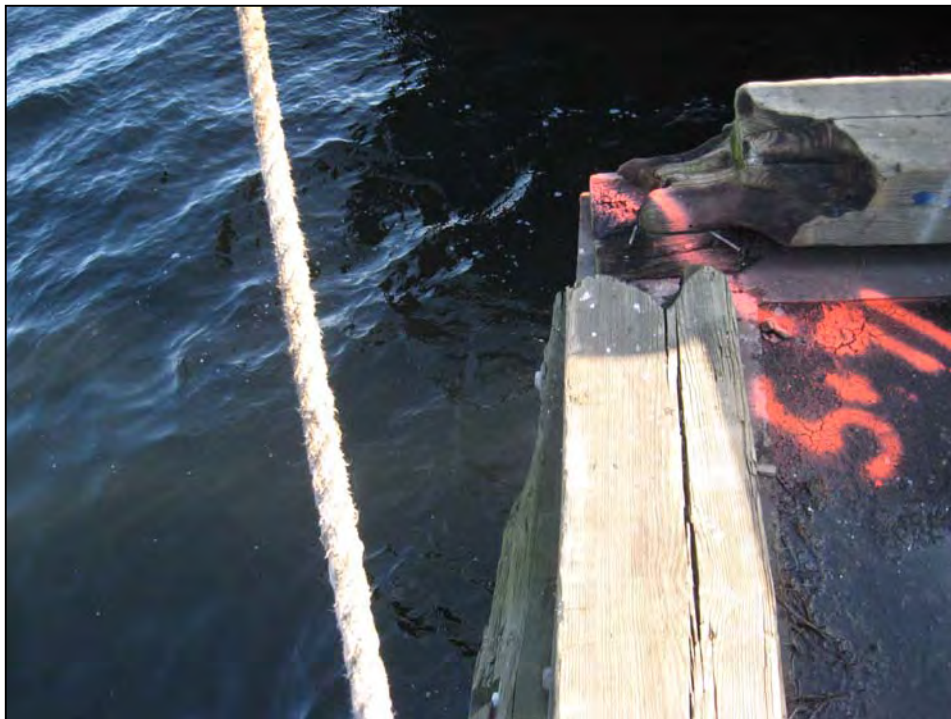
Photo No. 8: Fire damage on the timber curb at the corner of the bulkhead at Station 5+91.

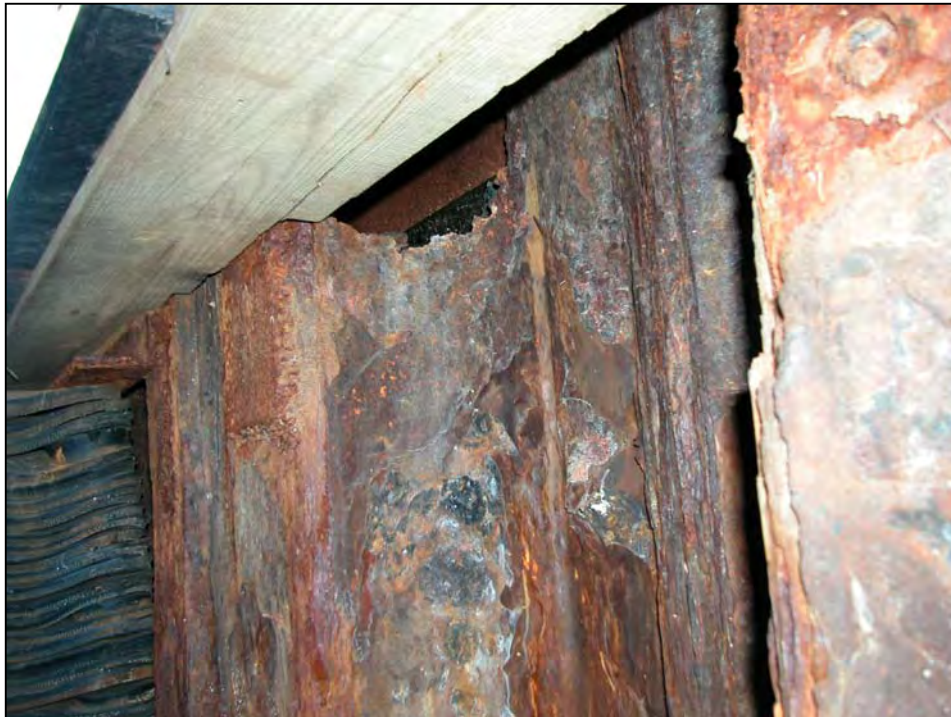
Photo No. 10: Hole in steel sheet pile bulkhead at Station 5+93.

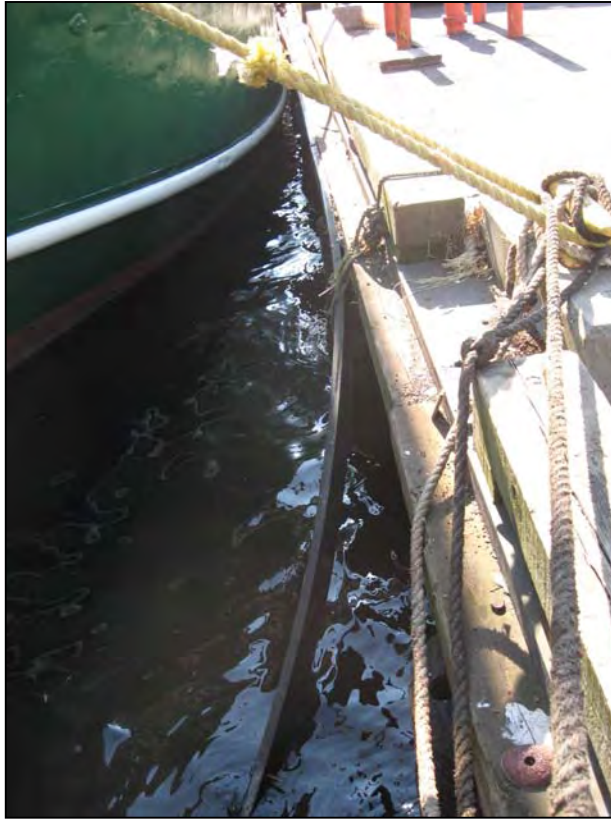
Photo No. 11: Loose UHMW rub rail near Station 6+90.

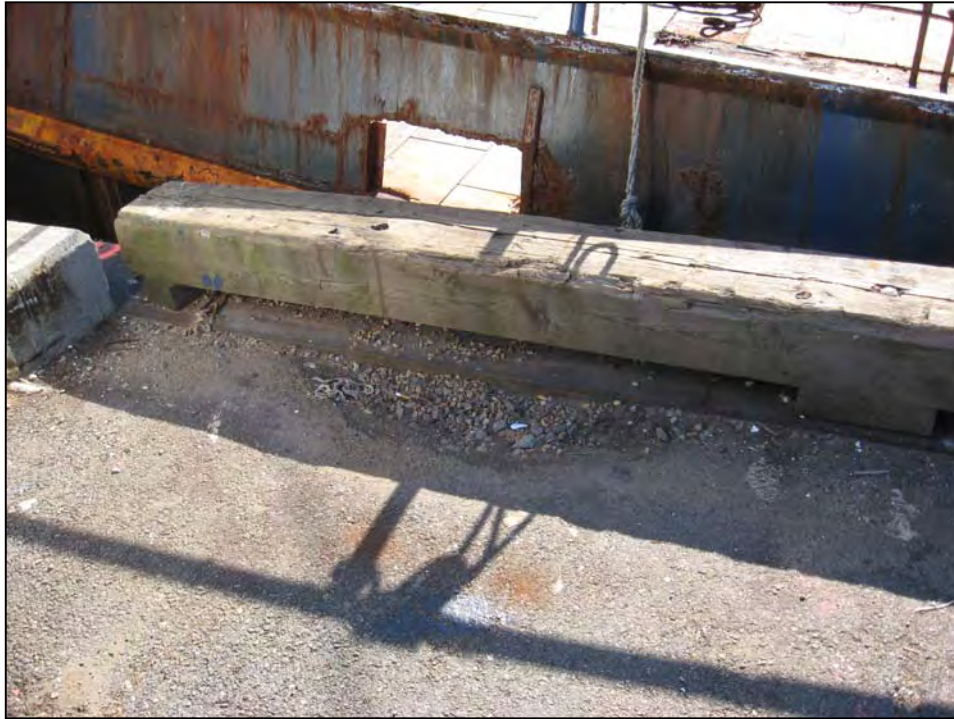
Photo No. 13: Subsidence behind the sheetpile bulkhead at Station 7+57.

- STA 7+57 - 48" L X 12" W X 1.5" D
SUBSIDENCE BEHIND SSP

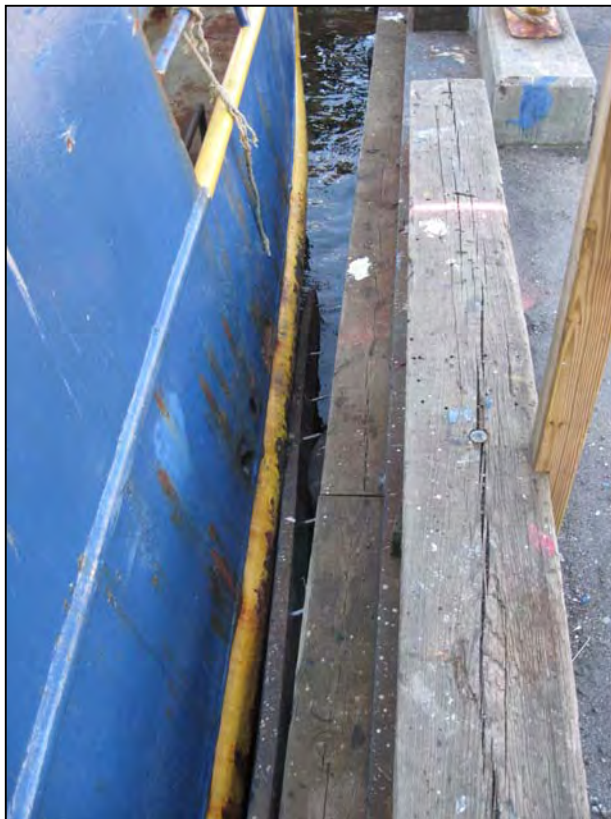
Photo No. 14: Typical loose UHMW rubber rail near Station 7+75.

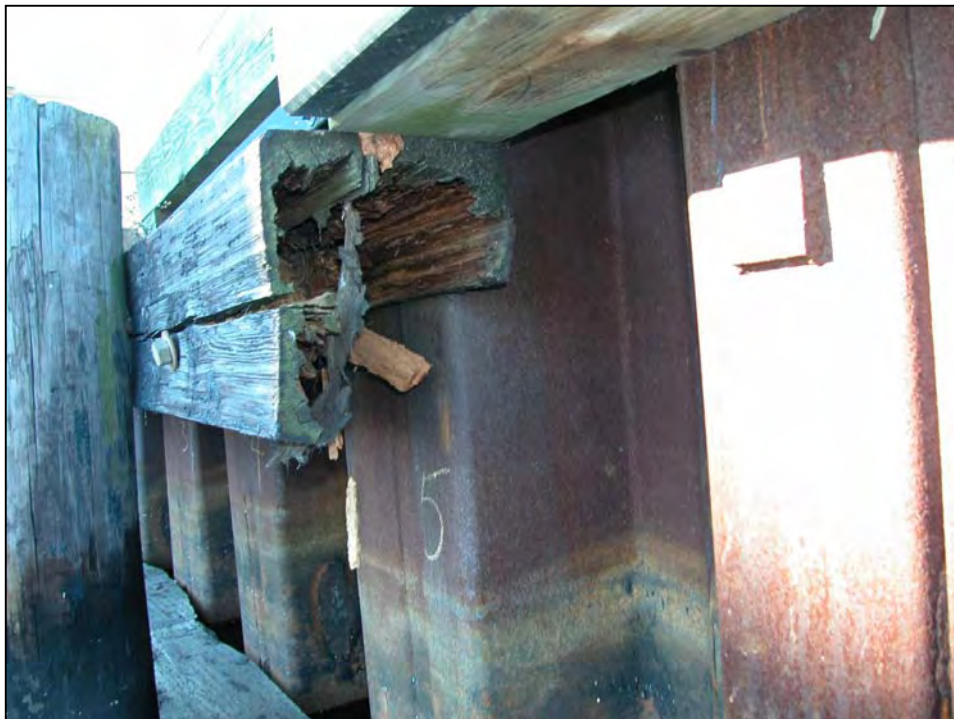
Photo No. 16: End of rotted top wale of the old timber fender system.

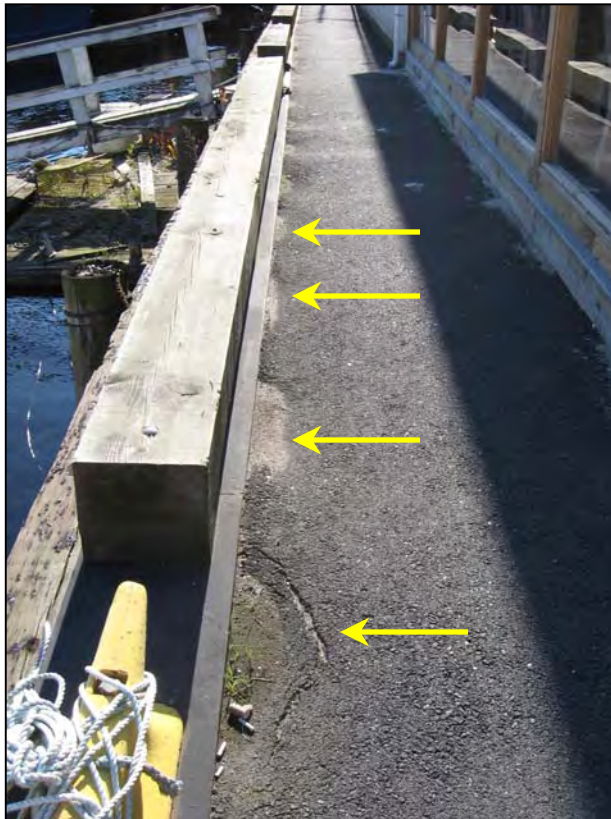
Photo No. 17: Timber curb and bituminous deck. Note several small areas of subsidence.

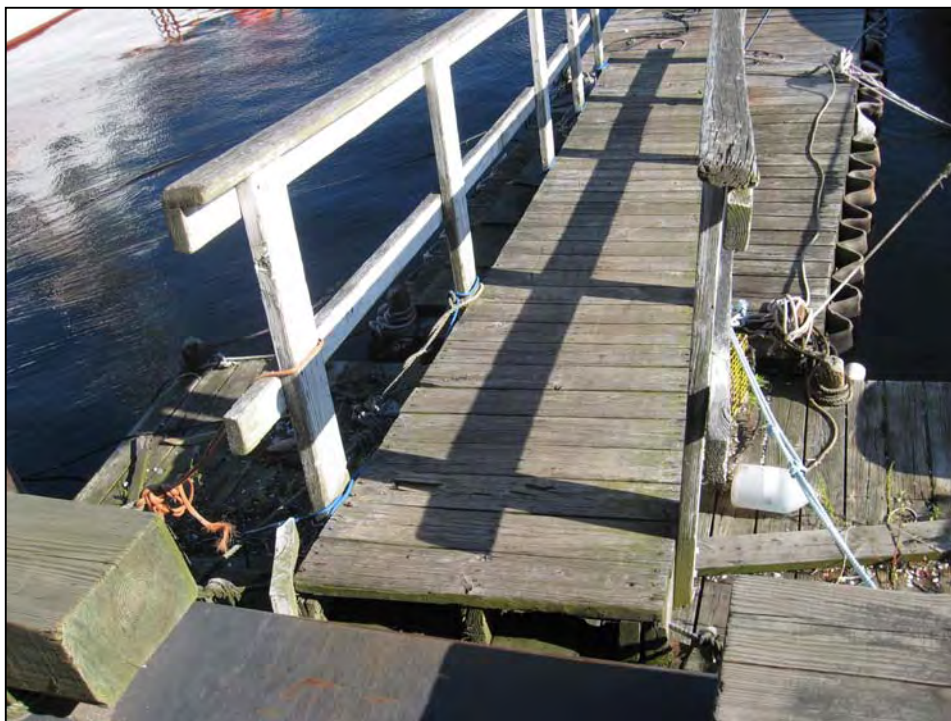
Photo No. 18: Timber gangway at Station 12+37.

STA 12137 - TIMBER GANGWAY (20' L)
POOR CONDITION - 36" CLEAR

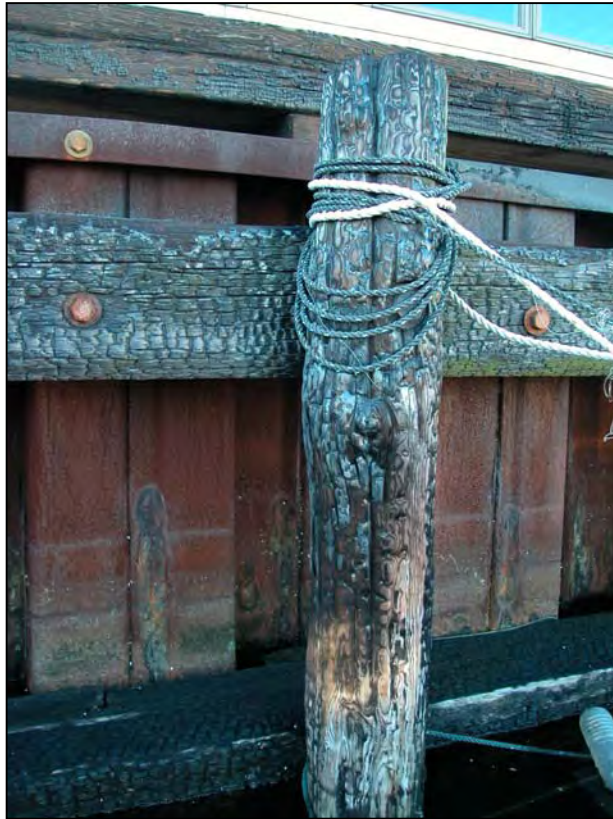
Photo No. 19: Typical fire damage on the timber fender system at Station 12+57 to Station 12+80.

STA 12157 - 12180 - FIRE DAMAGE TO
TOP AND BOTTOM WALK
