PARE PROJECT NO. 08216.00

**INSPECTION REPORT  
STEAMSHIP PIER  
NEW BEDFORD WATERFRONT  
FACILITIES INSPECTIONS  
NEW BEDFORD, MASSACHUSETTS**

MARCH 2009

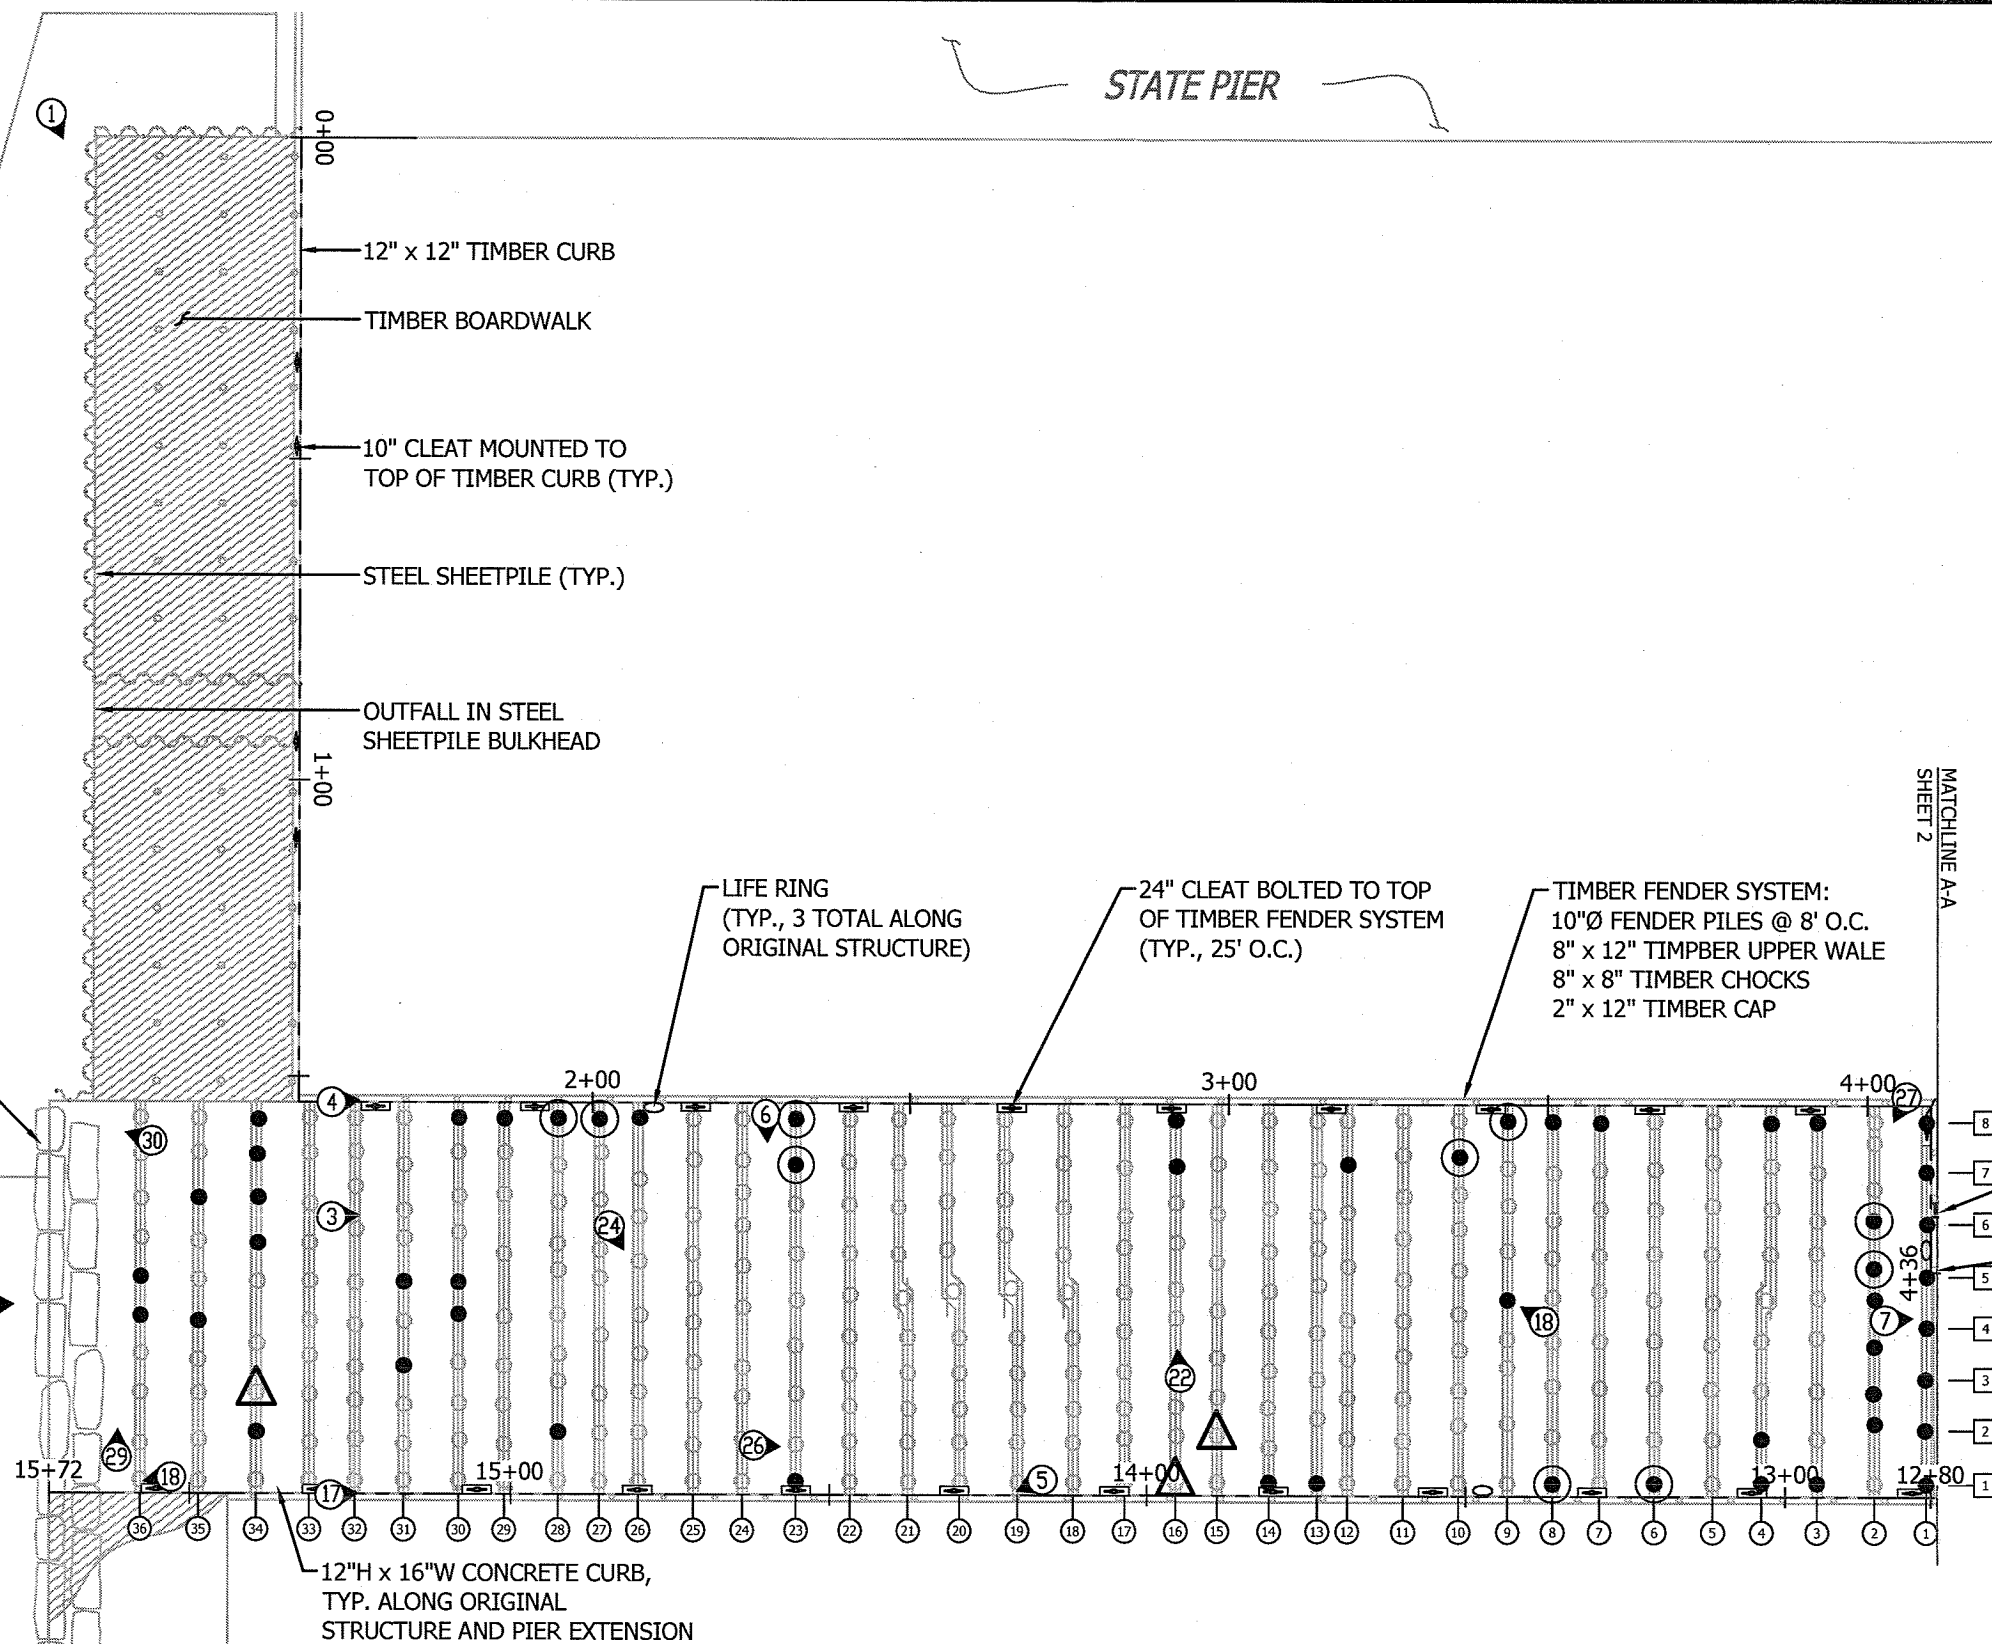
- The concrete caps are in fair condition, with localized areas of repair required.
- The concrete encasements (jackets) on the timber piles were observed to have areas of deficiencies as indicated on Figure 2 – Existing Site Plan. The loss of concrete section exposing reinforcing steel above the waterline must be repaired or replaced, as this area comprises a structural column and is required for the support of the pier. The loss of concrete cover on the underwater sections of the concrete encasements is not as critical, as this area of concrete serves primarily as a protection to the timber.

- SUPPORT PILE LEGEND:**
- ⊙ ENCASUREMENT DETERIORATED WITH EXPOSED TIMBER PILE (10)
  - ENCASUREMENT DETERIORATED IN TIDAL ZONE (41)
  - △ MUDLINE EXPOSED WITH LESS THAN 6" OF TIMBER PILE SECTION REMAINING (3)

Recommended remedial measures include the replacement of deteriorated concrete pile encasements, extension of concrete jackets to the mudline where pile diameters have been significantly reduced, and repair of limited cracking and spalling of the reinforced concrete pile caps. It is also recommended that the piles be inspected at regular intervals of approximately 3 years, to monitor further deterioration of the concrete encasements and deterioration of the unprotected areas of the timber piles.

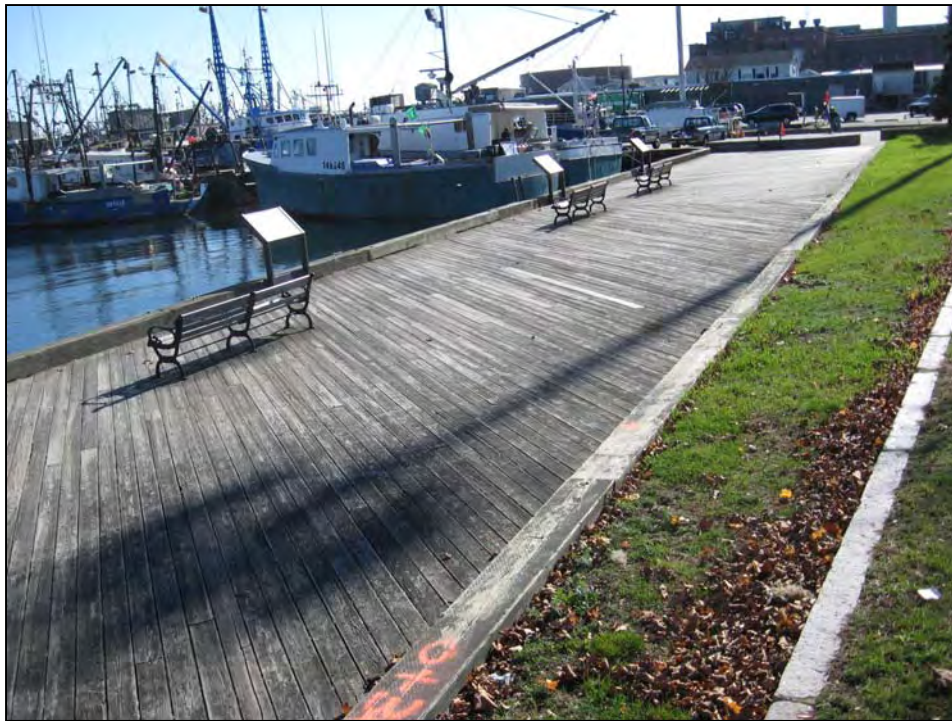
Photo No. 1: Timber wharf from Station 0+00 to Station 1+54.

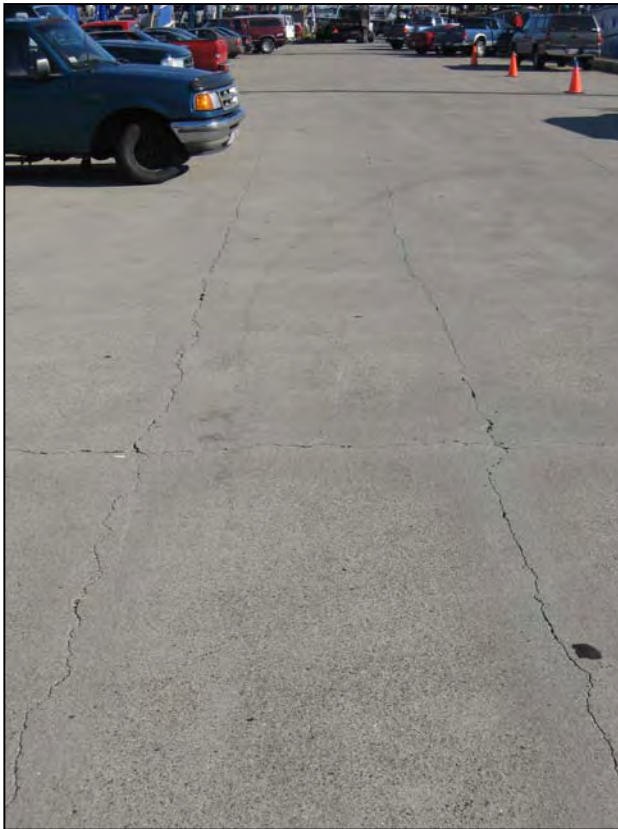
- Cracking of the concrete deck is symmetrical with the precast concrete deck panels, and is typical of this type of construction. Lateral loads causing deflection of the pier

structure induce movement in the precast slabs, causing cracking of the concrete deck overlay.

Photo No. 3: Typical longitudinal and transverse cracking observed along the deck of the original structure.

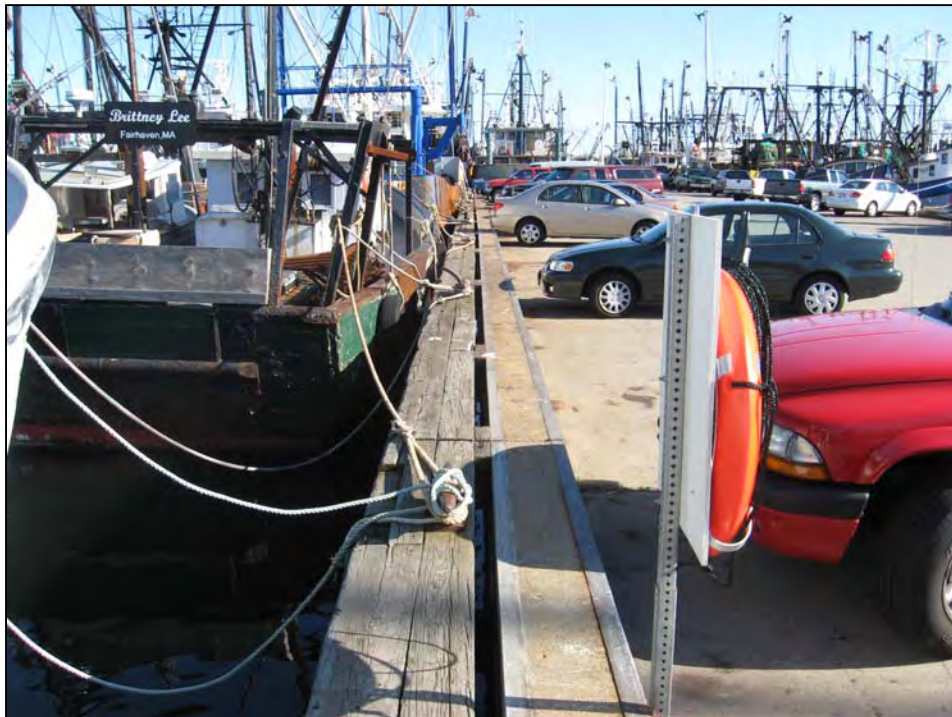
Photo No. 4: Overview of the concrete curb and fender system on the north face of the pier.

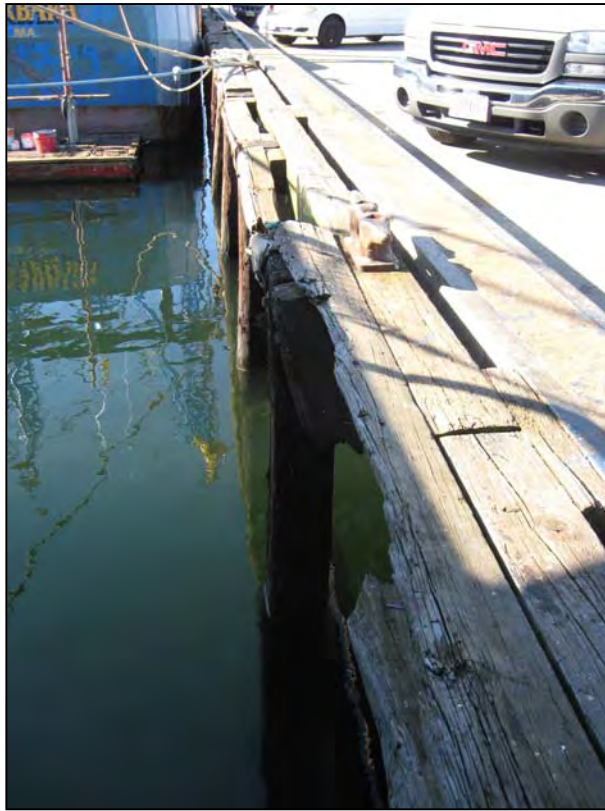
Photo No. 5: Typical fender section with broken chock and damaged or missing cap board.

This item consists of the removal of broken fendering members and replacement with new timber. This includes removal of old hardware, disposal of materials, and the furnishing and installation of new hardware and timber members. The opinion of probable construction cost for this work is approximately \$150,000.

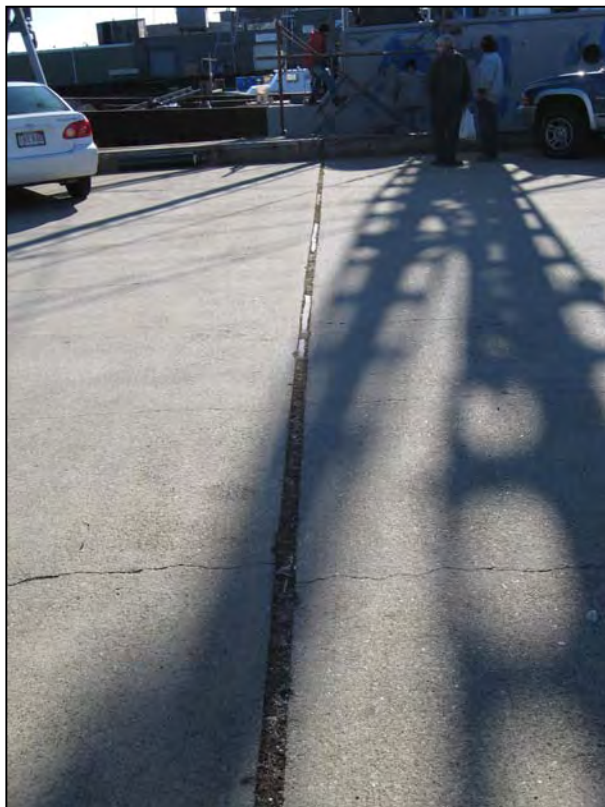
Photo No. 6: Typical expansion joint in the deck of the original structure. Note missing joint sealer.

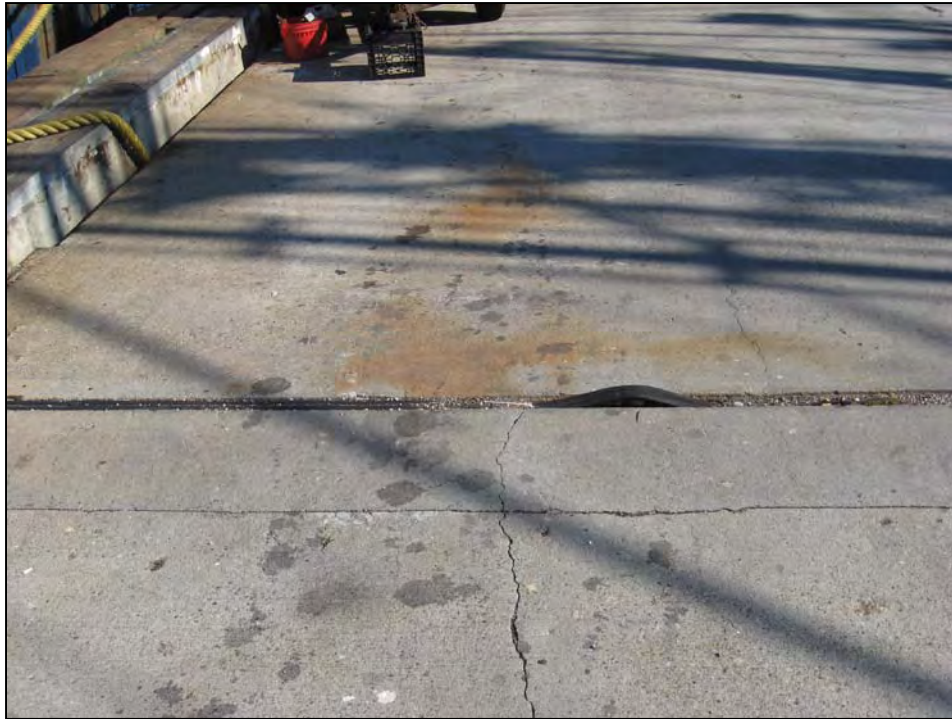
Photo No. 7: Loose joint filler at intersection of original structure and pier extension.

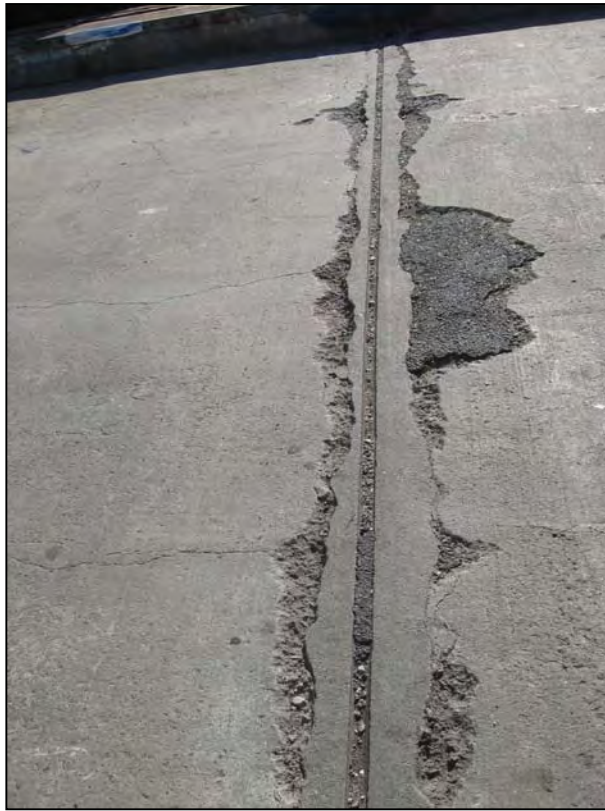
Photo No. 9: Typical expansion joint in the deck of the pier extension. Note spalling of concrete and asphalt patch.

This item consists of repairs to the deteriorated concrete deck along the pier extension. The proposed work will include patching spalled areas and installation of joint filler. The opinion of probable construction cost for this work is approximately \$25,000.

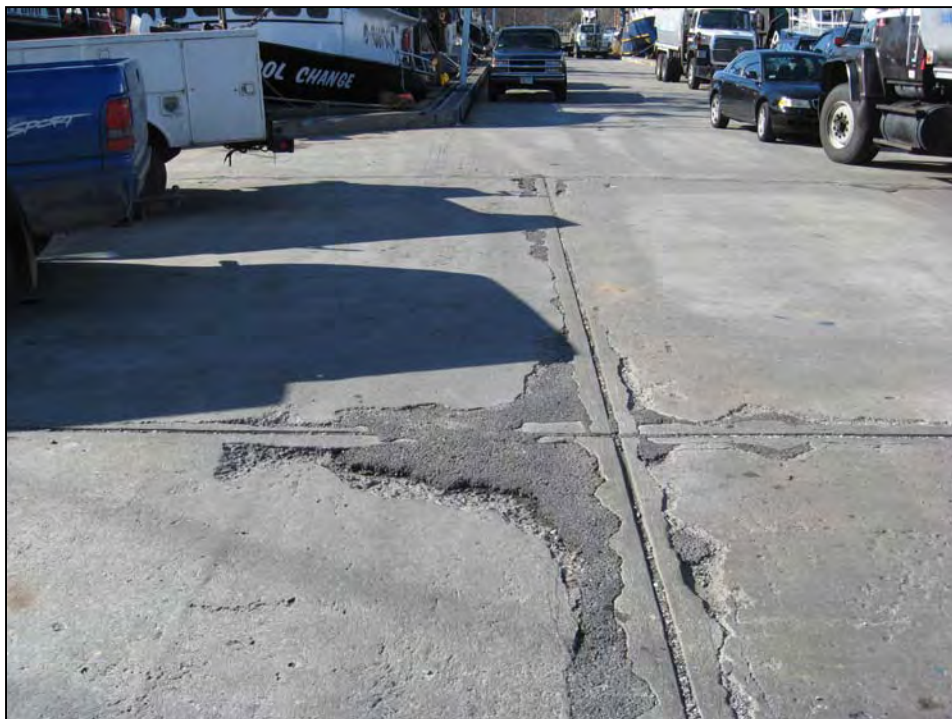
Photo No. 10: Four way intersection of expansion joints at the head of the pier extension.

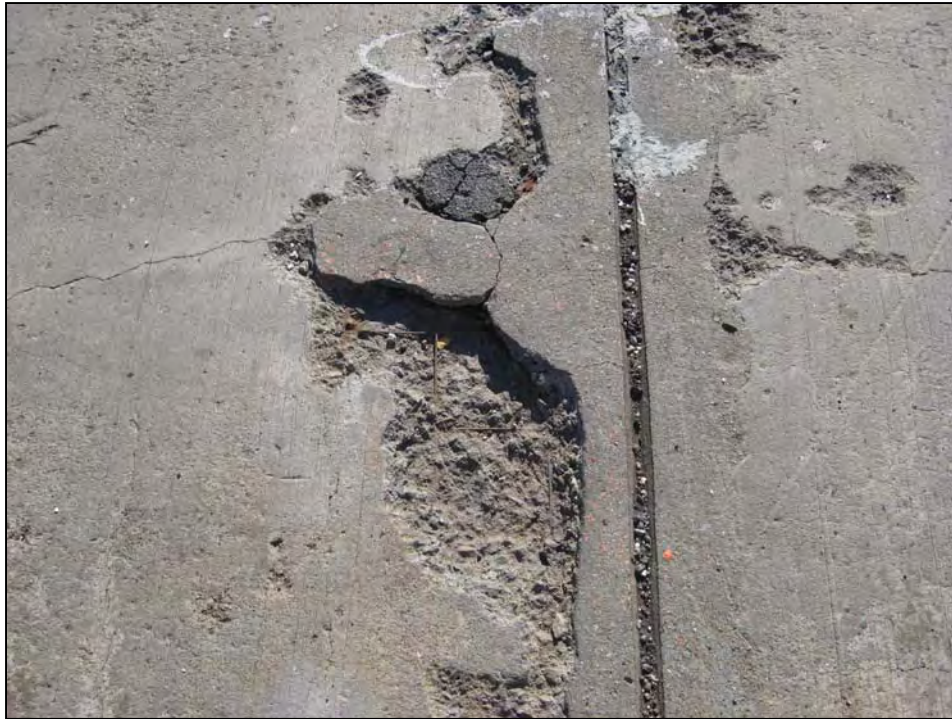
Photo No. 11: Spalling of the concrete deck with exposed reinforcement observed in several locations.

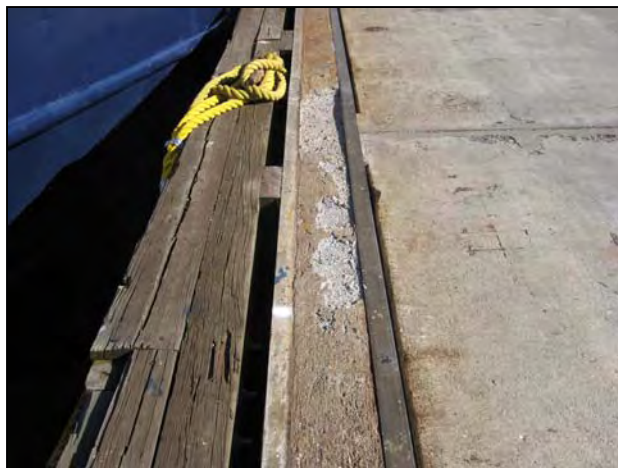
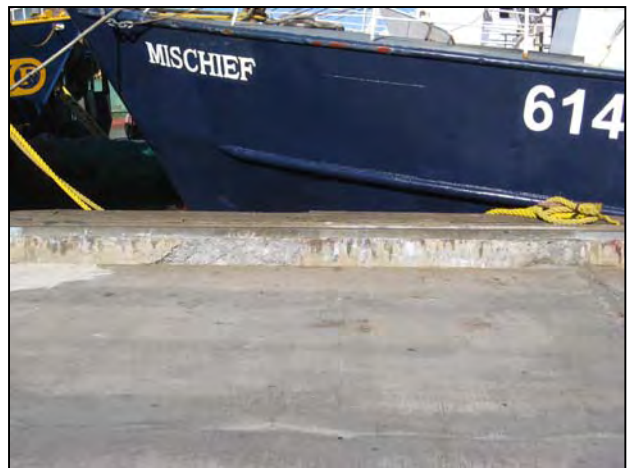
Photo No. 12: Spalling of concrete on top and face of curb.

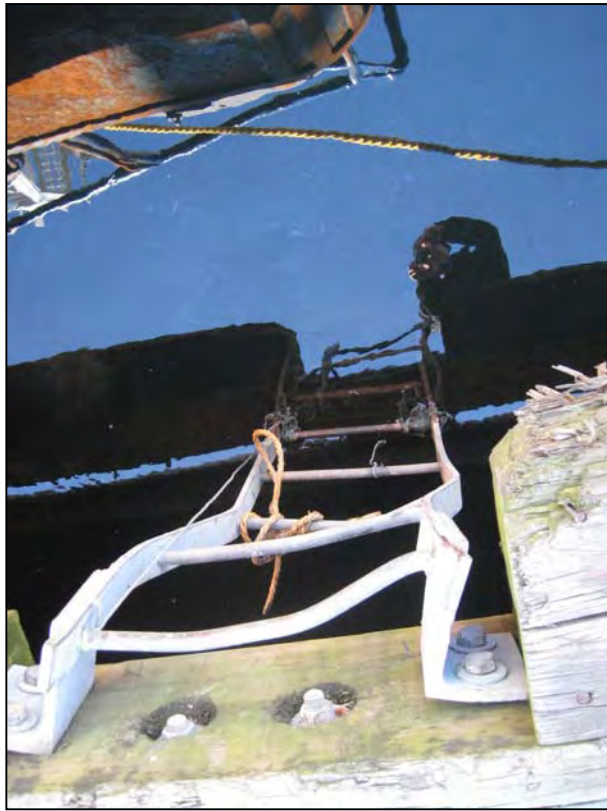
Photo No. 13: Typical buckled ladder.

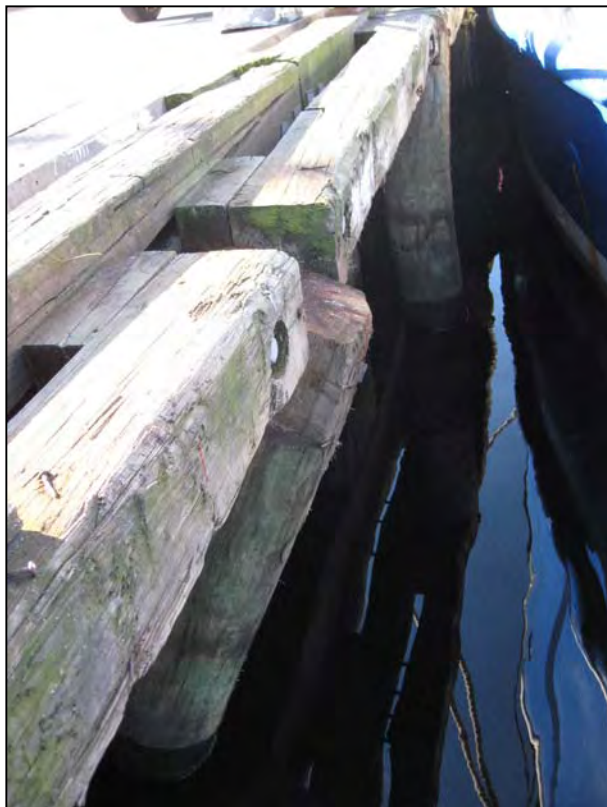
Photo No. 14: Broken fender pile at Station 8+06.

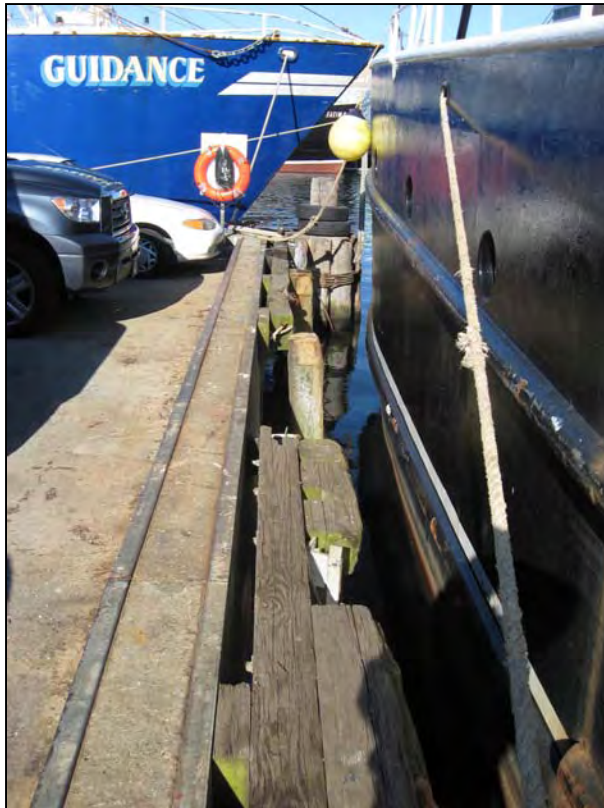
Photo No. 15: Damaged fender system from station 8+20 to Station 8+65.

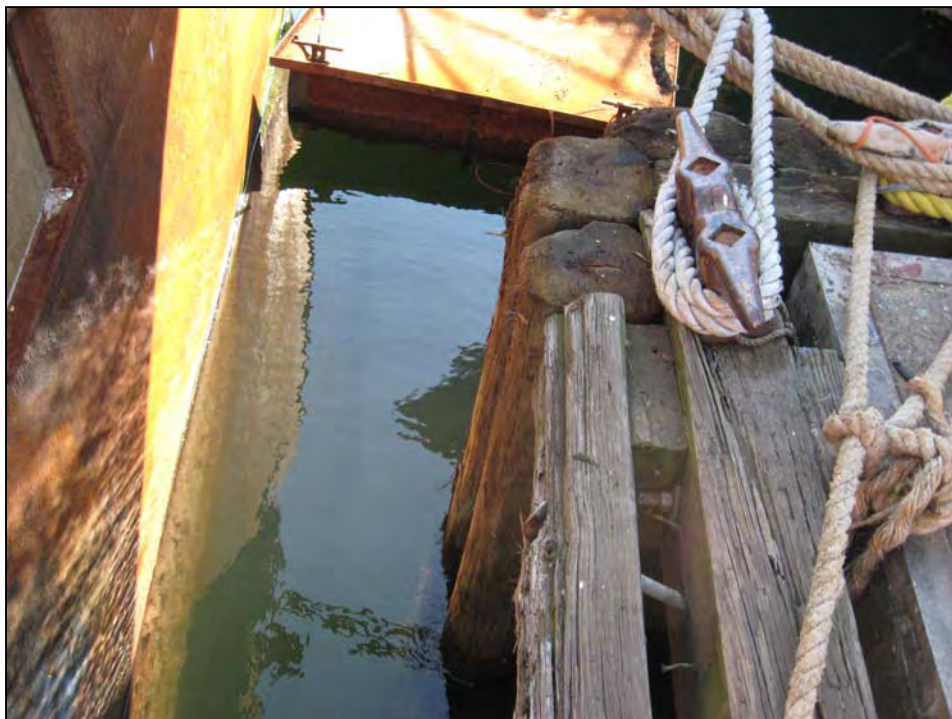
Photo No. 16: Worn fender piles and loose cleat at Station 8+80.

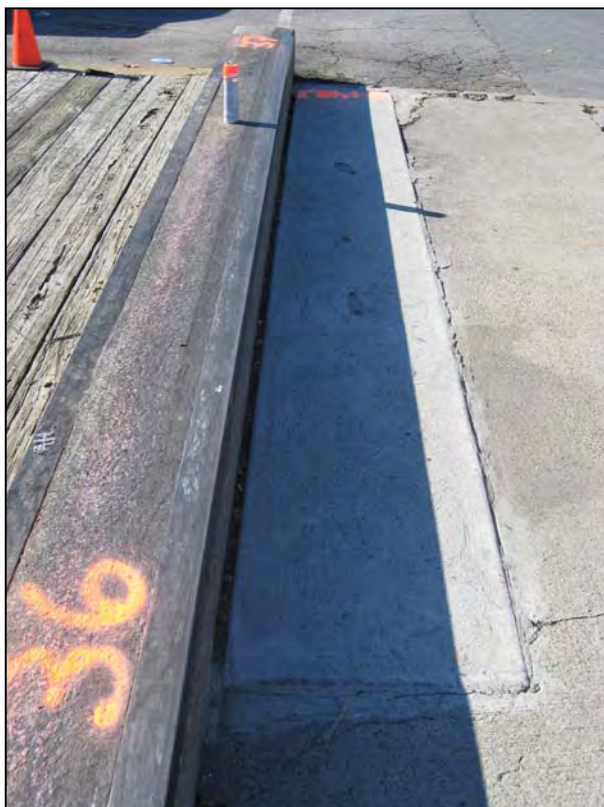
Photo No. 18: Patch in the southwest corner of the concrete deck.

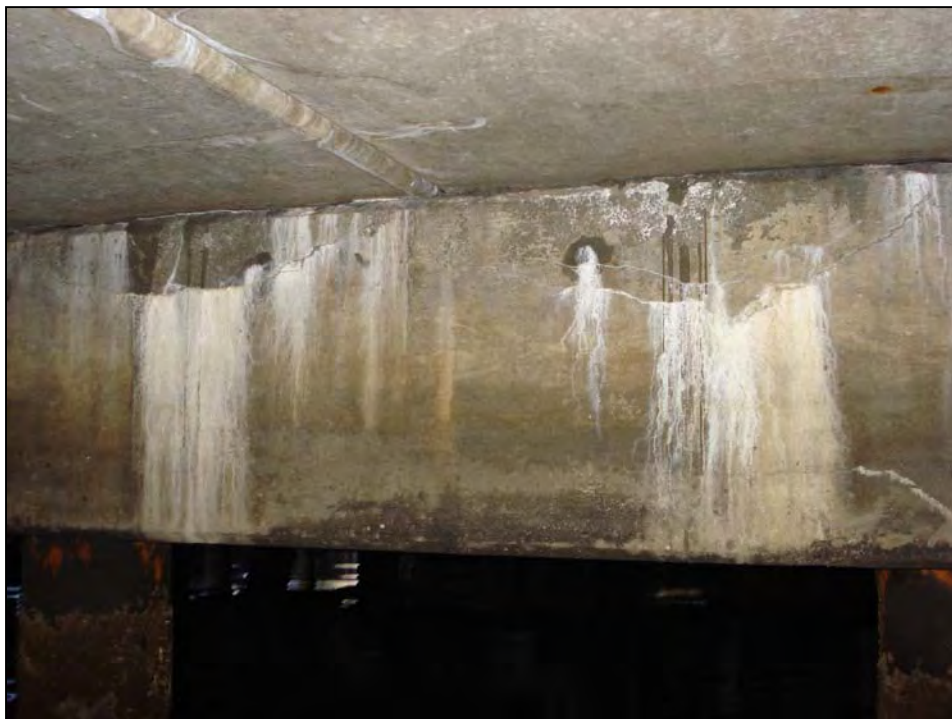
Photo No. 20: Typical spalling of the pile cap beneath the pier extension. Note presence of efflorescence.

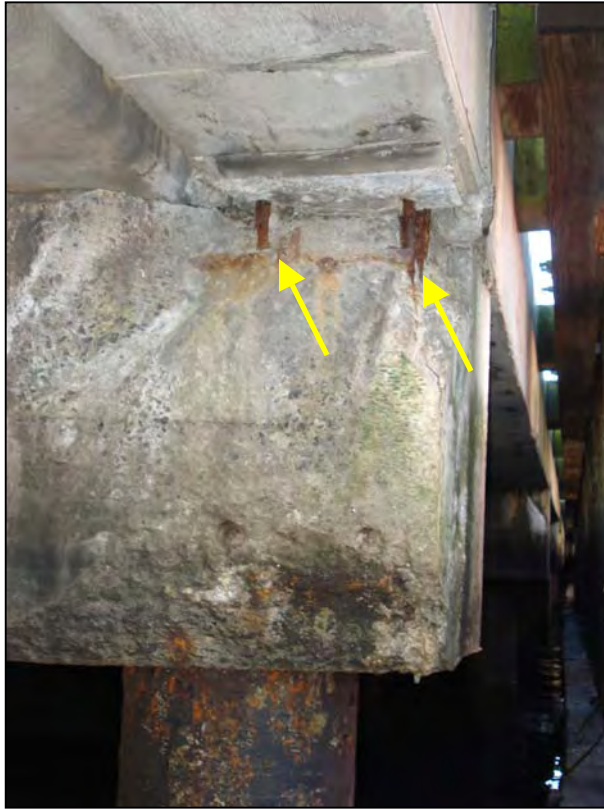
Photo No. 21: Significant spalling of the concrete pile cap along the waterside edge beneath the original pier structure. Note exposed reinforcement.

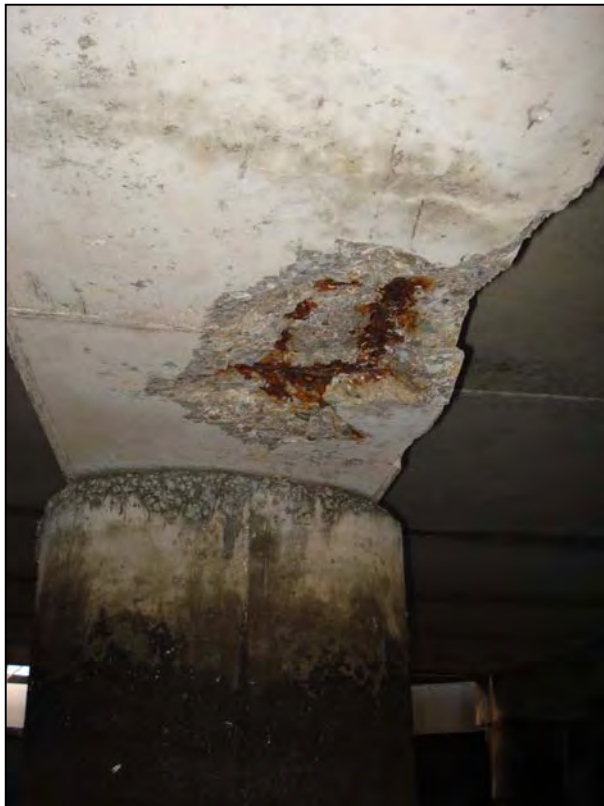
Photo No. 22: Typical spalling of the underside of the pile cap beneath the original pier structure.

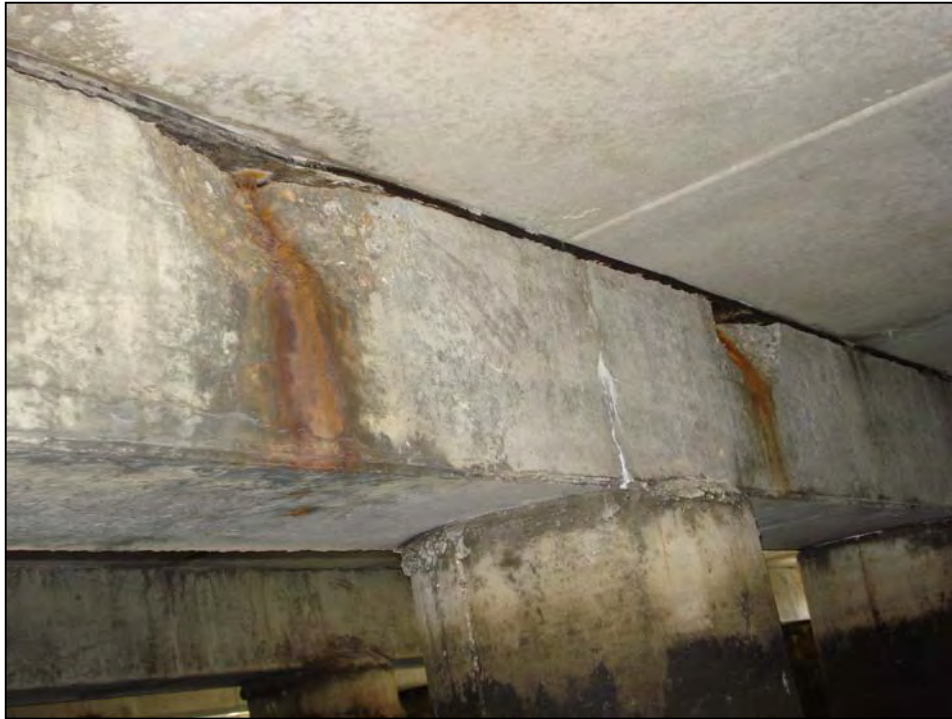
Photo No. 23: Spalled areas on the concrete pile cap with rust staining from exposed steel reinforcement.

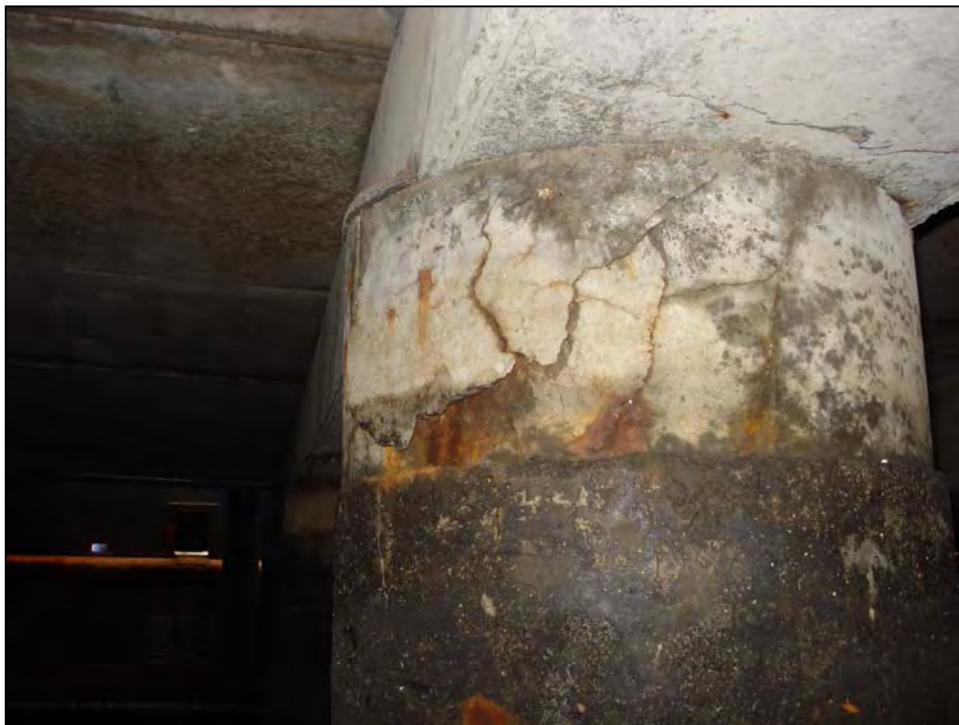
Photo No. 24: Cracking at the top of the concrete pile beneath the original pier structure.

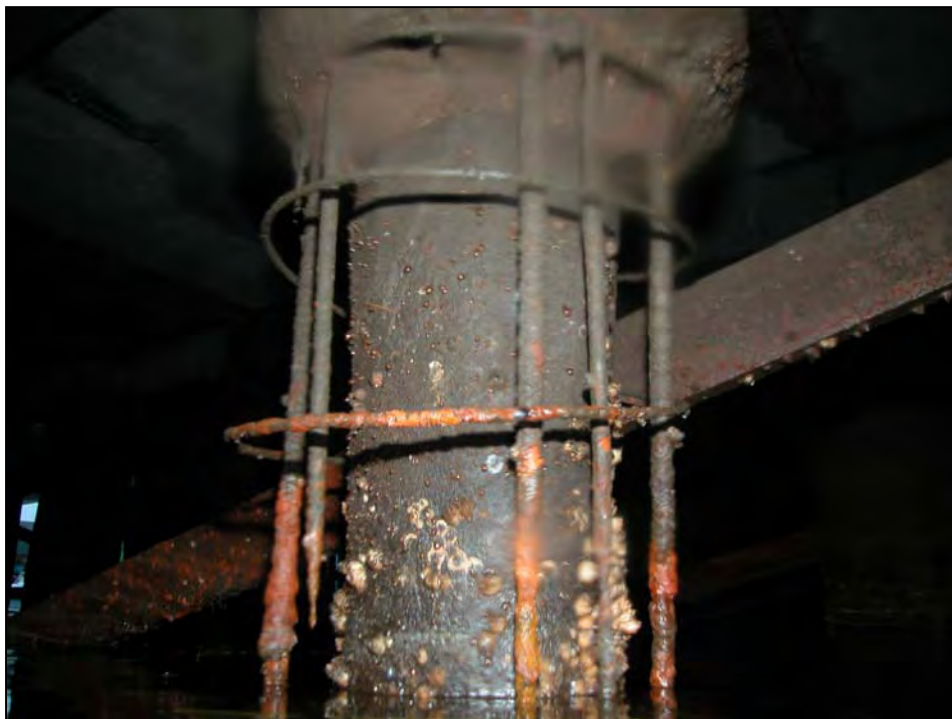
Photo No. 26: Missing concrete jacket with exposed steel reinforcement cage and timber pile. (Photo by Childs Engineering Corp.)

This item consists of the encasement of the severely deteriorated piles supporting the original structure of Steamship Pier. Providing “fish plates” or concrete jackets as means of repair is the most viable option at this site. Similar repairs to the piles beneath the pier were completed in the past.

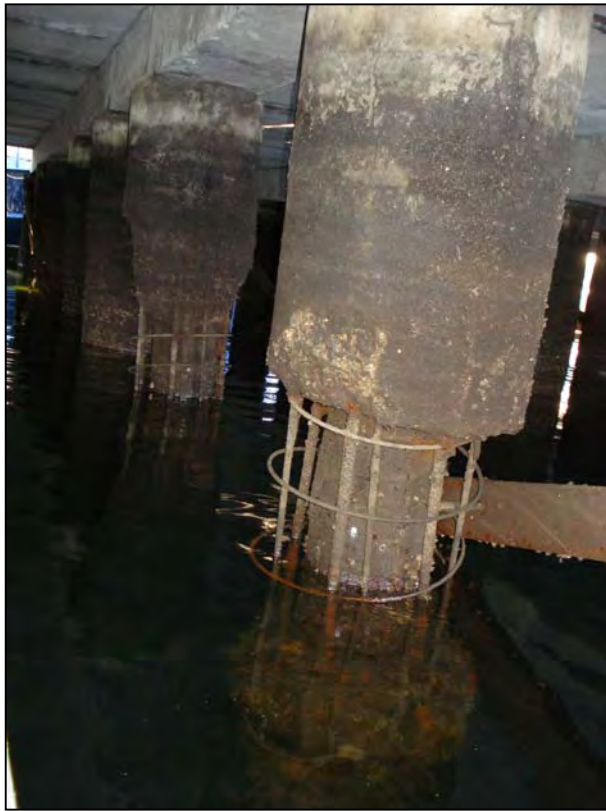
Photo No. 27: Missing concrete jacket with exposed steel reinforcement cage and timber pile.

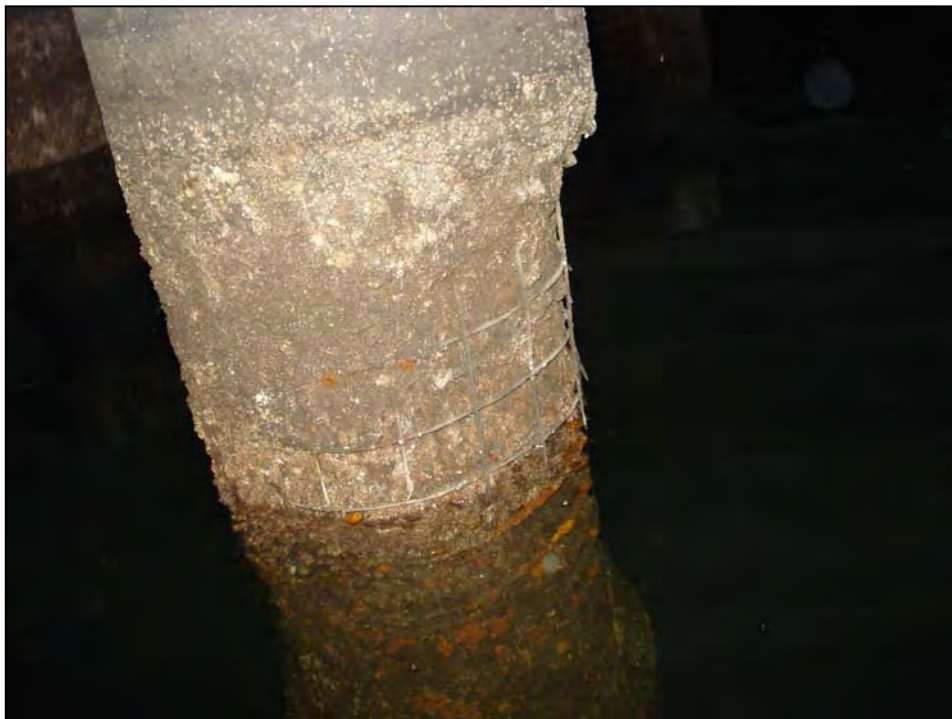
Photo No. 28: Missing concrete jacket with exposed steel reinforcement cage in the tidal zone.

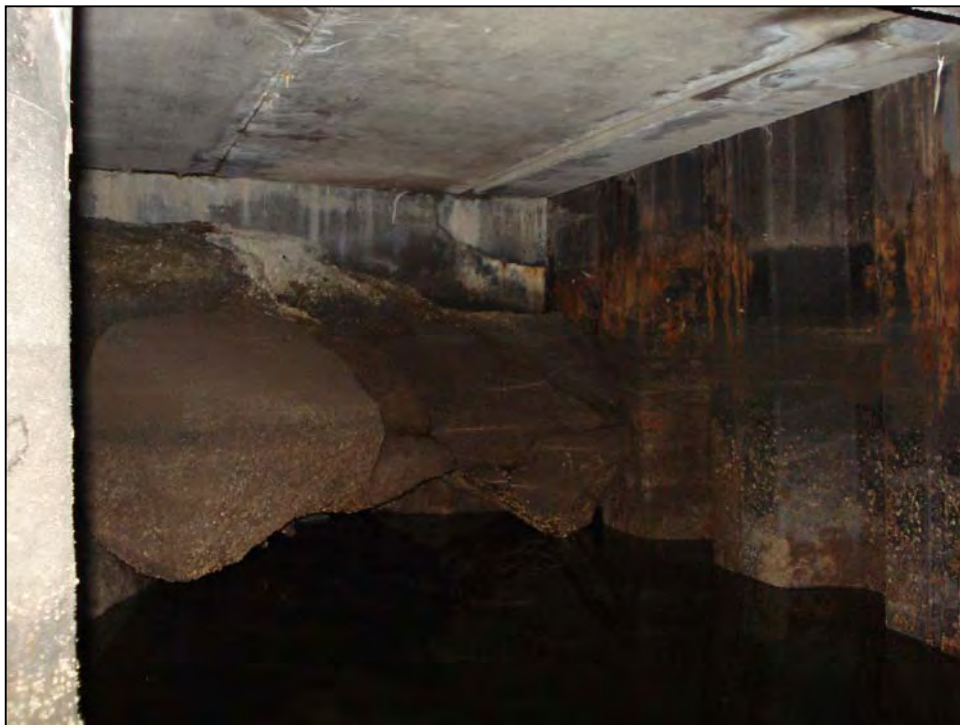
Photo No. 30: Overview of the void at the corner of the granite block wall and the steel sheetpile bulkhead under the timber boardwalk.

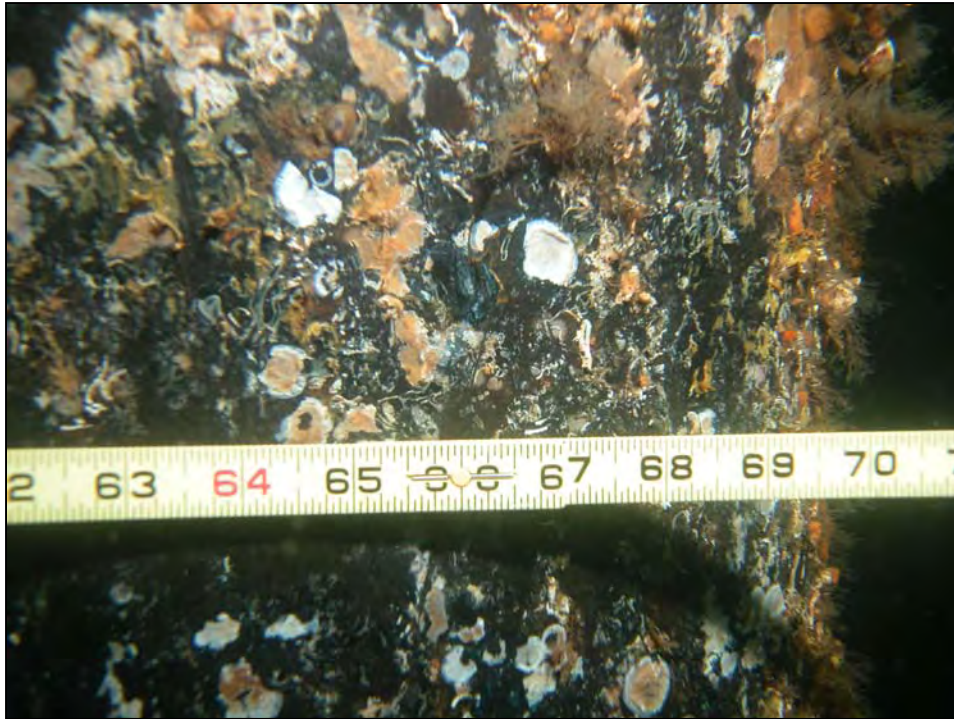
Photo No. 31: Typical marine growth below water. (Photo by Childs Engineering Corp.)

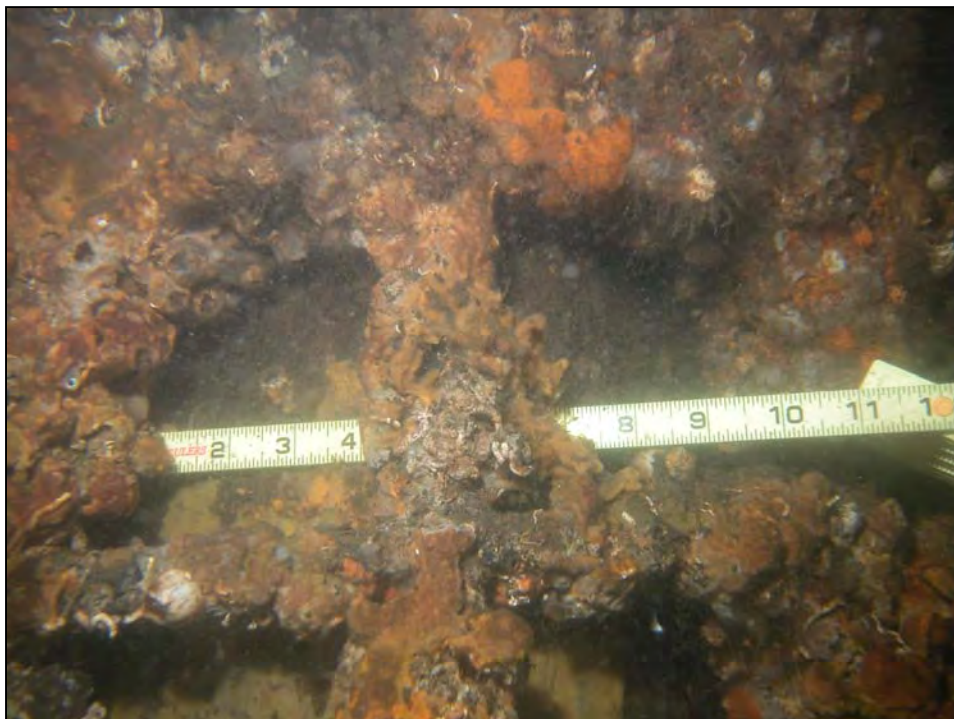
Photo No. 32: Underwater photo of exposed reinforcement. (Photo by Childs Engineering Corp.)

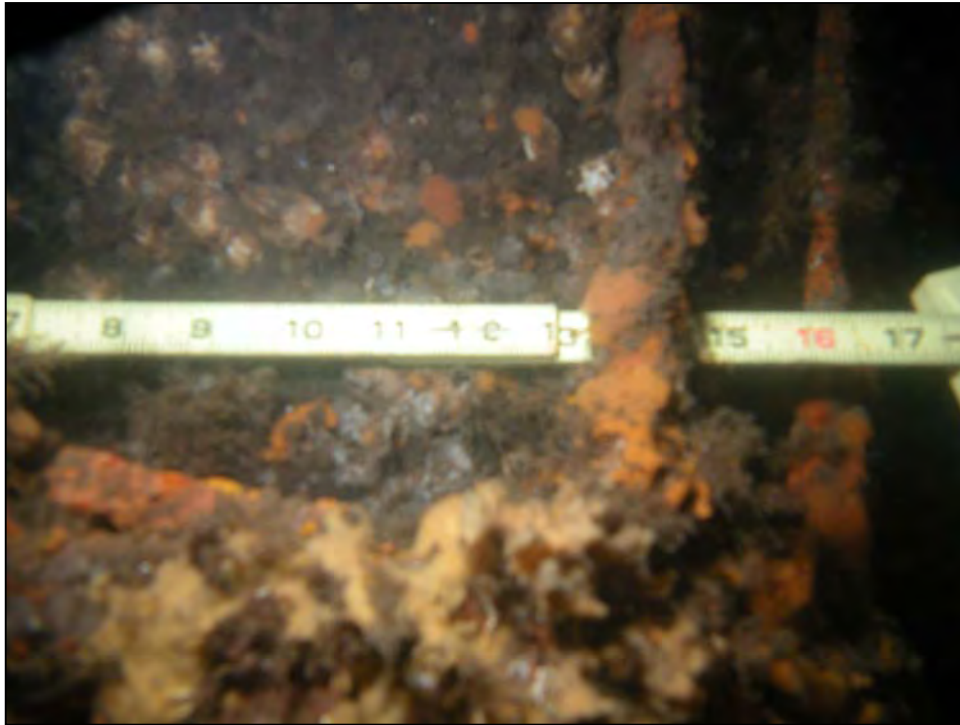
Photo No. 33: Typical view of the exposed steel reinforcement cage at the location of the missing concrete pile jacket. (Photo by Childs Engineering Corp.)

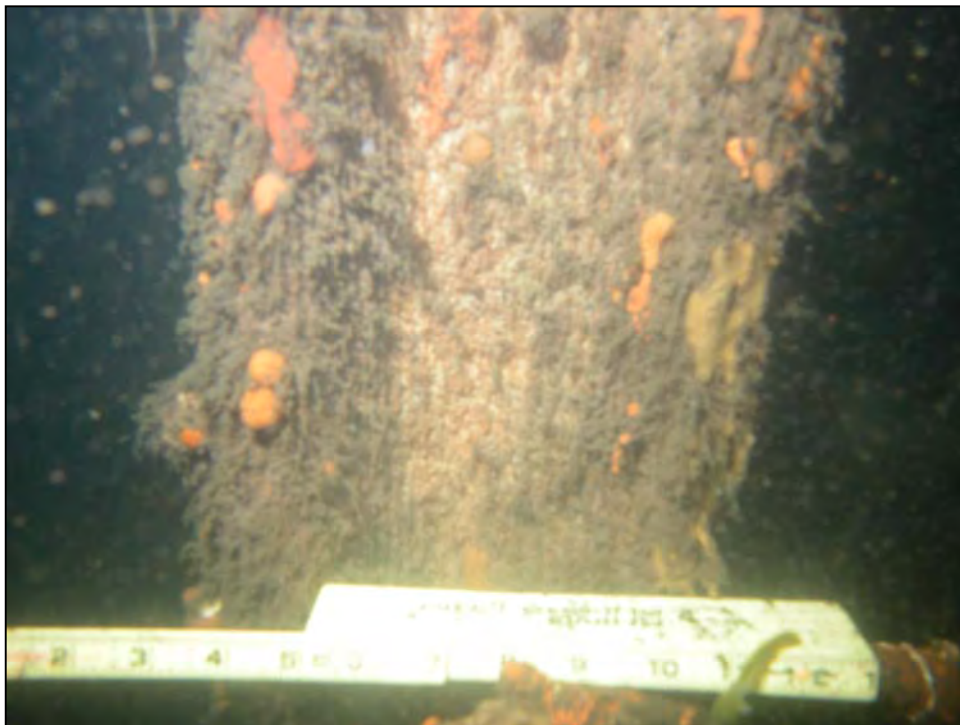
Photo No. 34: Underwater photo of marine growth on the pile. (Photo by Childs Engineering Corp.)
