Evaluation of surface water quality impacts
and potential threats to drinking water supplies
from a piggery in Rochester, MA

Joseph E. Costa, Ph.D.

Buzzards Bay Project National Estuary Program

Technical Report

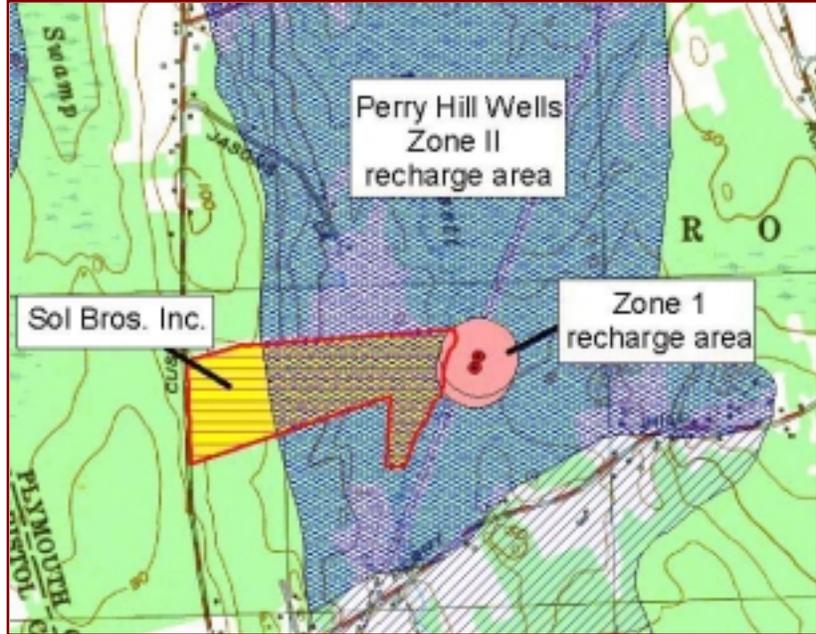
The Sol Brothers, Inc. property is adjacent to two public drinking water supply wells (Fig. 3). One of these wells is known as “Perry Hill North Well on New Bedford Road” (DEP ID #4169000), the other is “Perry Hill South Well on New Bedford Road” (DEP ID #4169000-06G). Both wells are owned by the Town of Marion, but the water supply serves both the Towns of Rochester and Marion. New Bedford Road is also identified as Perry Hill Road on some maps. Together, both wells pump more than 700,000 gallons per day (pers. comm. R. Zora, Town of Marion Public Works).

The east portion of the Sol Brothers, Inc. property, is within the “Zone I” recharge area of these wells; that is, within 400 feet of the wells. However, none of the actively used portions of the parcel area are within the Zone I of this well. Most of the property, including all of the pig operation and purported composting (or alleged landfilling) operation, is located within the Zone II⁴ recharge area of the two wells, and the remaining area of the property is within the Zone III⁵ of these two wells. Because the approved pumping rate for these wells exceed 100,000 gpd, Zone II regulations and policies apply.

Figure 3. Two public wells and Zone I and Zone II areas adjoining and coincident with the Sol Brothers, Inc. parcel.

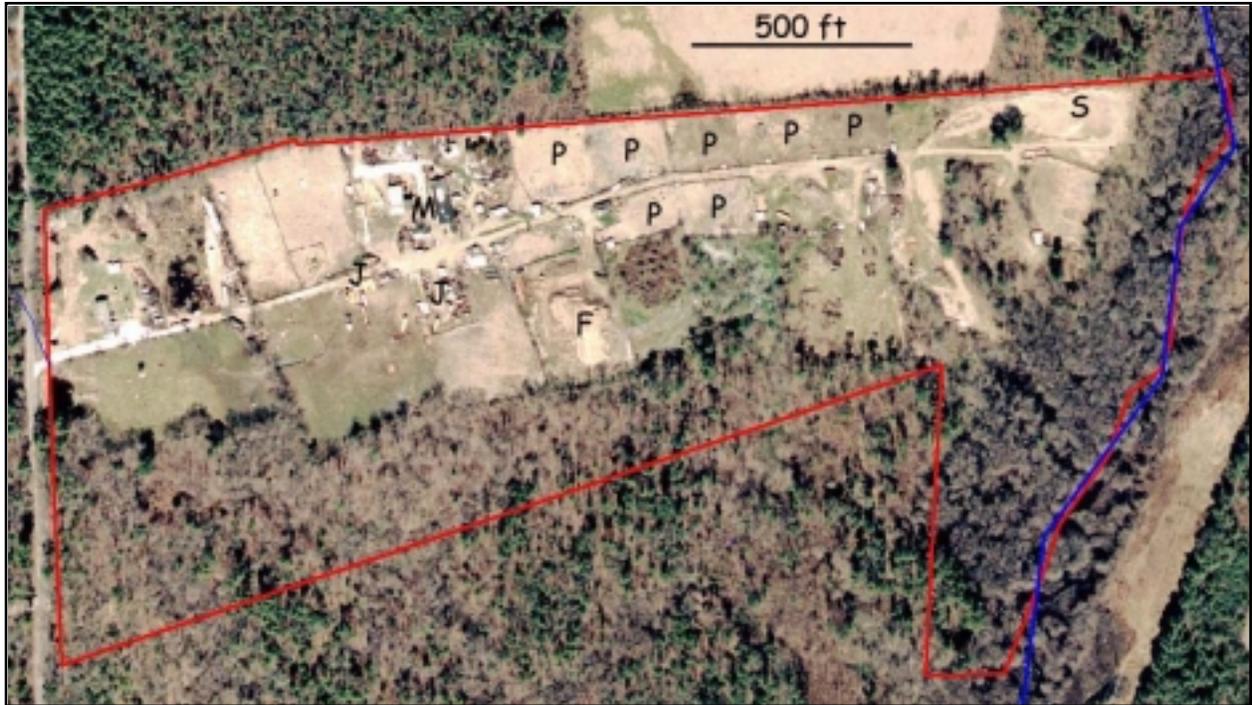
Figure 4. General layout of the Sol Brothers, Inc. farm showing main barn and operations areas (M), fields with pigs (P), area of fill (F), areas of accumulated metal or junk vehicles (J), and an apparent sand mining area (S.). The approximate location of the Mattapoissett River is shown in blue along the property's eastern boundary. Parcel boundary (red) from Town of Rochester.

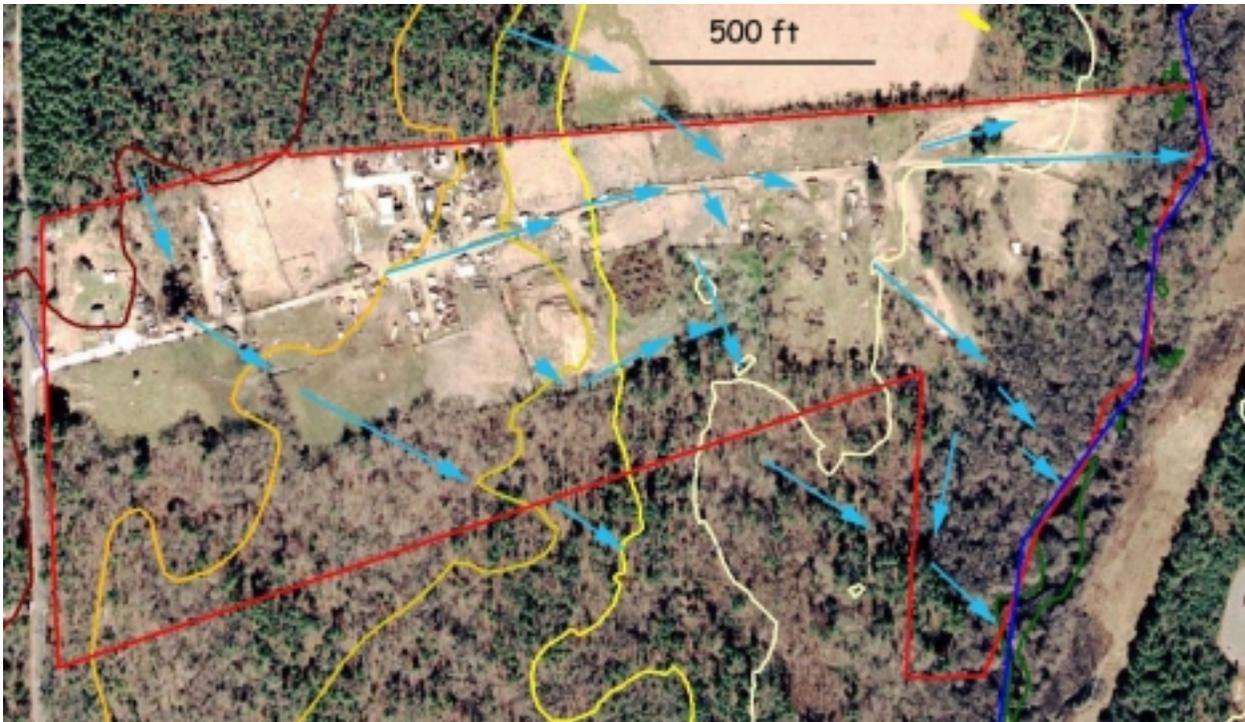
The stormwater from this farm flows through creeks, ditches, and wetlands to the Mattapoissett River. During the May 2 visit, a light to moderate rain had fallen prior to and during the visit. At the Wareham Cranberry experiment station, 0.6 inches of rain was recorded, and 0.2 inches were recorded for the previous day. The National Weather Service recorded for New Bedford, 0.54 inches on May 2, and no rain on May 1⁶. Based on observed rainfall and saturation of soils, we presume that at least 0.3 inches of rain had fallen in the storm by the time of sampling. Stormwater flow patterns were evaluated based on observed actual flows, washout areas on the property from past heavy rainfalls, and contours and vegetation at the site. These stormwater flow patterns are shown in Fig. 5. As shown, stormwater flows through several pathways to the Mattapoissett River.

Figure 5. Surface flow of stormwater based on direct observations, contours, and aerial imagery. Colored lines are 10-foot contours (red, shades of yellow, to white is 78 ft, 68 ft, 58 ft, 48 ft and 38 ft respectively, data from Mass GIS).

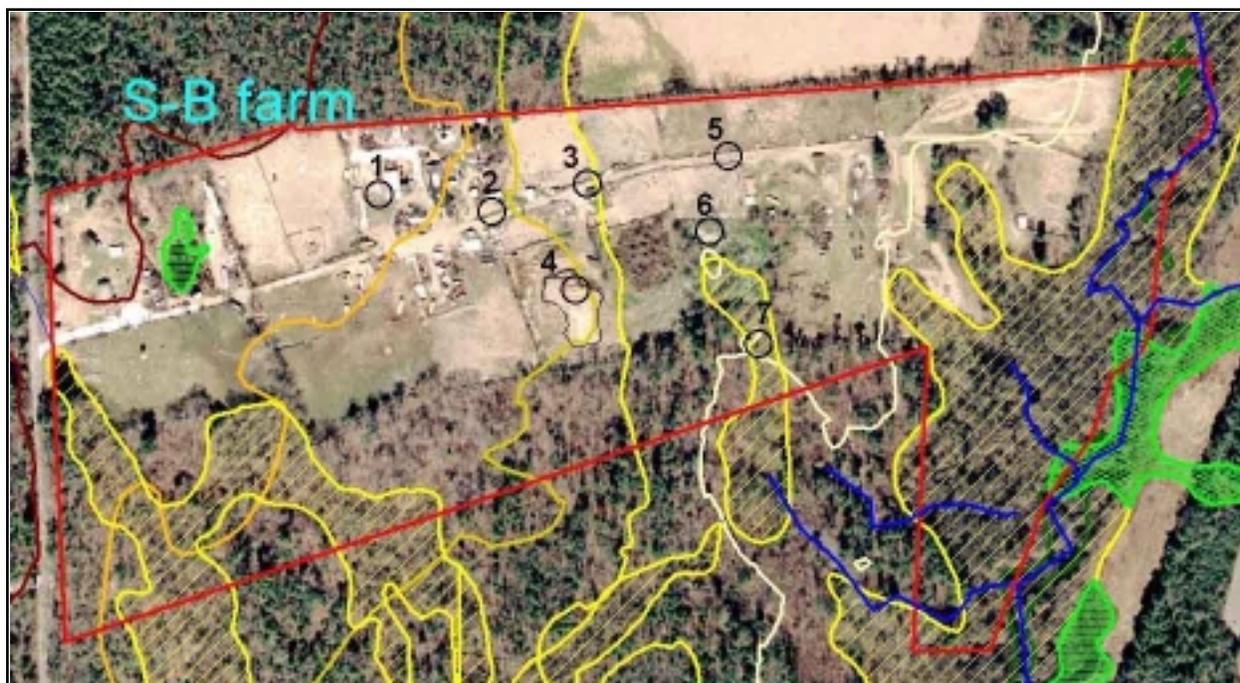
As shown in Table 1, stormwater traveling across the Sol Brothers, Inc. farm is remarkably high in the bacterial indicators used for assessing threats to human health and safety of shellfish. Concentrations of bacteria often exceed hundreds of thousands or even millions of bacteria per 100 milliliters of sample. Many of the strains of bacteria measured, including the *E. coli*, and Enterocci, are themselves considered harmful. They are also indicators that more harmful pathogens are also present. Since 1989, the Buzzards Bay Project has collected or evaluated stormwater contaminant data from hundreds of sites around Buzzards Bay and in the watershed, and rarely have samples been documented this high. If stormwater in suburban and urban areas contains more than 1,000 bacteria per 100 milliliters (ml) of any of these bacteria, those samples are considered very high and an indicator of a significant pollution source. In the case of fecal bacteria, counts of 50 to 300 is more typical of “contaminated “ stormwater in areas where pet waste, wildlife, and human contamination contribute to the accumulative non-point sources of contamination.

Figure 6. Locations of May 2, 2002 sampling. Observed stormwater flow was from the road opposite station 1 to 2, 3, 5, 6, then to 7. Sample 4 represents a pool of water on the top of the fill, but stormwater and leachate from the base of the fill area flows NE for a short distance toward a point between station 6 and 7, eventually flowing into station 7. Yellow and green crosshatched areas are the minimum extent of wetlands estimated by MassGIS. Tributaries and rivulets (shown in blue) were approximated based on aerial photograph features.

In the stormwater samples collected at the Sol Brothers, Inc. property, bacterial counts mostly exceed 100,000 bacteria per 100 ml. In fact, *E. coli* were only below 100,000 at the standing water by the food bins (90,000 per 100 ml) and at station 7 (53,000 per 100 ml). These values, in and of themselves, are not surprising in the sense that pig feces are recognized as having very high concentrations of Enterococci and fecal bacteria per unit weight. However, the results of station 7 are especially significant because they represent diluted stormwater runoff leaving the property and entering rivulets discharging into the Mattapoissett River. The bacteria concentrations observed here are *E. coli*= 53,000, Enterococcus= 14,000, and fecal coliform=56,000 per 100 ml sample, respectively. To better put these values in perspective, the safe swimming standard for freshwater is that no single sample exceed 235 *E. coli* per 100 ml or 61 Enterococci per 100 ml.

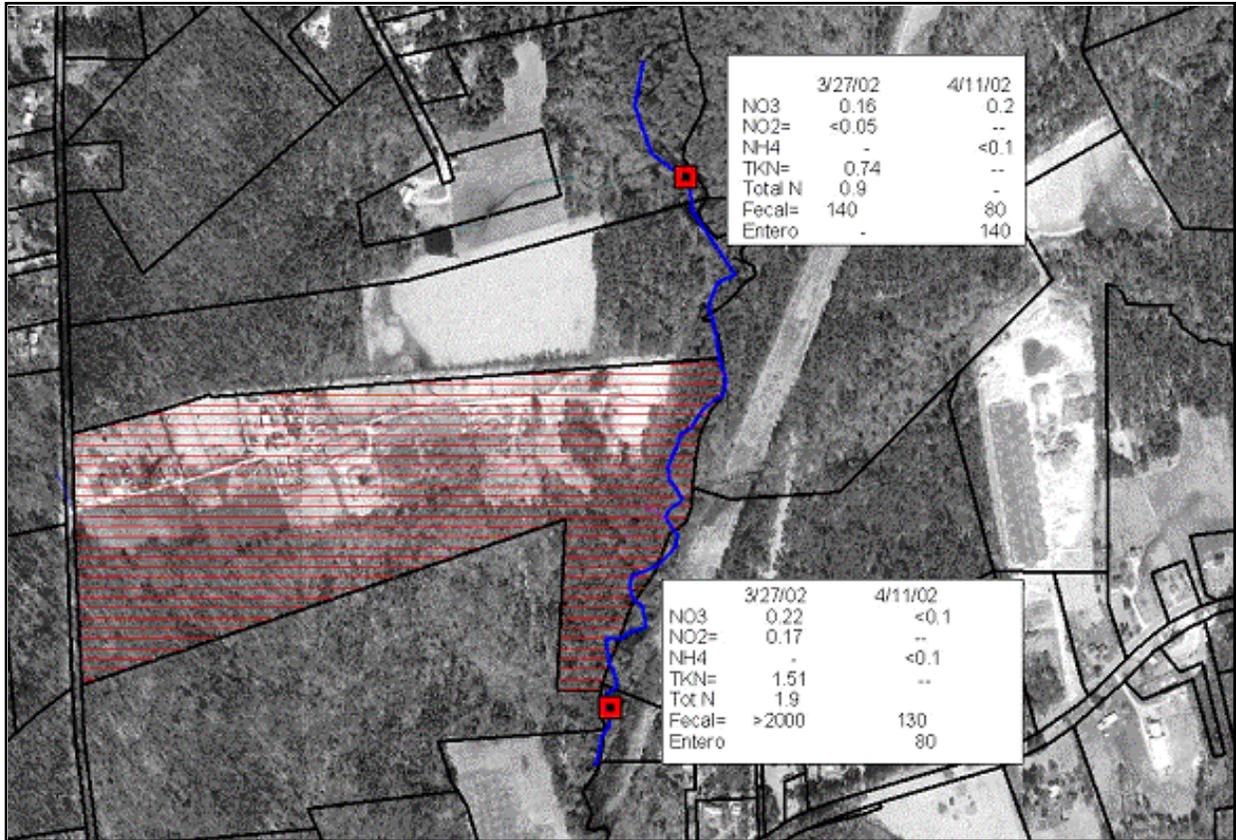
Figure 7. Monitoring results (nutrients and bacteria) of samples taken from the Mattapoissett River during a day of rain on March 27, and during a dry period on April 11, 2002. Sol Brothers, Inc. property is crosshatched area.

The Mattapoissett River monitoring results from the rainfall of March 27, and the dry weather sampling from April 11, 2002 (Fig. 7) are consistent with the super elevated concentrations of stormwater leaving the property. The bacteriological data, and the earlier river monitoring demonstrate that this farming operation is a major pollution source to the Mattapoissett River. For example, the 2000 fecal coliform per 100 ml observed on March 3 in the River at the southern edge of

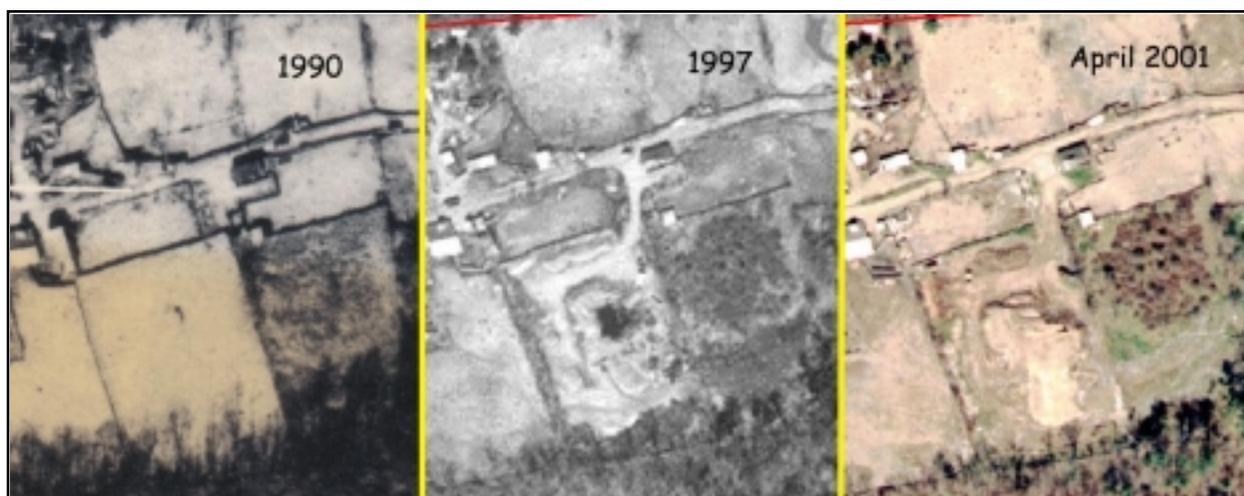
The fill area at sampling Station 4 (within the Zone II of the Perry Hill wells) does not appear to be a typical “composting area”, and instead has the appearance of a landfill of manure, shells, and fish products. Composting operations turn and aerate soil and organic mixtures to prevent putrefaction. The aerobic decomposition of the material produces compost that can be used on agriculture fields or gardens. There was no evidence of this practice. A core of sediment showed that less than one foot below the surface of portion of the fill was an unrecognizable foul smelling white chalky substance. Other areas within the fill had high organic, black, anaerobic (lacking oxygen) putrefied soils approximately six inches below the surface. In many respects, the site appeared to look like a landfill of fish parts and pig manure.

Aerial photographs of the site between 1990 and 2001 show a progressive filling of the site (Fig 8), which appears to be at least 10 feet above grade at the southernmost end. In the 1990 photograph,

Figure 8. Area of apparent fill activity center-lower rectangular area as observed in 1990, 1997, and 2001 aerial photographs. The 1990 photograph shows a relatively flat field with a small structure in the center. The 1997 photo appears to have pooled water in a depression.

the area appears to be just another pig field. In the 1997 photograph, the site is highly altered, showing standing water most likely in a hole, as well as mounds of fill. Such a depression could have been created by sand mining, for example, but stereoscopic views of the aerials would need to be examined or the fill area could be cored to determine the depth of natural soils and whether the area was mined before fill was added. In the 2001 image, the apparent depression appears filled, and the fill more extensive. In the 2001 photograph, the fill covers 0.35 acres. If the average thickness of the filled area is 7 feet (as an approximation of original grade), then there is nearly 4000 cubic yards of fill at the location. If the site was mined for sand prior to filling, then more fill is located there. A machine powered coring device is needed to determine the extent of fill at the site.

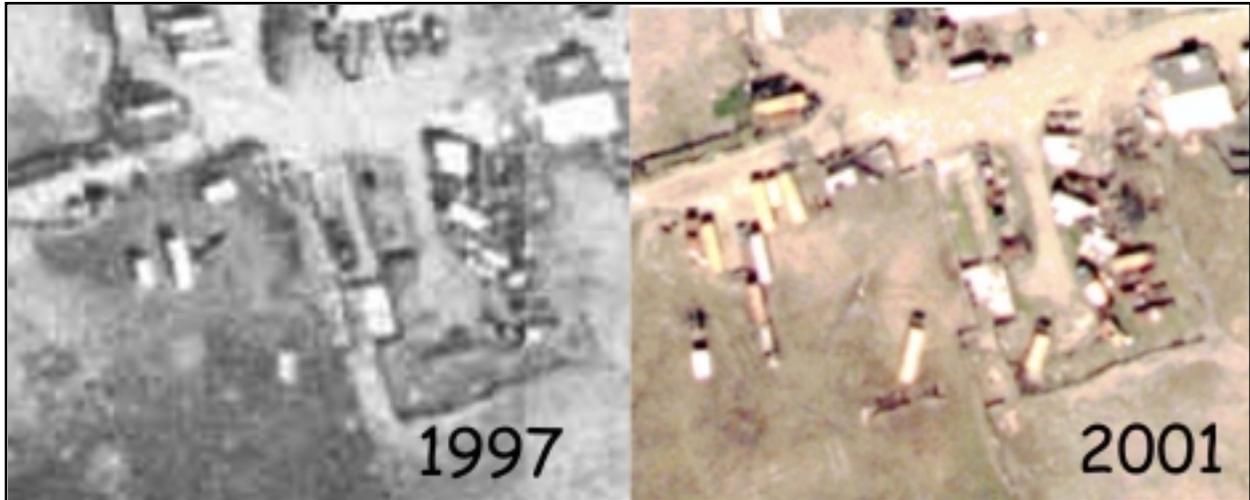
The siting of automobile graveyards and junkyards are prohibited in Zone IIs and IIIs of drinking water supply wells because leaching metals and leaking oils pose a threat of groundwater contamination. At the site, at least 7 derelict school buses were observed during the site visit of May 2 as well as many other vehicle parts, trailers, and truck cabs. A visible sheen on the surface of the stormwater was observed at stations 3 and 5, down gradient of the vehicle graveyard areas. If the buses do not serve a farm function, it may be desirable to have them removed to protect drinking water supplies. If they are used for any farm storage function, at a minimum, it would be desirable to have the engine blocks, gas tanks, and transmissions removed to minimize the threats to groundwater, surface waters, and drinking water supplies.

Figure 9. Apparent vehicle graveyard and storage area, including school buses and trailers. School buses are yellow-orange in the color photo dated 2001. There was an apparent increase in the number of school buses on the site between 1997 and 2001.

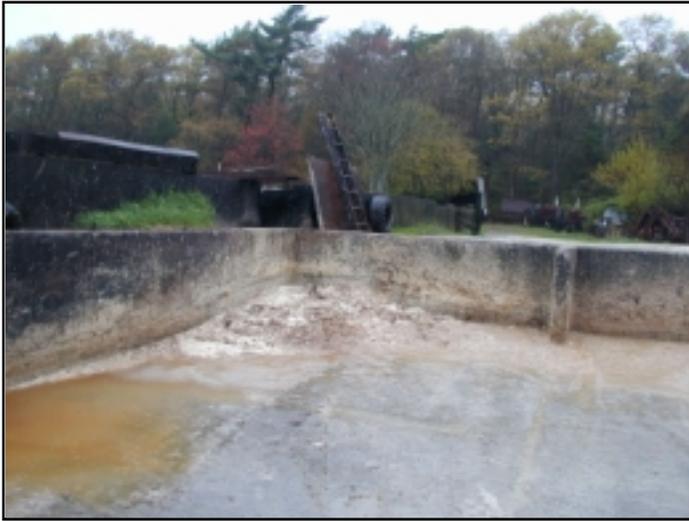
Fig. A1-1. Food bin, puddle is Station 1.

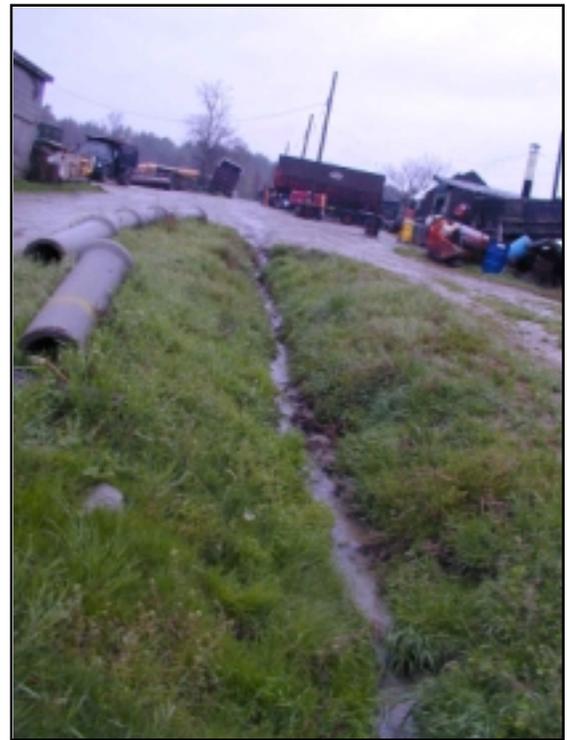
Fig. A1-2. Drainage ditch (Station 2), down slope of main barn area.

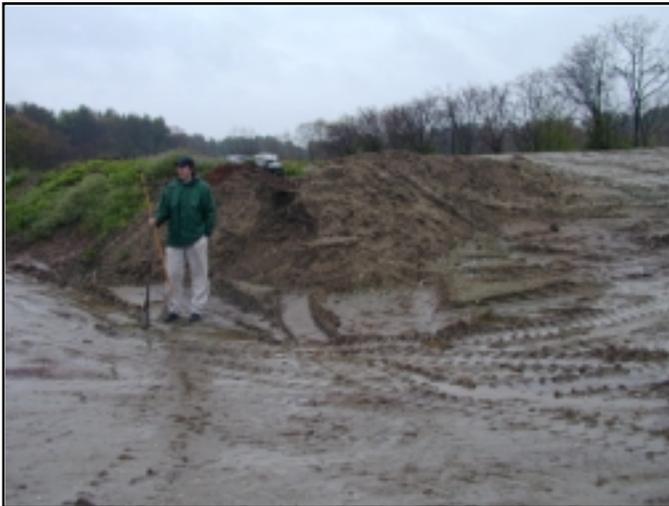
Fig. A1-3. Fill area near Station 4.

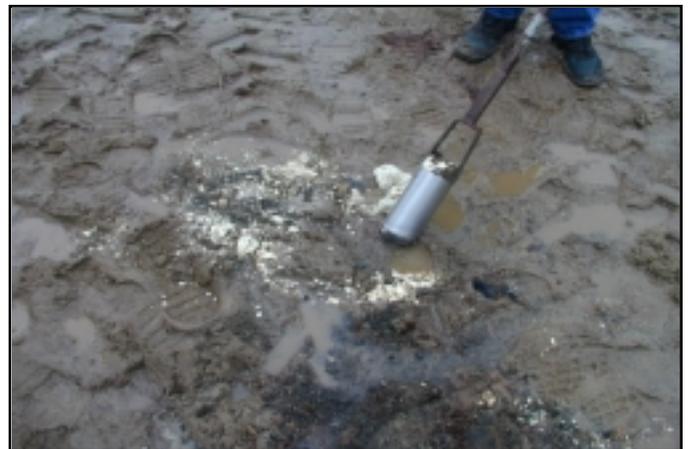
Fig. A1-4. Solids sample from fill, near Station 4.

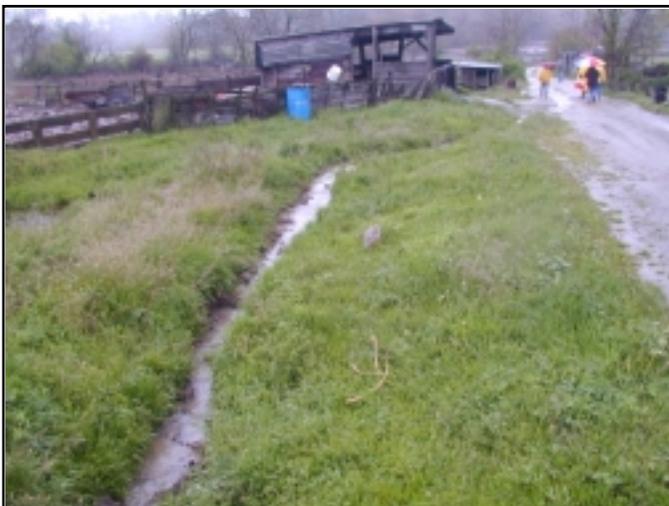
Fig. A1-5. Looking down slope to stations 3 and 5 (drainage across road).
