Tidal Restriction Site Profiles Buzzards Bay Watershed

Bourne
Dartmouth
Falmouth
Fairhaven
Marion
Mattapoisett
New Bedford
Wareham
Westport

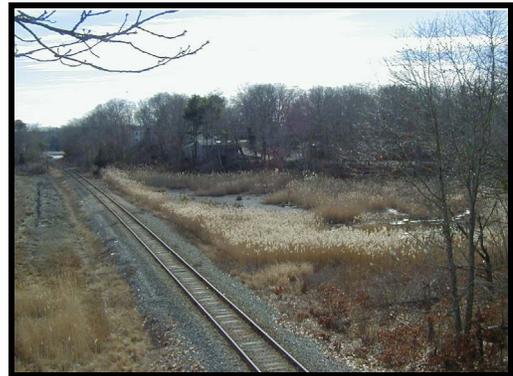
A culvert could be installed under the tracks to allow tidal flow to the wetland to the West. The low elevation of the tracks relative to the salt marsh make this an affordable railroad bed project.

View of railroad tracks

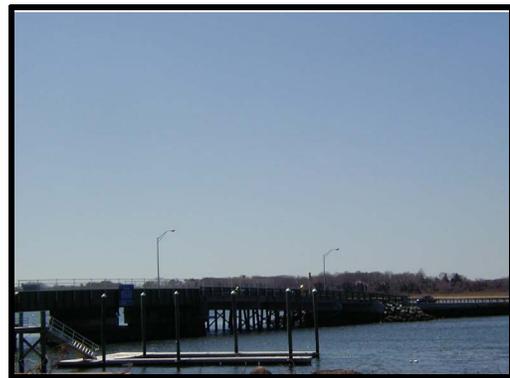
Looking south

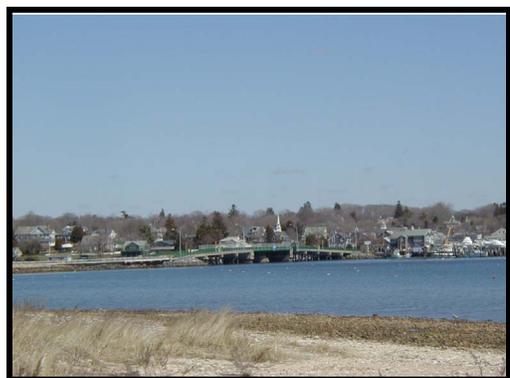
This bridge was recently rebuilt. It might be more cost effective to install new culverts under selected areas of Bridge Street rather than to expand the opening of the bridge or deepen the channel.

View of bridge and road

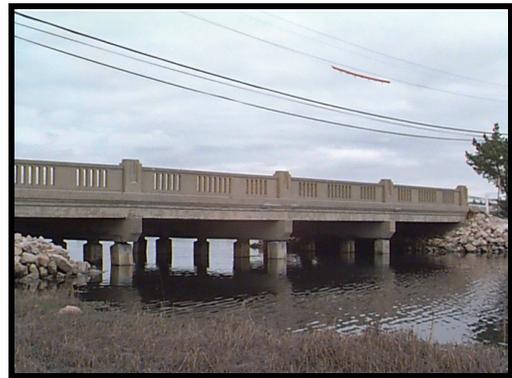
This bridge was originally built in 1938, and it has recently been rebuilt. Deepening of the channel or adding additional culverts may improve flushing upstream.

View of bridge

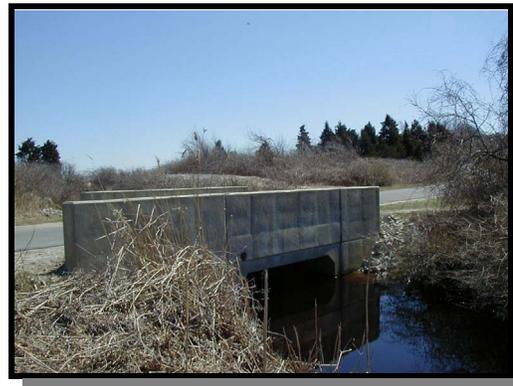
Culvert condition: fair

Culvert under road

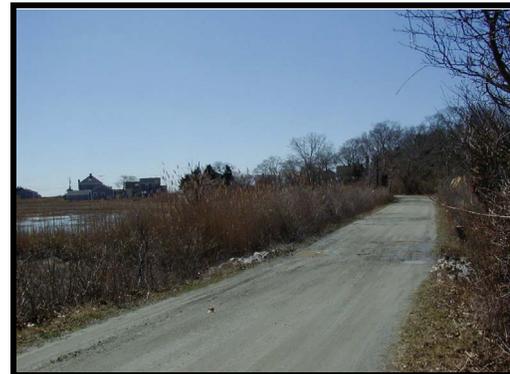
The major restriction to this marsh system, DA08, will be replaced with a larger culvert in the near future as part of a GROWetlands project. As there are some low lying developed areas above DA06 and DA07, further study may be warranted prior to initiating further remediation efforts at this marsh. Due to the fact that the driveway is not paved and the culverts are not far below the road surface, these restrictions would be easy to fix. DA07 is partially buried in mud.

Gravel road passing over restriction DA06

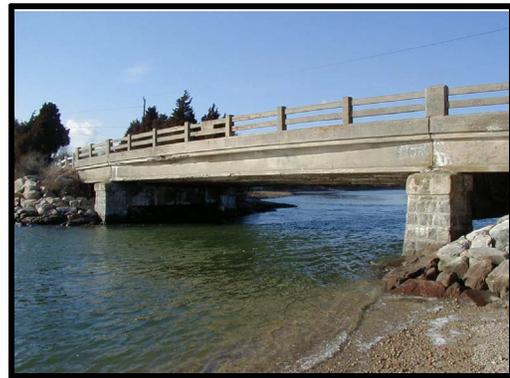
Tidal restriction DA09 is the Little River Bridge in Dartmouth (see map on page 80). Located at the mouth of Little River, this bridge has cracks and spalling in many areas and may need reconstruction in the future.

The plunge pool created by tidal scouring is a favorite spot for illicit bridge jumping. Although this site scored high for a number of reasons, further study would be required to determine if upstream impairments are caused by this restriction, and whether dredging of the channel or widening of the bridge during construction would mitigate these impacts.

South side of bridge looking upstream

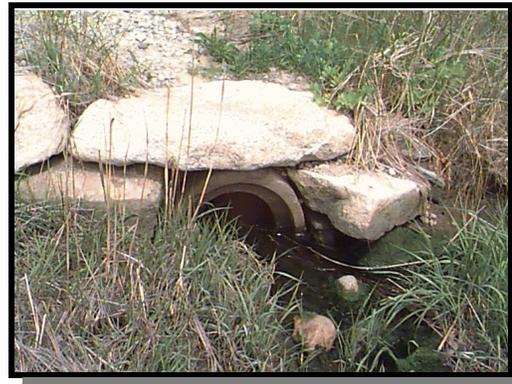
Culvert condition: poor
Road width: 12 feet
Culvert length: 14.4 feet
Acres of wetlands affected: 6.3 acres
Acres of *Phragmites* present: 2.2 acres

North side of culvert

The Buzzards Bay Project has initiated discussions with the Massachusetts Audubon Society and the Town of Dartmouth concerning the replacement of the undersized culvert with two 24" culverts.

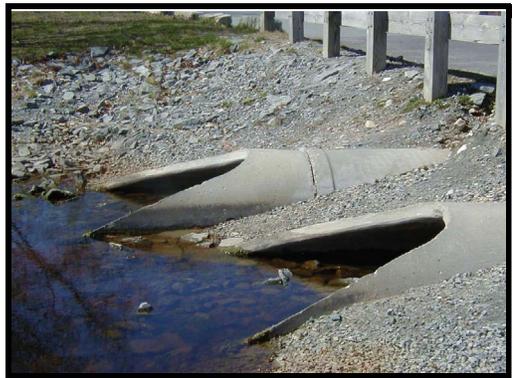
DA12 consists of two culverts under the access road to Demarest Lloyd State Park at the mouth of the Slocums River estuary (see map on page 82). The existing culverts drain George’s Pond. Stabilization rocks for the sides of the access road have been thrown into the culverts, partially blocking them.

South end of culverts

Buzzards Bay Project staff members have made arrangements with the Department of Environmental Management’s park supervisor to remove the stones in the culvert. While removal of the obstructing stones within the existing culverts may improve flushing, a new culvert may be needed. The road edge at the culverts is crumbling due to the loss of the stabilizing rip rap.

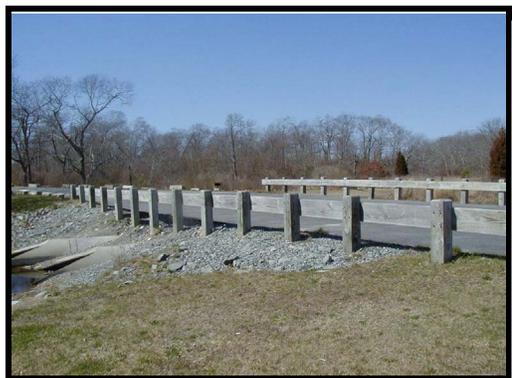
View of road edge

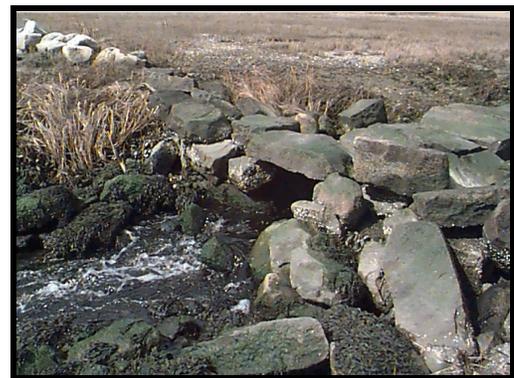
Culvert condition: poor

Old stone box culvert

The replacement of the existing stone path with a footbridge would increase the tidal flow yet still allow pedestrian access to the property.

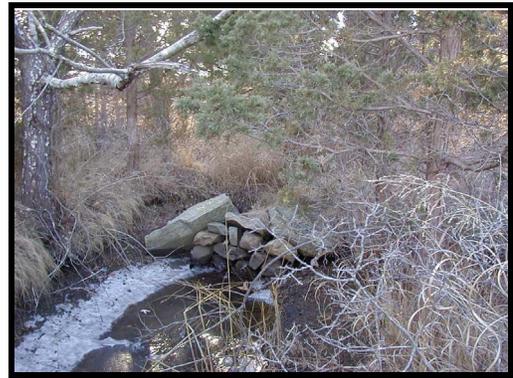
DA17 is another restriction in the northwest corner of Apponagansett Bay (see map on page 78). It is an old stone box culvert that has completely collapsed. This was the original road location to access the upland area to the south. The wetland restricted by the culvert also receives tidal flushing through DA14, a restriction to the north of DA15. Much of this marsh was an old gravel pit.

Downstream view

Since this road is no longer used, the removal of the old road and culvert would be fairly simple.

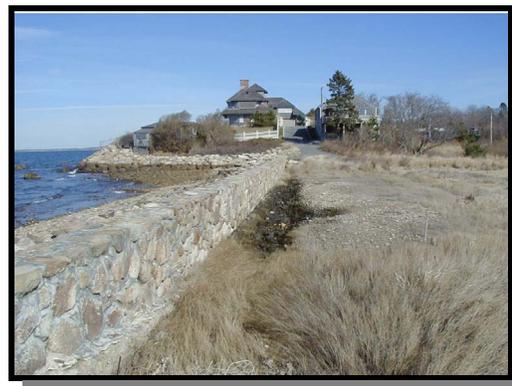
Due to the low lying areas, this site should be investigated to determine if a self regulating tide gate is needed. The impacted marsh is the same area affected by FA03, FA04, FA05, FA06, FA40, and FA41. A study that looks at all restrictions affecting this marsh system is recommended.

View of rock wall

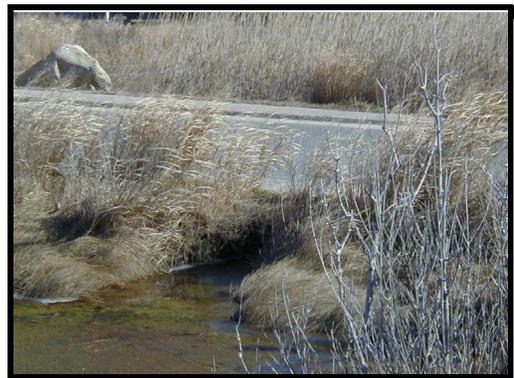
Restriction site FA05

There is a lot of *Phragmites* on the upstream side of this culvert. The culvert has filled in on the east side with soil and is not visible, as it is covered by rocks. A larger culvert is required. The impacted marsh is the same area affected by FA02, FA03, FA04, FA06, FA40, and FA41. A study that looks at all restrictions affecting this marsh system is recommended.

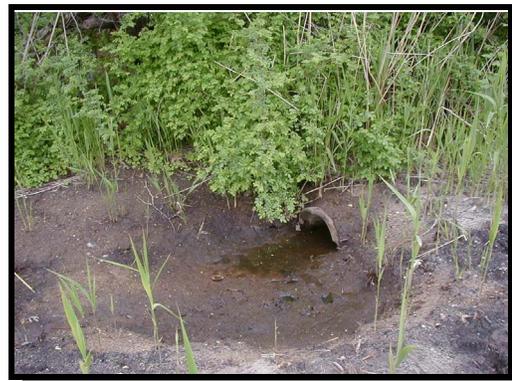
The culvert is 95% blocked at the Eel Pond end and not visible. In the spring of 2002 the culvert was broken during the reconstruction of the home on the Eel Pond side and covered over without being replaced. The length of the culvert and density of development will provide challenges to restoration. The impacted marsh is the same area affected by FA02, FA03, FA04, FA05 FA06, and FA40. A study that looks at all restrictions affecting this marsh system is recommended.

Mill Pond side of culvert

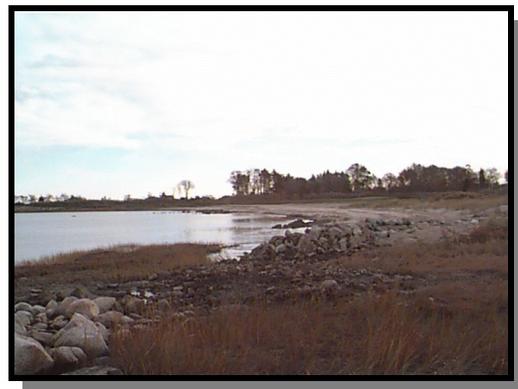
Most of the *Phragmites* has died back since the restriction was partially removed in 1998. This site should be investigated further to determine if other improvements to flushing can be achieved.

Section of wall that was removed

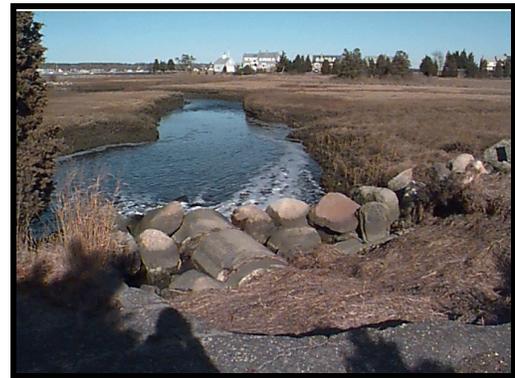
This culvert is broken in many places. Additionally, the road is broken up and two-thirds washed away. This site has been selected as a GROWetlands project. The Massachusetts Wetlands Restoration Program has secured an engineering firm to study the site.

Downstream side

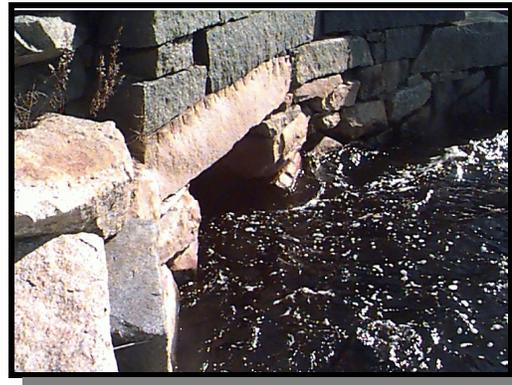
Restriction site MT09

The culvert is submerged and Eel Pond has developed a breach in the barrier beach west of this site. The breach may provide adequate flushing to the pond. Further study of this issue is warranted prior to planning a secondary culvert.

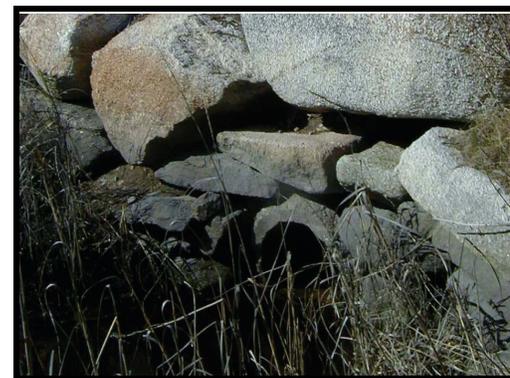
Due to the lack of paving and utilities and the shallow culvert depth, this culvert would be easy to replace. There has been somewhat of a breach in the barrier beach to the south at MT17, which allows tidal waters to the same wetland.

Upstream end of culvert

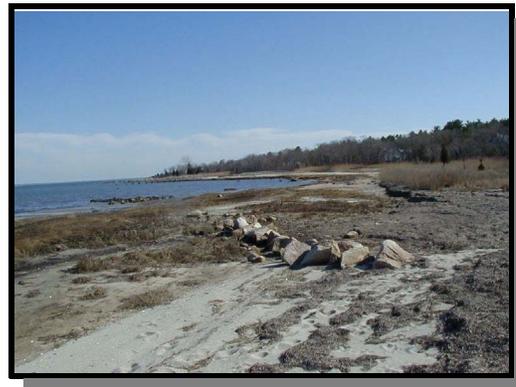
The rock wall has sunk and is clearly over washed. While the removal of this wall would provide only a marginal increase in tidal flooding, the project would be easy to complete.

Stone wall on beach, looking south

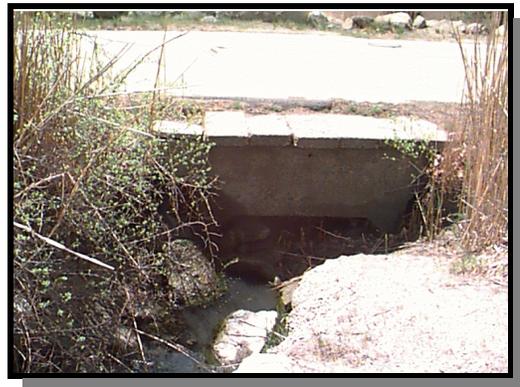
Tidal restriction WH1 I

There is a water main bleeder pipe discharging at the culvert which lowers the salinity in the area. Sediment washing off the road and low velocity through the culvert have caused sand to accumulate. Dredging of the ditch, along with installation of a larger culvert would be needed to improve flushing.

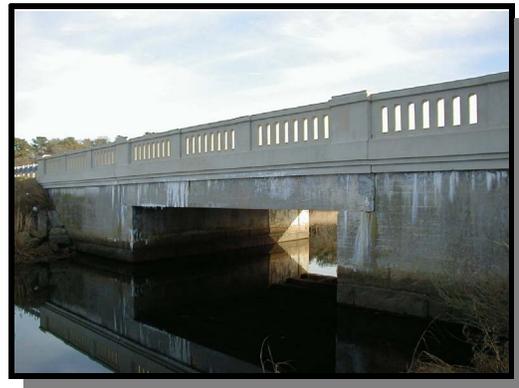
This opening is very small for the size of the river. The river supports a herring run as well as sea run brown trout. Increased flushing may also improve water quality impairments caused by the wastewater treatment plant.

North side of bridge

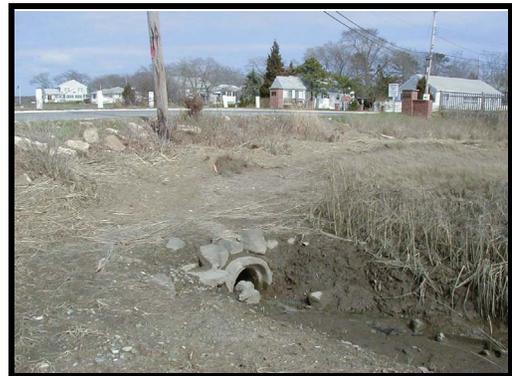
Due to the shallow culvert depth, this would be an easy culvert to replace. The location of any utilities (gas, water, and sewer are present in the street) could add appreciably to the final costs.

East end of pipe

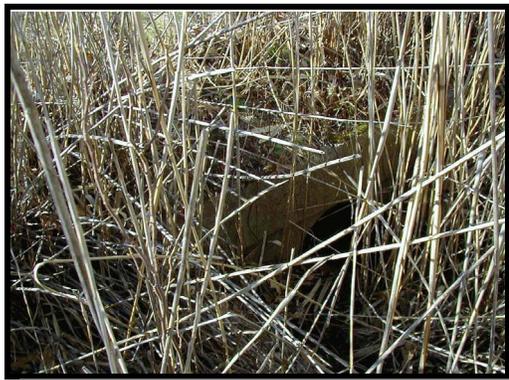
This project must be remediated in conjunction with WH29. Although there are no properties accessed by this section of road, the road contains water mains and active electric/telephone poles precluding road removal. The marsh to the south was flooded for several days by salt water after Hurricane Bob in 1991. All freshwater vegetation in the marsh was killed as a result of that flooding.

Phragmites at end of pipe

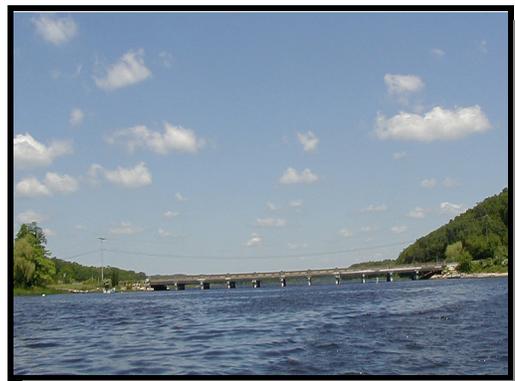
This tidal restriction is caused by fill material deposited under Hix Bridge, which impedes tidal flow and creates a damming effect (see map on page 141). Large granite blocks were toppled in the river as a result of the destruction of the old Hix Bridge by the Hurricane of '38 and from the demolition of the bridge in 1939.

View of Hix Bridge, looking North

The Town of Westport is planning to rebuild this bridge. The U.S. Army Corps of Engineers is conducting a tidal flushing study to determine the benefits of increased tidal flushing. There may be problems associated with the removal of the granite blocks. A detailed report on this site is available on the Buzzards Bay Project's website, www.buzzardsbay.org.
