**Buzzards Bay Project**  
*National Estuary Program*

April 16, 2004

The Buzzards Bay Project National Estuary Program has received the Bouchard Transportation Company's March 2004 response to our report dated February 3, 2004 and titled "An interim analysis of the June 14, 2003 report by Independent Maritime Consulting Ltd. on the volume of oil spilled by the Bouchard Transportation Company tank barge Bouchard No. 120 in Buzzards Bay." Our report was essentially an evaluation of the David Hall report "Investigation and reconciliation of cargo quantities for *Bouchard No. 120* oil spill at Buzzards Bay, April 2003," dated June 14, 2003, and ullage reports prepared by inspectors for the firm Caleb Brett. The Caleb Brett inspector reports from the *Bouchard No. 120* in Buzzards Bay were the basis of the estimated 98,000 gallons spilled as reported in May 2003. In his June 2003 report, Mr. Hall discounted the Caleb Brett inspector ullage reports as accurately quantifying oil remaining on board the *Bouchard No. 120*, or remaining on the lightering vessel *Bouchard No. 10*. Instead, his estimate of the volume of oil spilled focused on the volume of oil collected in the Caddell Dry Do

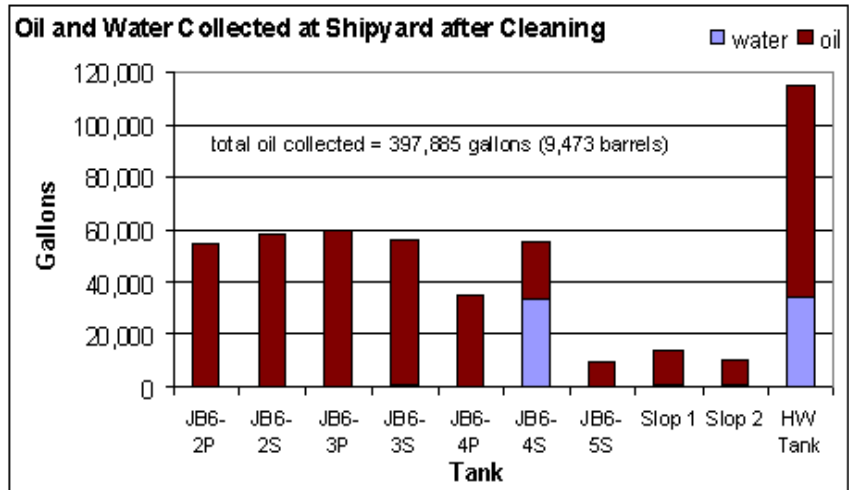
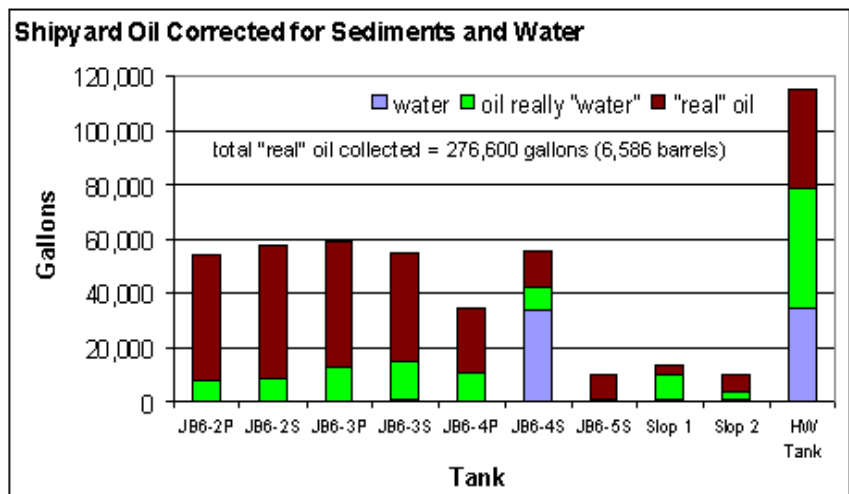
Mr. Hall was able to resolve this problem of too much oil, by adjusting the oil volumes in each of the ten tanks by measuring the “water and sediment” content of the oil layer (Appendix P, Method D1796). The “water and sediment” content of the oil layer was highly variable and ranged from 14% to 70%. However, in one tank (JB5S) a different assay was used to measure water only (Method D95) in the oil layer. This tank was found to have only 6.5% water. The highly variable results and two different methods used seem inexplicable. Mr. Hall notes, “the samples taken of the oil were what are termed ‘running samples.’ This technique of sampling makes the best effort to sample the entire column of oil.” Mr. Hall needs to precisely describe the sampling device and protocols on the collection of these samples to demonstrate they are representative of the entire oil column. These adjustments were the basis of the calculations concluding that 22,000 to 55,000 gallons of oil were spilled in Buzzards Bay. Mr. Hall’s findings are summarized in the two figures on the next page. The top chart is the volume of oil actually documented in the tanks by the Caleb Brett inspectors; the bottom graph shows the adjustments for the sediment and water analyses.

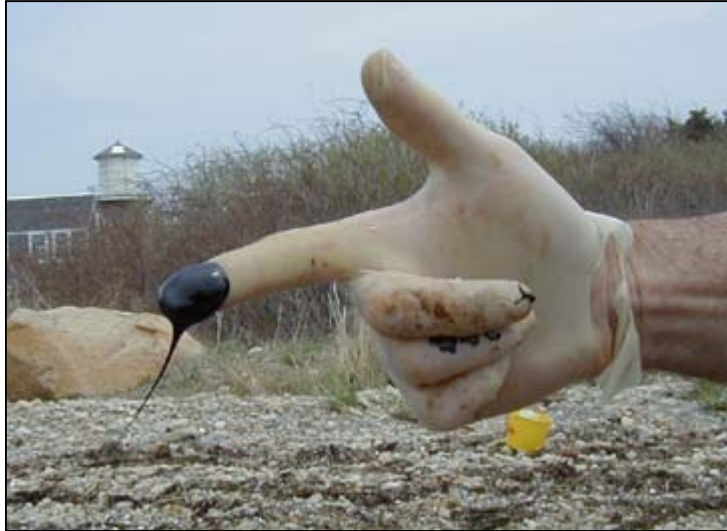
What is the basis of the half-inch layer? Mr. Hall shows a picture from a study of Gambian crude oil stuck to a refrigerated pipe to a thickness of 1/2 inch. In the study, the refrigerated pipe was cooled down to different temperatures, in this case down to 0° F. The Gambian crude was an example of the greatest amount of clingage in the report. The temperature of Buzzards Bay at the time of the accident was 44° F. The picture below shows the actual clingage of the No. 6 oil washing ashore, at ambient seawater temperature, two days after the accident. As shown by the picture, actual clingage was on the order of a few millimeters. This picture contradicts Mr. Hall's statement that this fuel oil "happens to have the consistency of Jell-O when its temperature falls below 95 degrees F." Even the 1984 report Mr. Hall included as an appendix to his recent report shows the clingage drops to negligible levels when the temperature of the oil is above 70° F. As Mr. Hall noted in his report, when the *Bouchard No. 120* delivered its oil to Mirant three days after the accident, oil in eight of the ten tanks was still between 93.6° F and 122.8° F. In fact, 7 of the 10 tanks were above 100° F. The two cooled tanks with seawater had temperatures of 50° F and 99° F, respectively. The warm temperatures of the oil, even if exposed to a single hull with water on the other side at 44° F would not seem to support Mr. Hall's assertion that a half-inch layer of oil would have existed in all the tanks, particularly in light of the photograph of the cold oil below.

Actual clingage of cold *Bouchard No. 120* oil that washed ashore 2 days after the spill. By this time, the oil had likely lost some of its most volatile constituents and was at ambient water temperature (around 44° F).
