**INSPECTION REPORT  
POPE'S ISLAND MARINA  
NEW BEDFORD WATERFRONT  
FACILITIES INSPECTIONS  
NEW BEDFORD, MASSACHUSETTS**

MARCH 2009

Pope's Island Marina is a timber "T-Pier" structure, provided with a system of floating docks. The marina opened in 1993 and provides 198 boat slips to the public.

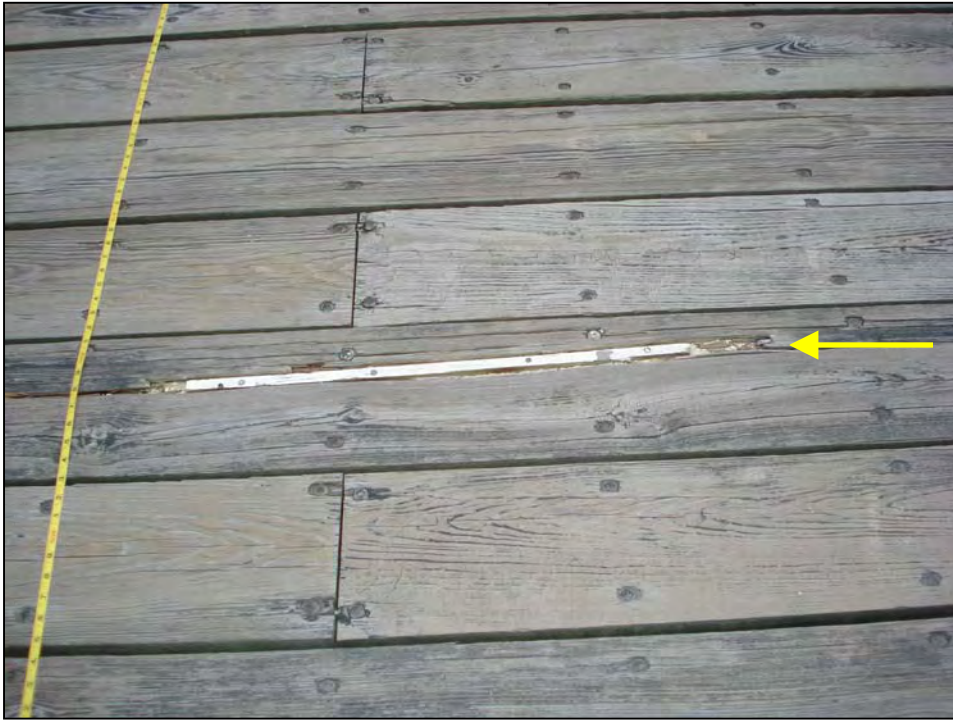
The topside of Pope's Island Marina Tee Pier is in generally good condition. Minor deficiencies include observed timber rot along the decking, some evidence of mildew growth, and minor damage to the timber curb. At Station 0+05 the timber deck board at the location of a timber ladder showed signs of rot on the southern edge, adjacent to the ladder. At Station 4+55, minor damage to the timber curb was observed with some cracking and splitting noted. Typically along the entire length of the tee pier and along the curb, the timber shows signs of mildew growth. This condition is a minor deficiency, but may become slippery during wet conditions.

Photo No. 3: Rotted timber deck with filler piece at Station 1+60.

Remove and replace rotting timber deck boards. Failure to repair damaged areas may cause an unsafe condition. The opinion of probable construction cost for this work is approximately \$2,000.

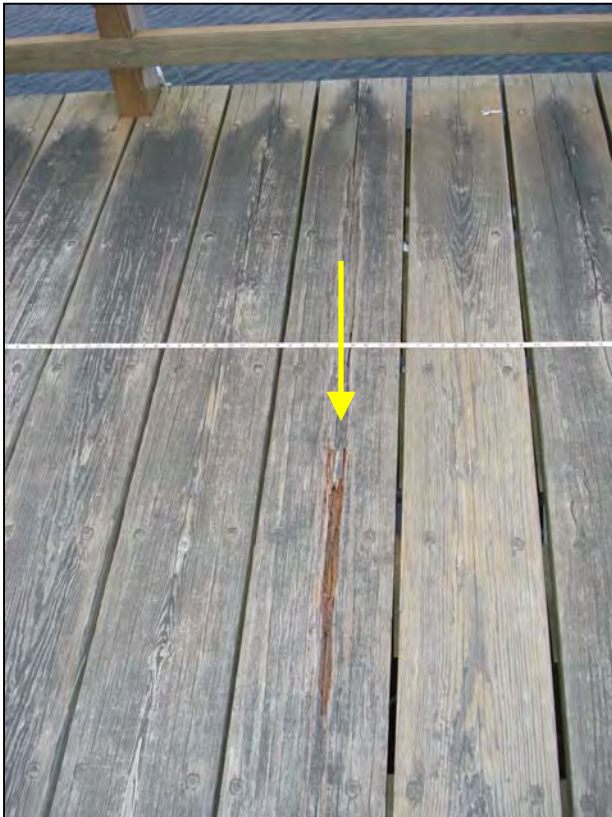
Photo No. 4: Rotted timber deck at Station 3+50.

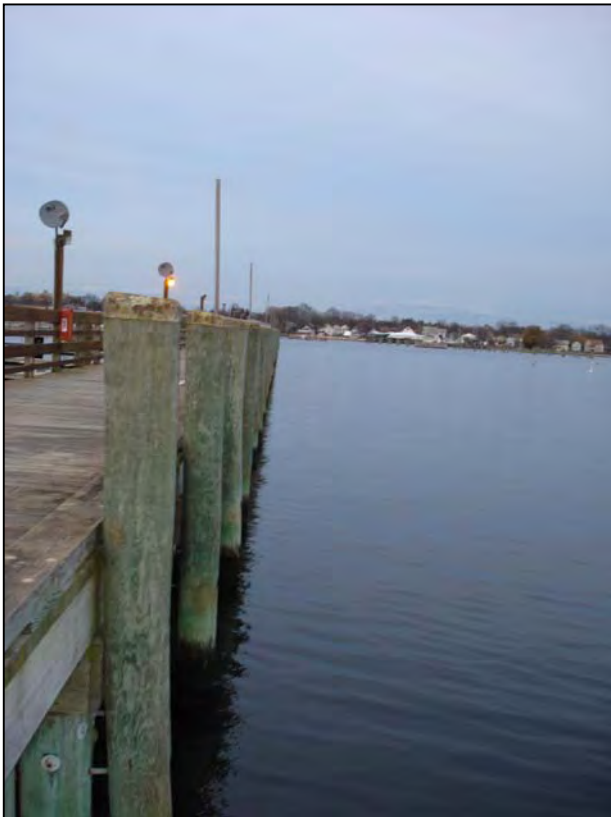
A timber fender system consisting of 12 inch diameter timber fender piles spaced 10 feet on center was observed along the southern face of the tee pier only. The above water portion of the timber fender system was in overall good condition. Typically the piles have significant wearing along the waterside face between mean low water and just below the bottom of the pier deck. Connecting bolts through the piles are countersunk, however some of the piles have worn down to the bolt head.

Photo No. 14: Overview of the timber fender piles along the Tee Pier.

Install UHMW rub rails to the face of the fender pile. The UHMW is more durable than the timber and will extend the life of the piles. The opinion of probable construction cost for this work is approximately \$25,000.

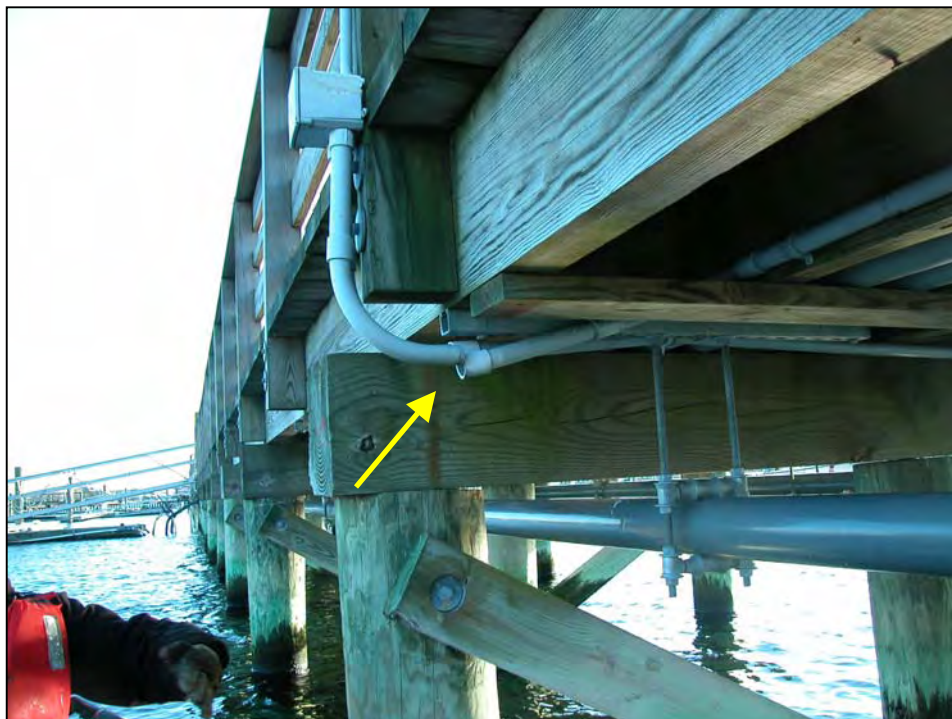
On the underside of the main pier and tee pier, PVC pipes providing sewer and electrical utilities pass between the timber stringers. A 4 inch diameter PVC pipe hangs with galvanized hangers beneath the timber pile caps. Some of the connections along these raceways have become loose or separated. On the tee pier at approximately Station 4+05, a small wooded shed acts as a pump house for these utilities. Along both the main pier and tee pier structures, fire extinguishers and fire alarms were observed along the light posts and handrails. Water standpipes were also observed at several locations. Along the main pier, 5 electrical generator boxes were observed. The generators were located within wider sections of the pier at Station 1+57, 2+87, and 4+32.

Photo No. 16: Damaged utility raceway along the underside of the main pier.

Repair the PVC raceways on the underside of the main pier. If not repaired the utilities in the pipes may become damaged, limiting or preventing service. The opinion of probable construction cost for this work is approximately \$30,000.

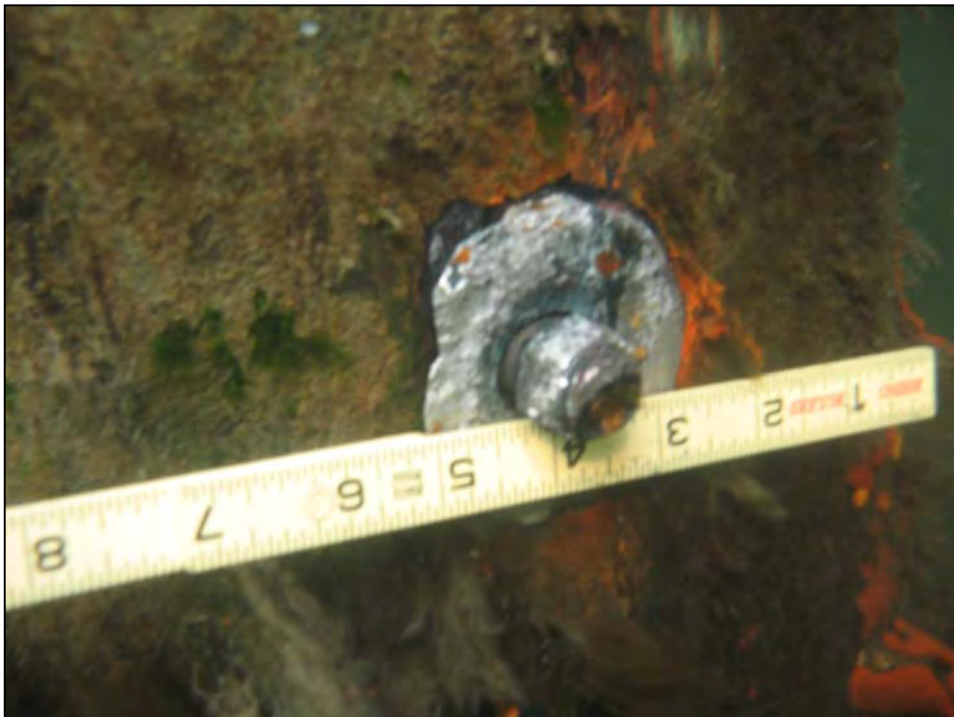
Photo No. 18: Typical low water connection hardware. (Photo by Childs Engineering Corp.)

Remove and replace underwater connection hardware. Failure to repair the connections will render the timber cross bracing ineffective, reducing the structural capacity of the pier and possibly creating an unsafe condition. The opinion of probable construction cost for this work is approximately \$70,000.

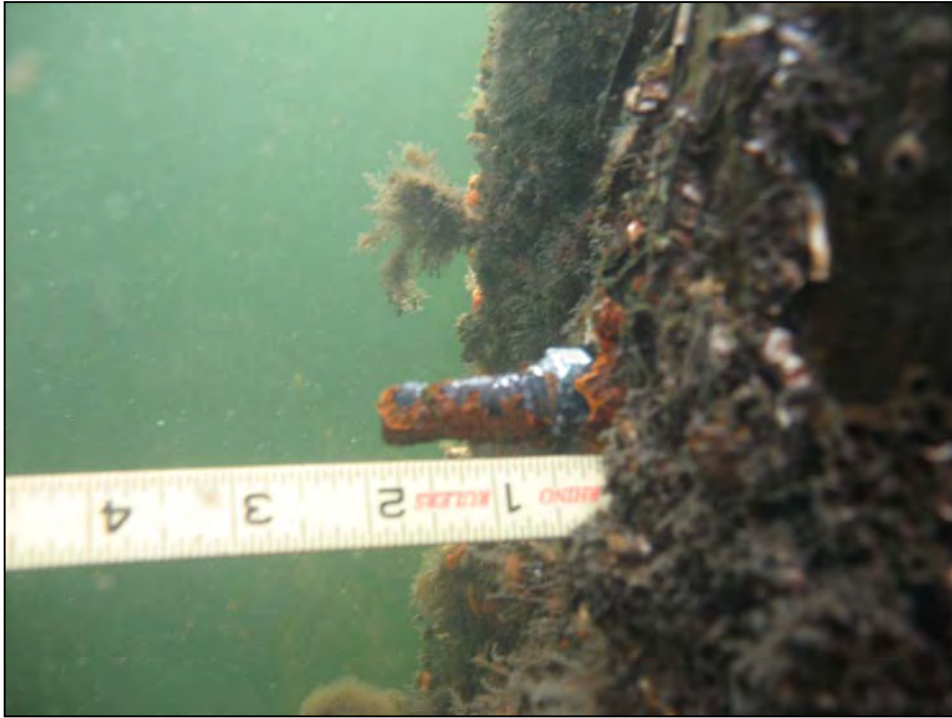
Based upon the visual inspection of topside and underwater structures, Pope's Island Marina is considered to be in generally good condition. No severe rot or deficiencies of the timber piles were observed, with no reduction in pile section noted during the underwater inspection. Some of the timber cross bracing has become detached or is likely to become detached due to the condition of the lower hardware.

Photo No. 19: Corroded underwater connection hardware. (Photo by Childs Engineering Corp.)

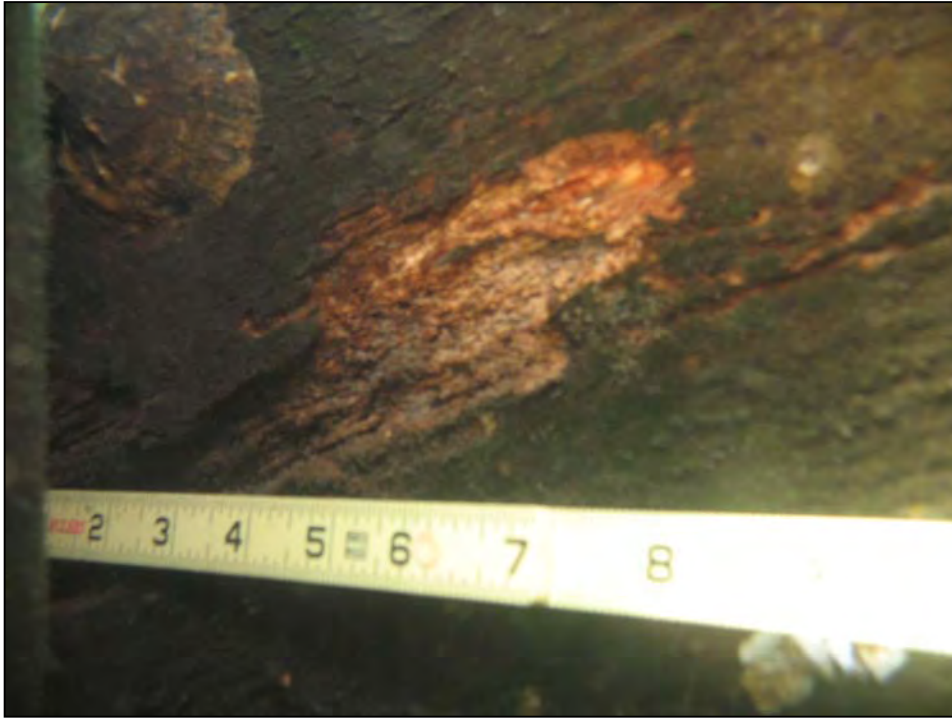
Photo No. 21: Evidence of marine borer activity along the timber cross bracing.  
(Photo by Childs Engineering Corp.)

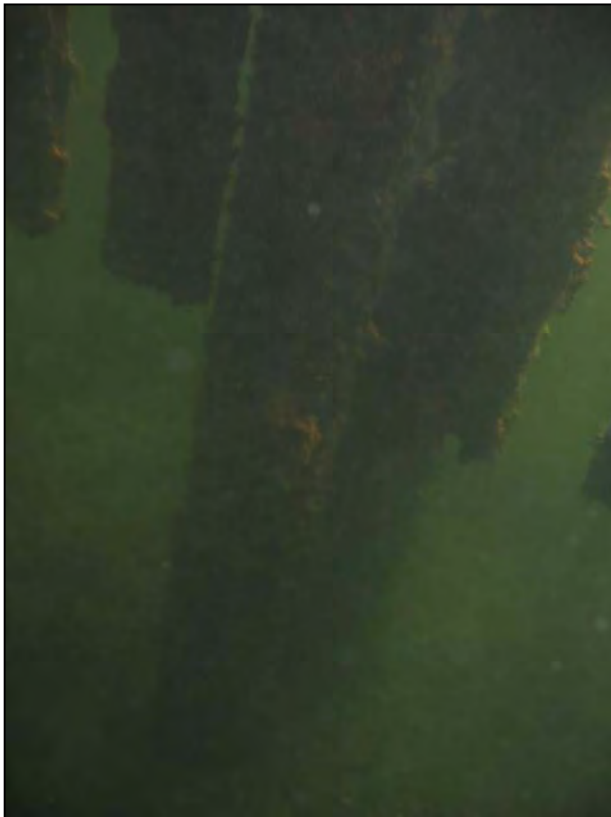
Photo No. 22: Overview of the wave attenuator underwater. (Photo by Childs Engineering Corp.)

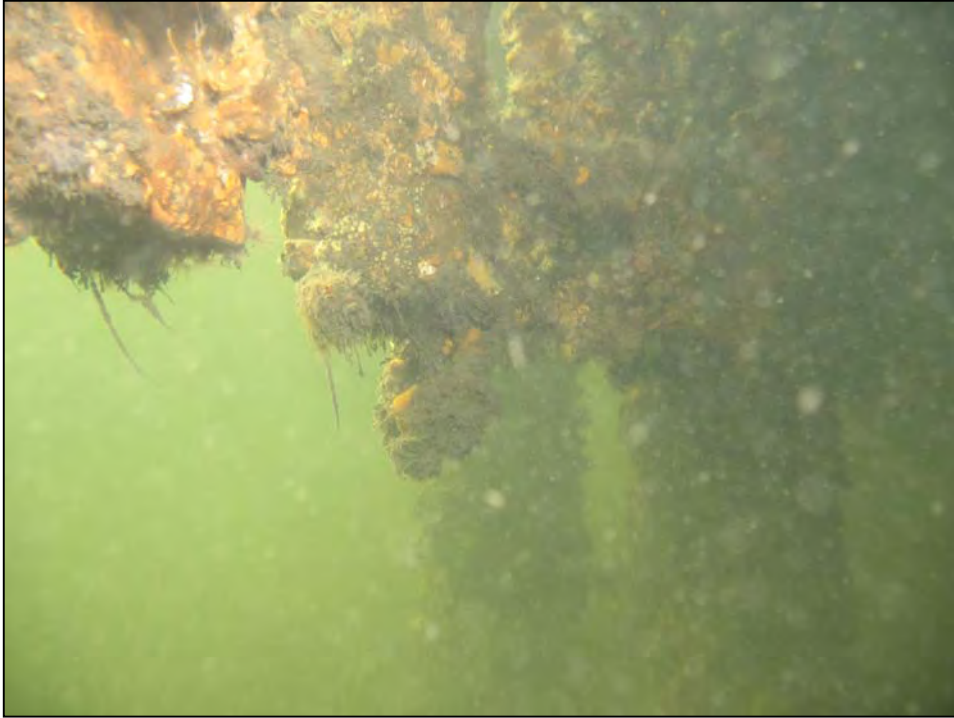
Photo No. 23: Detail of the lower portion of the wave attenuator underwater. Note heavy marine growth. (Photo by Childs Engineering Corp.)

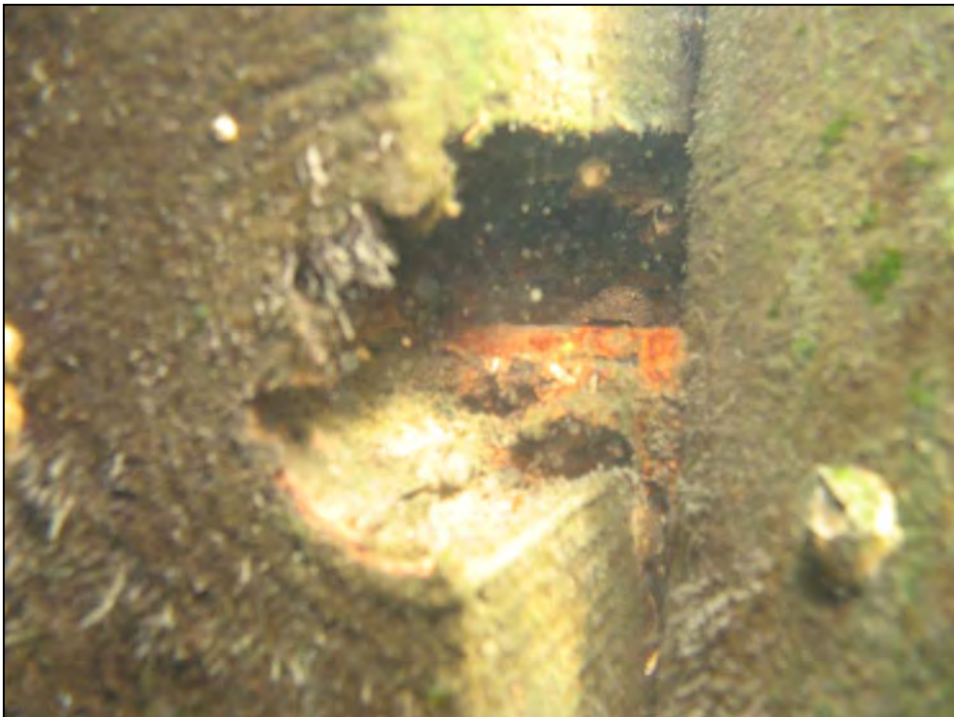
The wave attenuator (wave fence) is bolted to the southern face of the tee pier, and helps to protect the vessels and floating concrete docks from wave action. The wave fence is comprised of 3 inch by 8 inch vertical boards, with 6 inch spacing. The above water portion of the wave attenuator appeared to be in to poor condition, with many of the boards were observed to be loose, broken, or missing. Approximately 10% of the boards comprising the wave fence are missing. Specific locations of loose, broken, or missing boards are available in the underwater inspection notes in Appendix E – Field Notes.

Photo No. 24: Rotted timber wave attenuator stringer underwater. (Photo by Childs Engineering Corp.)

Repair the wave attenuator. Repairs should include removal and replacement of any rotted timber stringers, replacement of broken vertical members, reconnection of loose vertical members, and replacement of missing members. Because of the protection provided by the attenuator, critical damage to floating docks may occur if repairs are not undertaken quickly. The opinion of probable construction cost for this work is approximately \$18,000.
