**Massachusetts Division of Marine Fisheries  
Technical Report TR-16**

## **A Survey of Anadromous Fish Passage in Coastal Massachusetts**

### **Part 2. Cape Cod and the Islands**

May 2004

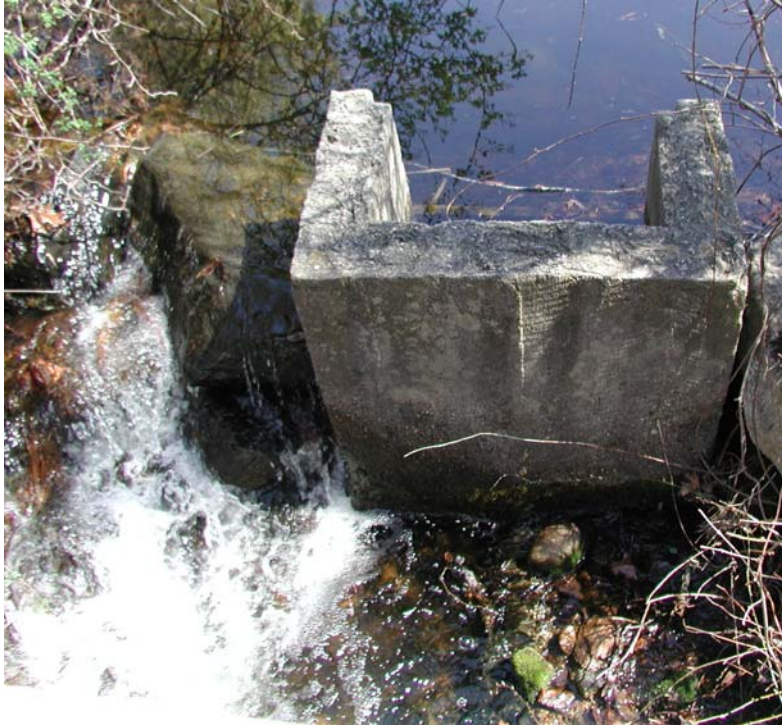
Mill Pond Dam

Design	Material	Length (ft)	Inside W (ft)	Outside W (ft)	# of Baffles	Baffle H (ft)	Notch W (ft)	Pool L (ft)	Condition/Function
Weir-pool	Concrete with a wooden baffle	8.5	2.9	4.1	1	0.4	-	-	Poor Not passable

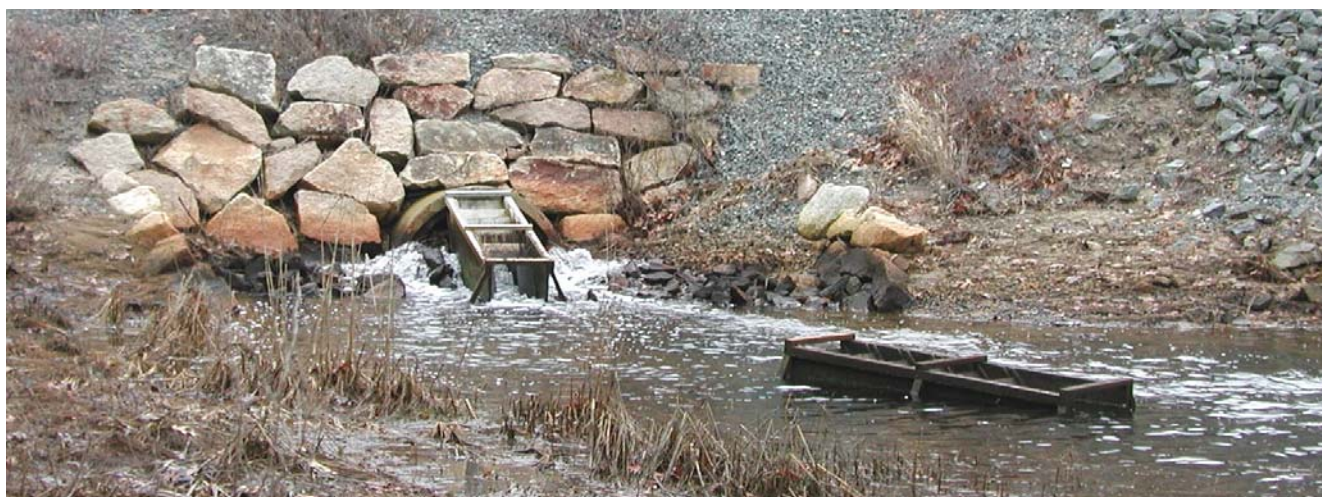
Red Brook Conrail Culvert and Denil fishways

Design	Material	Length (ft)	Inside W (ft)	Outside W (ft)	# of Baffles	Baffle H (ft)	Notch W (ft)	Pool L (ft)	Condition/ Function
Denil	Wood	8.0	1.5	1.7	6	2.0	-	-	Poor Inefficient passage
Denil	Wood	8.0	1.5	1.7	6	2.0	-	-	Poor Inefficient passage

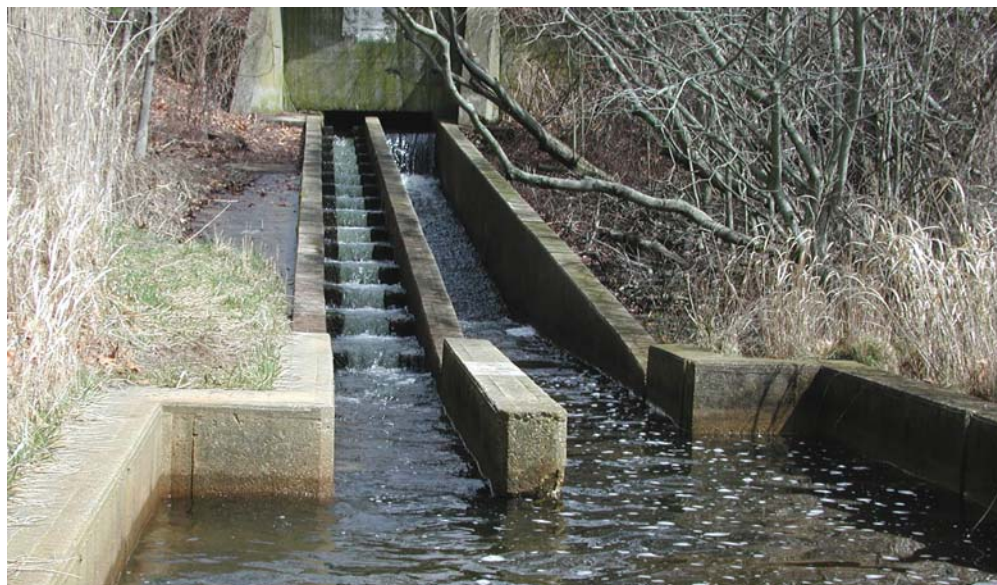
Red Brook Pond Dam and fishway

**Fishway** Being replaced

<b>Design</b>	<b>Material</b>	<b>Length (ft)</b>	<b>Inside W (ft)</b>	<b>Outside W (ft)</b>	<b># of Baffles</b>	<b>Baffle H (ft)</b>	<b>Notch W (ft)</b>	<b>Pool L (ft)</b>	<b>Condition/ Function</b>
Notched weir-pool	Concrete with wooden boards on upstream side of road	116.8	Varied (2.1 and 3.7)	Varied (3.4 and 4.9)	19	Varied (1.2-2.3)	Varied (1.0 and 2.3)	Varied (3.8-31.4)	Fair Passable

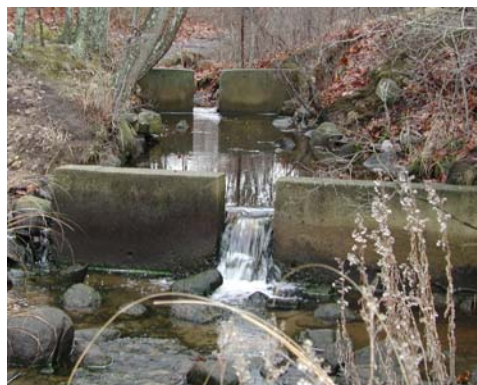
Stream baffles at Herring Brook Dam

Design	Material	Length (ft)	Inside W (ft)	Outside W (ft)	# of Baffles	Baffle H (ft)	Notch W (ft)	Pool L (ft)	Condition/Function
Stream baffle	Concrete, wood and stone	594	1.4	Stream width	12	Varied (1)	1.4	Varied (51-120)	Poor Inefficient

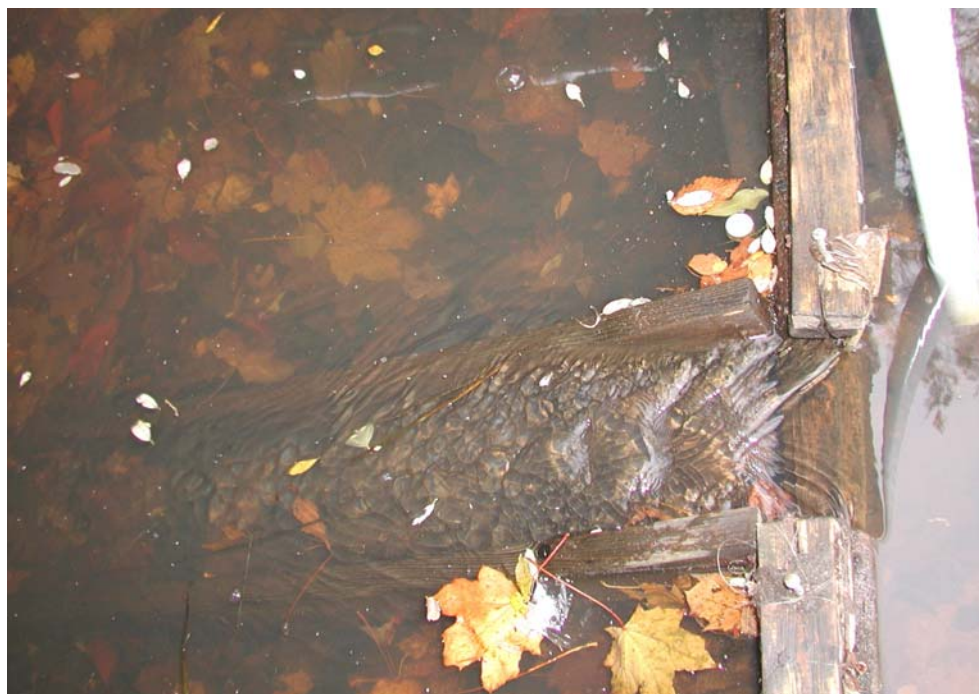
Shivericks Pond Dam with fishway

Design	Material	Length (ft)	Inside W (ft)	Outside W (ft)	# of Baffles	Baffle H (ft)	Notch W (ft)	Pool L (ft)	Condition/ Function
Weir-pool	Wood	3.7	0.7	0.9	3	0.2	-	0.8	Fair Inefficient passage

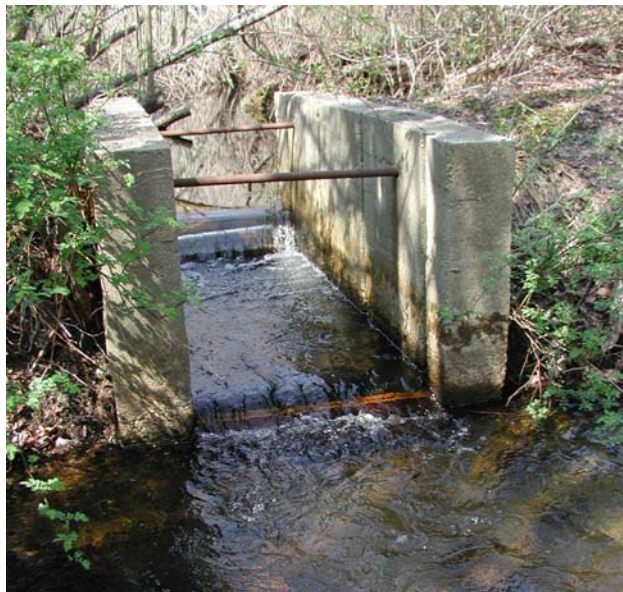
Weir pool ladder at Pond 14 dam (bypassing Alaskan Steeppass ladder)

<b>Design</b>	<b>Material</b>	<b>Length (ft)</b>	<b>Inside W (ft)</b>	<b>Outside W (ft)</b>	<b># of Baffles</b>	<b>Baffle H (ft)</b>	<b>Notch W (ft)</b>	<b>Pool L (ft)</b>	<b>Condition/Function</b>
Alaskan Steeppass	Aluminum	30.0	1.8	-	-	-	-	-	Excellent Passable
Weir-pool	Concrete with wooden baffles	8.5	2.9	4.3	2	~0.6	-	7.0	Good Passable

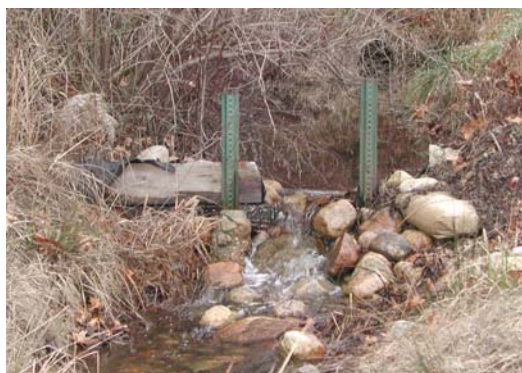
Fishway at John Parker Road culvert and bog sluice

Design	Material	Length (ft)	Inside W (ft)	Outside W (ft)	# of Baffles	Baffle H (ft)	Notch W (ft)	Pool L (ft)	Condition/Function
Stream baffle	Stone and metal with a wooden baffle	126.3	3-4	Stream edge	1	0.5	0.6	N/A	Fair Inefficient passage

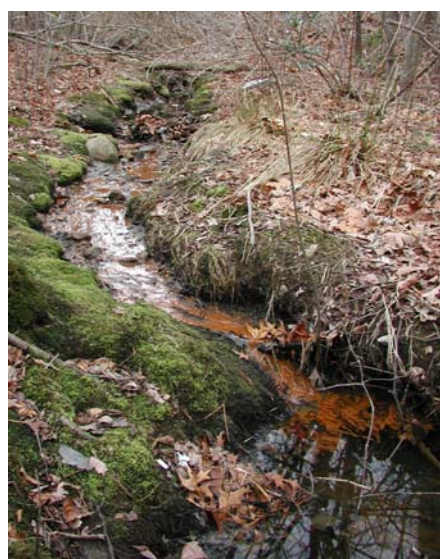
Mill Pond Fishway

Design	Material	Length (ft)	Inside W (ft)	Outside W (ft)	# of Baffles	Baffle H (ft)	Notch W (ft)	Pool L (ft)	Condition/Function
Stream baffle	Stone	131.0	Varied (1.0-3.7)	Stream edge	5	Varied (0.3-1.3)	1.0	Varied (13-27)	Poor Not passable

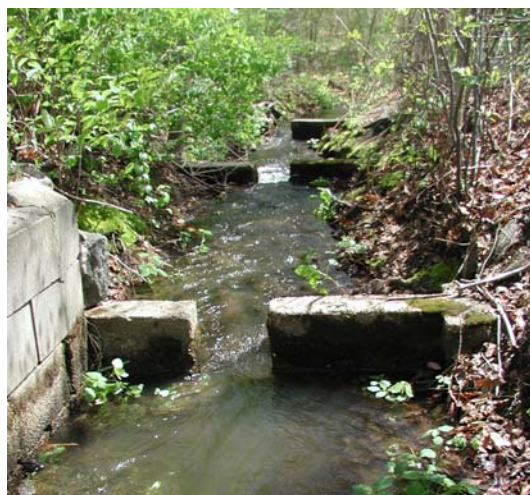
Carriage Shop Road Fishway

Design	Material	Length (ft)	Inside W (ft)	Outside W (ft)	# of Baffles	Baffle H (ft)	Notch W (ft)	Pool L (ft)	Condition/ Function
Stream baffle	Concrete and granite	100.0	3.0	Stream edge	6	1.5	0.8	10	Poor Not passable

This is one of two outlet streams from Johns Pond, a 317 acre natural water body. The first obstruction to fish passage is a small dam at Carriage Shop Road. A series of stream baffles once enabled fish to enter the pond but are now badly deteriorated. The second barrier is a control box below Johns Pond which regulates flow from a subsurface outlet in the pond.

The lack of adequate spawning area downstream of Johns Pond, the difficulties involved in providing access to the headwaters and the problems inherent in maintaining flow from two outlets make this stream a poor candidate for development. Resources should be directed toward improving passage conditions in the second outlet stream, the Quashnet River.

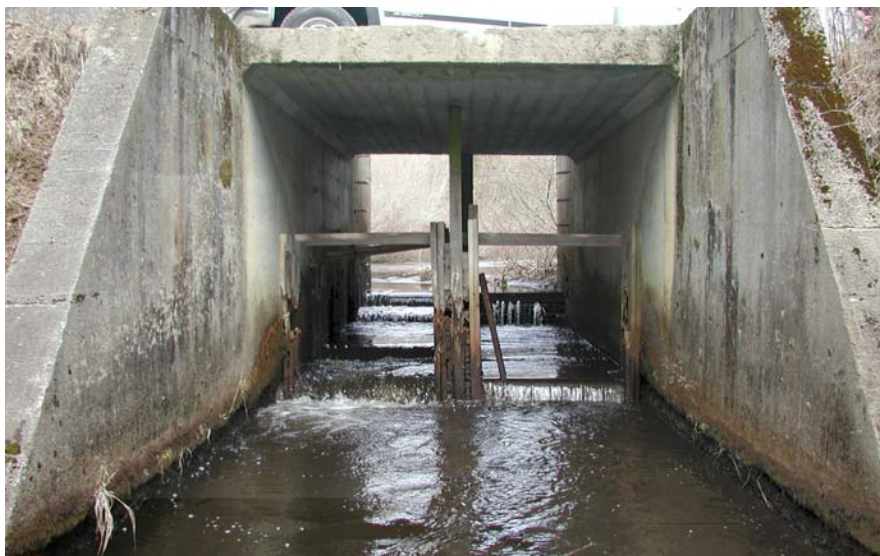
Second Unnamed Dam and Fish Ladder on U.S. Fish &amp; Wildlife Property

Design	Material	Length (ft)	Inside W (ft)	Outside W (ft)	# of Baffles	Baffle H (ft)	Notch W (ft)	Pool L (ft)	Condition/ Function
Weir-pool	Concrete with wooden baffles	24.5	4.5	4.7	4	0.9	-	6.0	Poor Inefficient passage

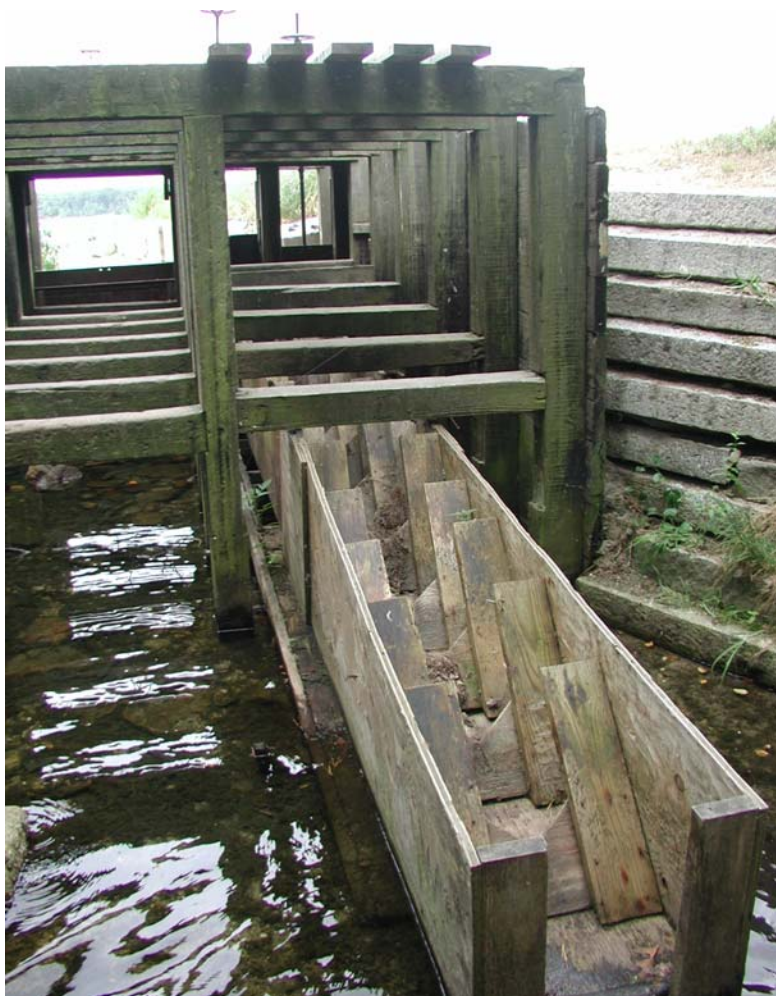
Dam and Fishway at outlet of John's Pond

Design	Material	Length (ft)	Inside W (ft)	Outside W (ft)	# of Baffles	Baffle H (ft)	Notch W (ft)	Pool L (ft)	Condition/ Function
Denil	Wood	25.0	1.7	1.8	17	Varied (1.7 and 2.0)	-	-	Poor Inefficient passage

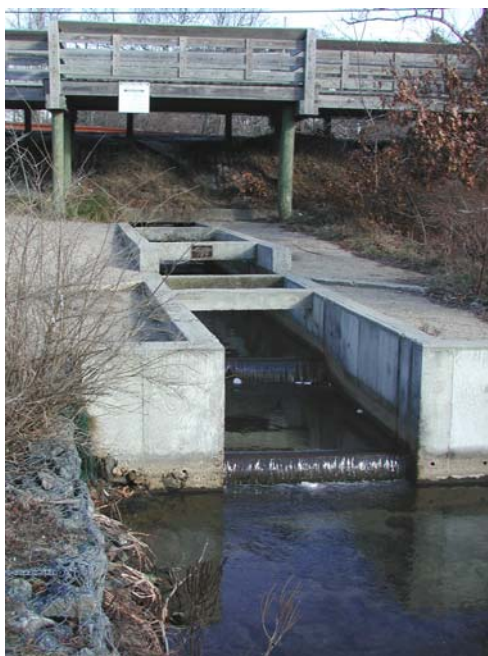
Fishway at Route 130 Crossing

<b>Design</b>	<b>Material</b>	<b>Length (ft)</b>	<b>Inside W (ft)</b>	<b>Outside W (ft)</b>	<b># of Baffles</b>	<b>Baffle H (ft)</b>	<b>Notch W (ft)</b>	<b>Pool L (ft)</b>	<b>Condition/Function</b>
Weir-pool	Concrete with wooden baffles	219.0	Varied (3.0 and 5.0)	Varied (4.6 and 6.6)	10	Varied (1.1-2.1)	-	Varied (8.0-35.0)	Excellent Passable

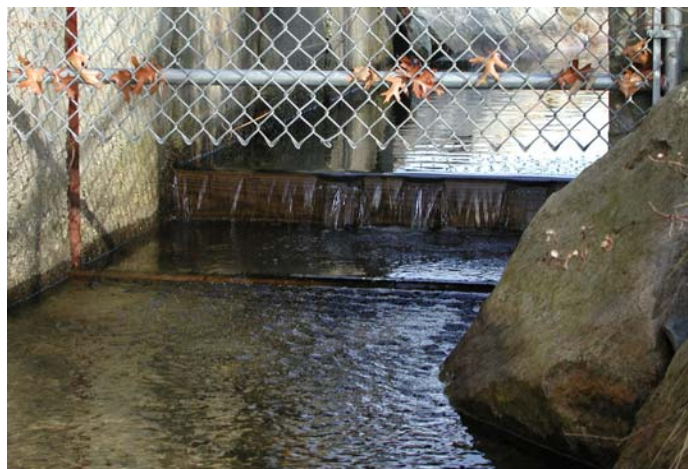
Fishway at Mashpee Pond Control Structure

<b>Design</b>	<b>Material</b>	<b>Length (ft)</b>	<b>Inside W (ft)</b>	<b>Outside W (ft)</b>	<b># of Baffles</b>	<b>Baffle H (ft)</b>	<b>Notch W (ft)</b>	<b>Pool L (ft)</b>	<b>Condition/Function</b>
Weir-pool	Concrete with wooden baffles	20	5.6	7.6	5	0.5	-	3	Excellent Passable

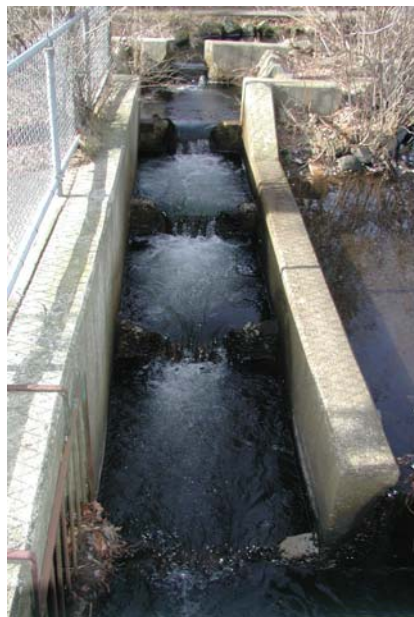
Mill Pond Fishway

Design	Material	Length (ft)	Inside W (ft)	Outside W (ft)	# of Baffles	Baffle H (ft)	Notch W (ft)	Pool L (ft)	Condition/Function
Notched weir-pool	Concrete	53.0	4.0	6.0	6	Varied (1.8-2.3)	1.5	5.0	Poor Inefficient passage

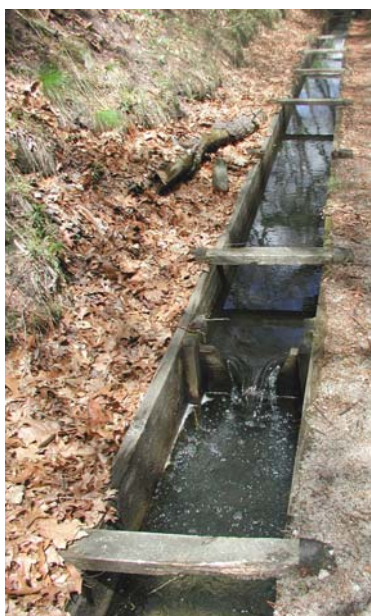
Notched weir-pool fishway at Middle Pond

Design	Material	Length (ft)	Inside W (ft)	Outside W (ft)	# of Baffles	Baffle H (ft)	Notch W (ft)	Pool L (ft)	Condition/Function
Notched weir-pool	Wood	1001	1.9	2.2	13	2.5	0.8	Varied (11.8-425)	Fair Inefficient passage
Denil	Concrete and wood	10.0	1.9	3.5	4	4.5	-	-	Fair Inefficient passage

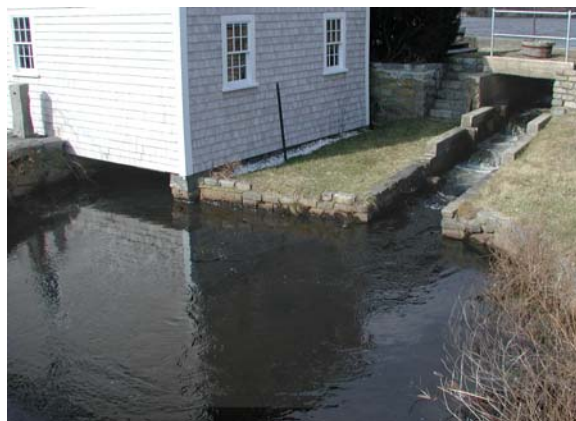
Mill Pond Fishway (at Baxter Grist Mill)

Design	Material	Length (ft)	Inside W (ft)	Outside W (ft)	# of Baffles	Baffle H (ft)	Notch W (ft)	Pool L (ft)	Condition/Function
Weir-pool	Concrete with wooden baffles	39.0	3.6	4.9	5	2.0	2.2	6.0	Good Passable

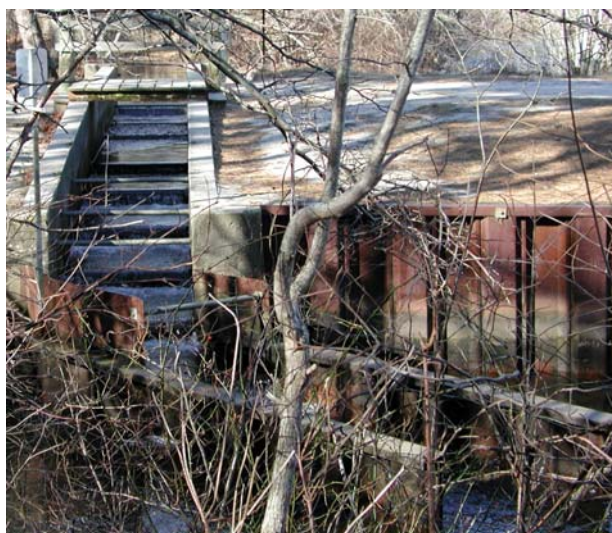
Fishway at West Reservoir

Design	Material	Length (ft)	Inside W (ft)	Outside W (ft)	# of Baffles	Baffle H (ft)	Notch W (ft)	Pool L (ft)	Condition/Function
Weir-pool	Concrete and metal with wooden baffles	88.0	4.7	6.7	10	Varied (2.4 - 4.4)	-	Varied (6 - 16)	Good Passable

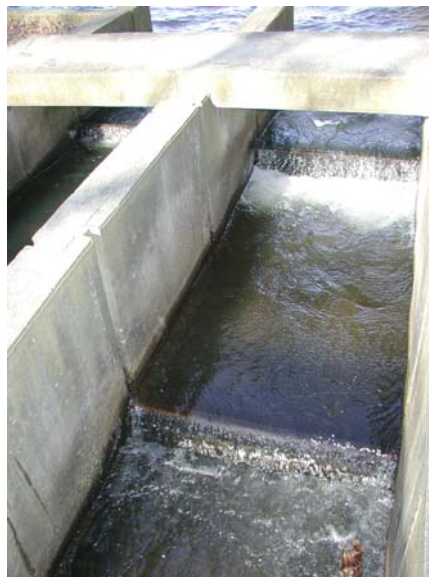
Hinckleys Pond Fishway

Design	Material	Length (ft)	Inside W (ft)	Outside W (ft)	# of Baffles	Baffle H (ft)	Notch W (ft)	Pool L (ft)	Condition/Function
Weir-pool	Concrete with wooden baffles	18.0	4.0	6.0	5	1.2	-	8.0	Excellent Passable

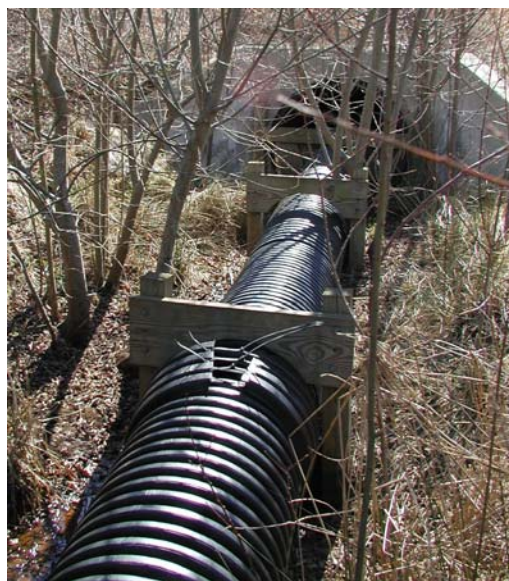
Notched Weir-pool at Lovers Lake Culvert

Design	Material	Length (ft)	Inside W (ft)	Outside W (ft)	# of Baffles	Baffle H (ft)	Notch W (ft)	Pool L (ft)	Condition/Function
Notched weir-pool	Corrugated plastic with wooden baffles	60.0	1.4	2.0	6	0.3	0.7	6.0	Good Passable

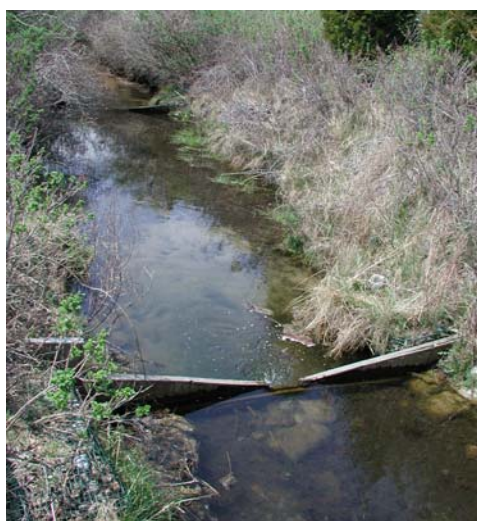
Herring Pond Stream Baffles

Design	Material	Length (ft)	Inside W (ft)	Outside W (ft)	# of Baffles	Baffle H (ft)	Notch W (ft)	Pool L (ft)	Condition/Function
Stream baffle	Wood	86.0	8.6	8.6	2	2.0	1.0	Varied (35.0 and 51.0)	Good Passable
Notched weir-pool	Concrete with wooden baffles	66.0	3.4	4.8	3	2.8	-	Varied (14.2-24.7)	Good Passable

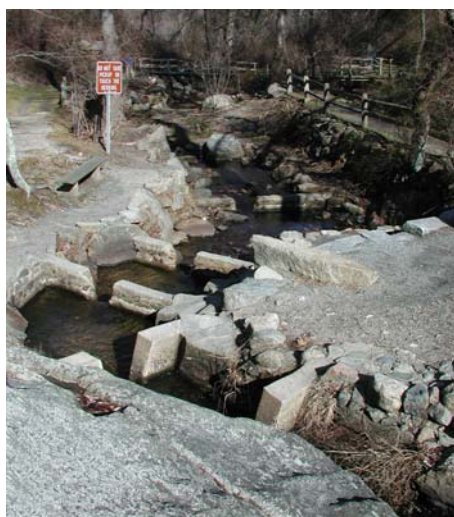
Lower Mill Pond Ladder (downstream side of Stony Brook Road)

Design	Material	Length (ft)	Inside W (ft)	Outside W (ft)	# of Baffles	Baffle H (ft)	Notch W (ft)	Pool L (ft)	Condition/Function
Notched weir-pool	Concrete and stone	490.0	Varied (3 - 4)	Varied (3 - 4)	27	Varied (0.4 - 1.2)	Varied (1)	Varied (8 - 25)	Good Passable

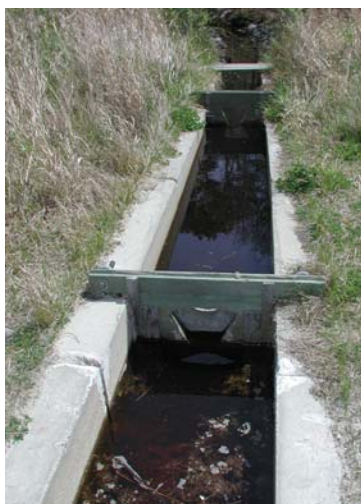
Scargo Lake Fishway

Design	Material	Length (ft)	Inside W (ft)	Outside W (ft)	# of Baffles	Baffle H (ft)	Notch W (ft)	Pool L (ft)	Condition/Function
Notched weir-pool	Concrete with wooden baffles	45.0	2.6	4.0	3	Varied (1.2-1.6)	0.3	Varied (7 – 15)	Poor Inefficient passage
