INSPECTION REPORT LEONARD'S WHARF NEW BEDFORD WATERFRONT FACILTIES INSPECTIONS

MARCH 2009

Figures Leonard's Wharf New Bedford, Massachusetts

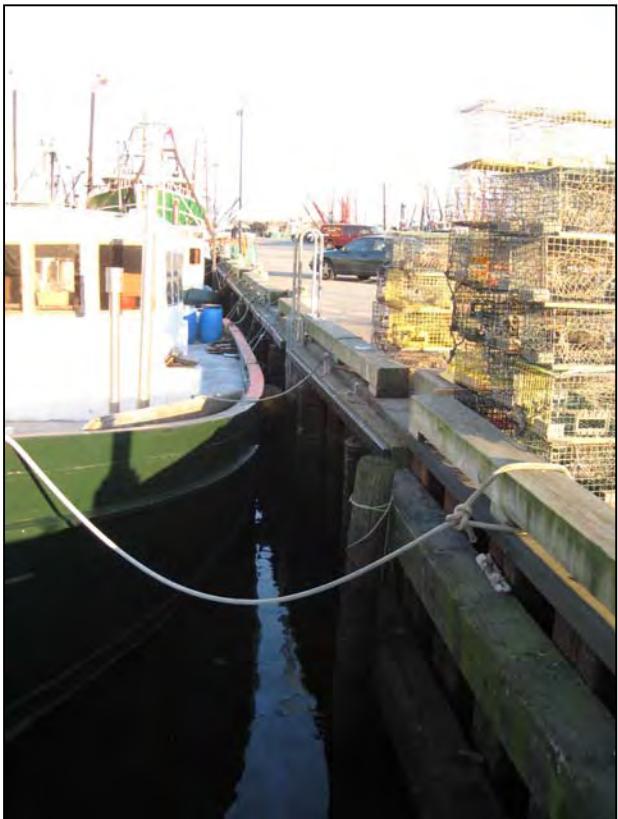
Photo No. 1: Overview of the Leonard's Wharf bulkhead with docked vessel from Station 0+00 looking east.

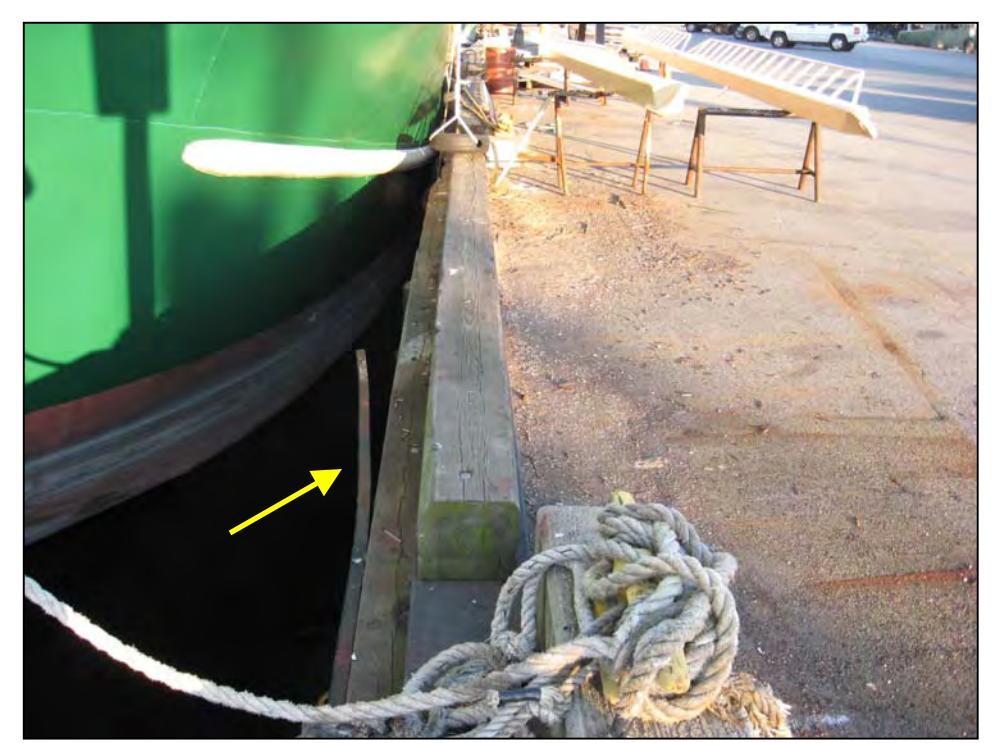
Photo No. 2: Overview of the timber curb. Note the loose UHMW rub rail along the timber wale.

Replace the UHMW rub rail on the face of the timber wale. Some of the existing UHMW is in good condition and may be reused. If the rub rail is not replaced and refastened, replacement of the timber wale will also become a high priority. The opinion of probable construction cost for this work is approximately \$27,000.

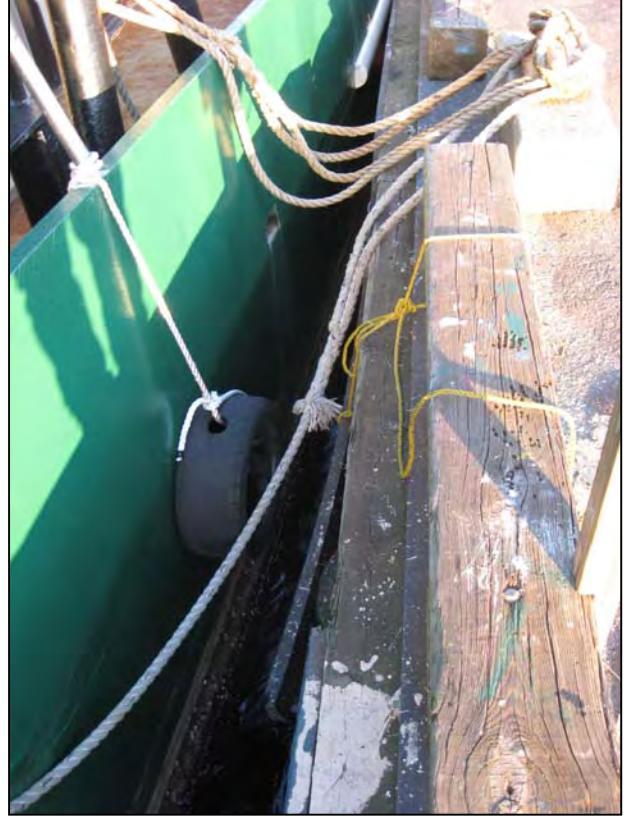
Photo No. 3: Loose UHMW held to fender system with nylon rope.

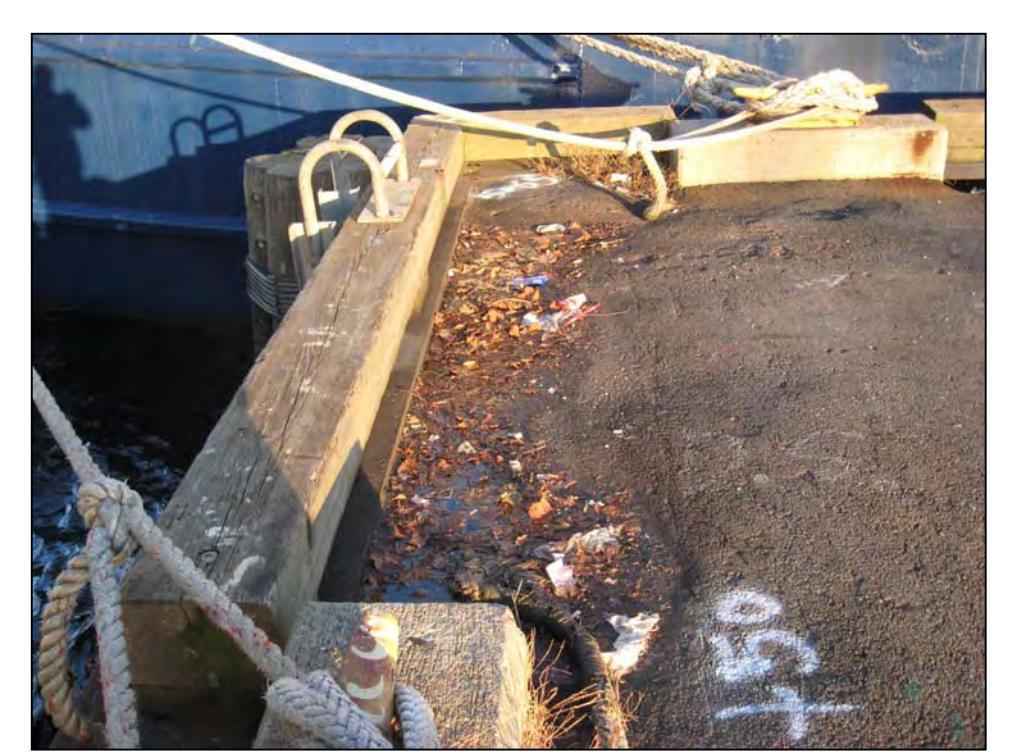
Several areas of local subsidence were observed behind the bulkhead. Smaller depressions with water ponding were observed behind the bulkhead from Station 5+50 to Station 5+62 as shown in Photo No. 4 in Appendix A: Photographs. Two depressions were observed to have grass and weeds growing within the exposed fill material. The depression at Station 5+70 measured 24

Photo No. 4: Subsidence with ponded water from Station 5+50 to Station 5+62.

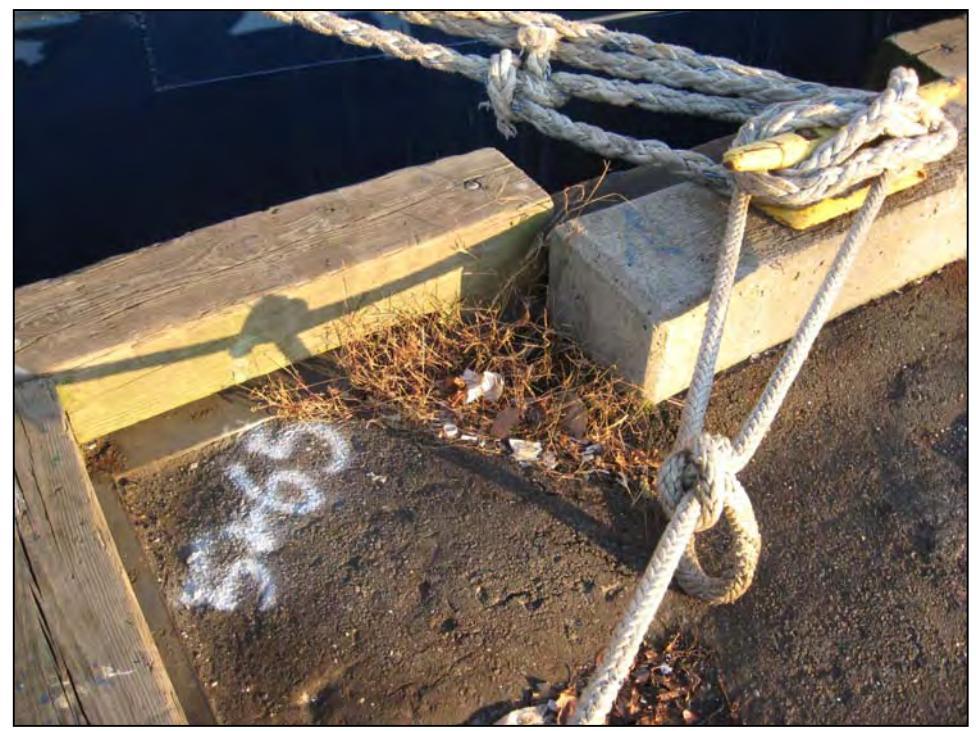
inch wide by 16 inches long by 4 inches deep, with the depression at Station 5+75 measuring 22 inches wide by 36 inches long by 15 inches deep.

Photo No. 5: Area of subsidence (4" deep) at Station 5+70.

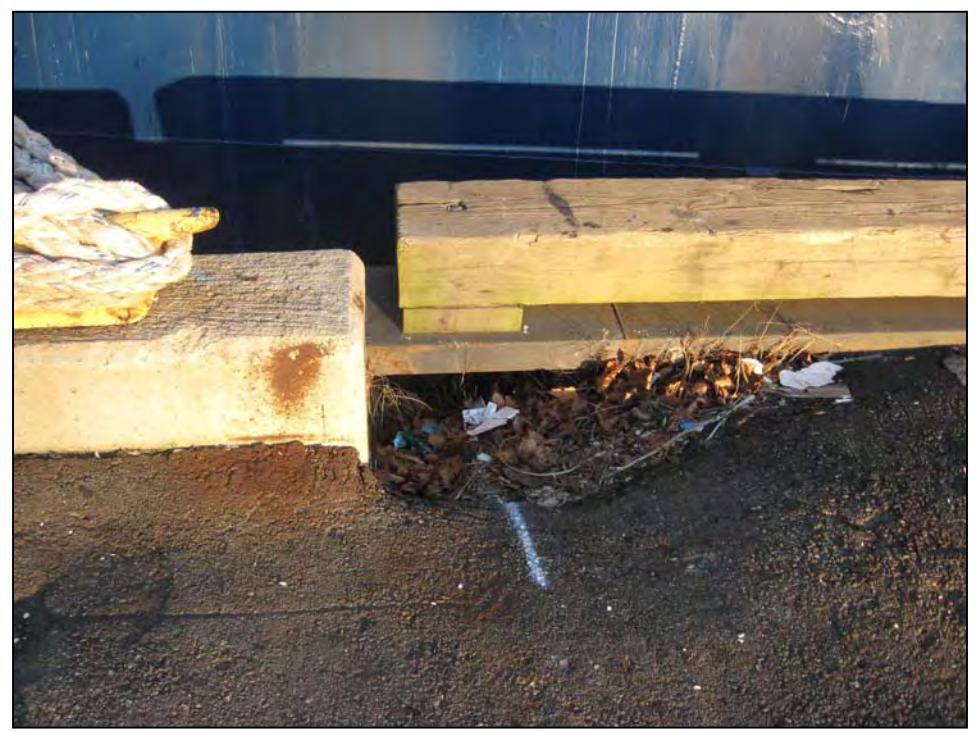
Photo No. 6: Area of subsidence (15" deep) at Station 5+75.

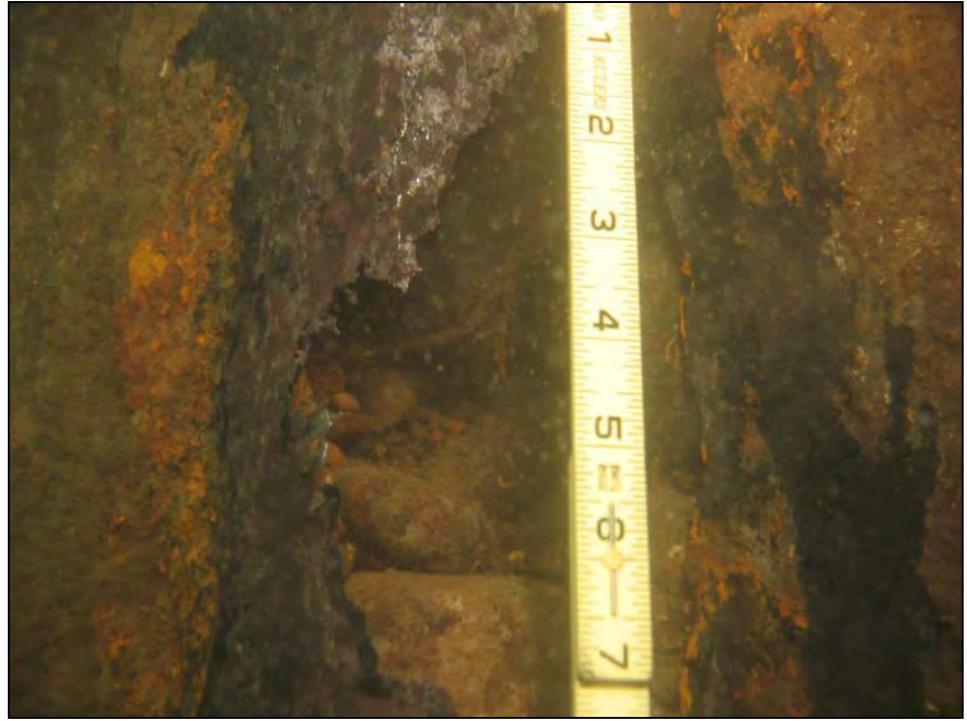
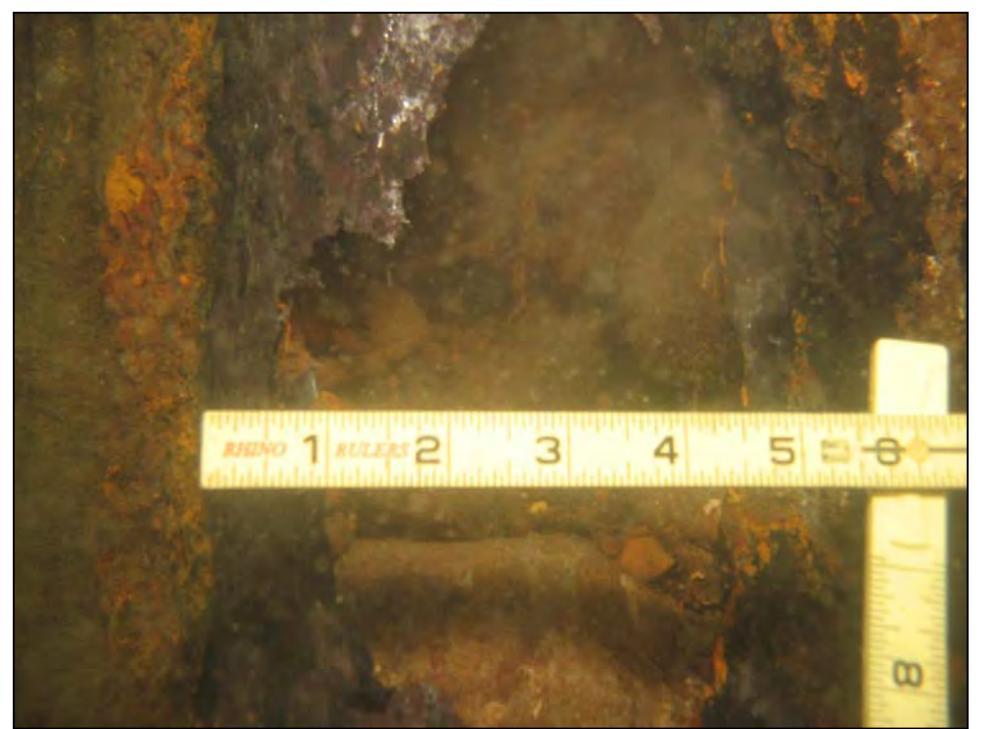
The first corrosion hole is located at station 5+70, approximately 2 feet below Mean Low Water. It is 13 inches long by 5 inches wide and runs through both the flange and web. Fill material could be seen inside and is actively being flushed out from behind the sheet. The second large corrosion hole was observed approximately 1 foot below Mean Low Water at Station 6+71. The

Photo No. 7: Corrosion hole in the steel sheetpile at Station 5+70. (Photo by Childs Engineering Corp).

Photo No. 8: Corrosion hole in the steel sheetpile at Station 5+70. (Photo by Childs Engineering Corp).

Repair the holes observed in the steel sheetpile bulkhead. Similar conditions at nearby structures have been repaired using a steel plate patch welded to the bulkhead face. The opinion of probable construction cost for this work is approximately \$20,000.

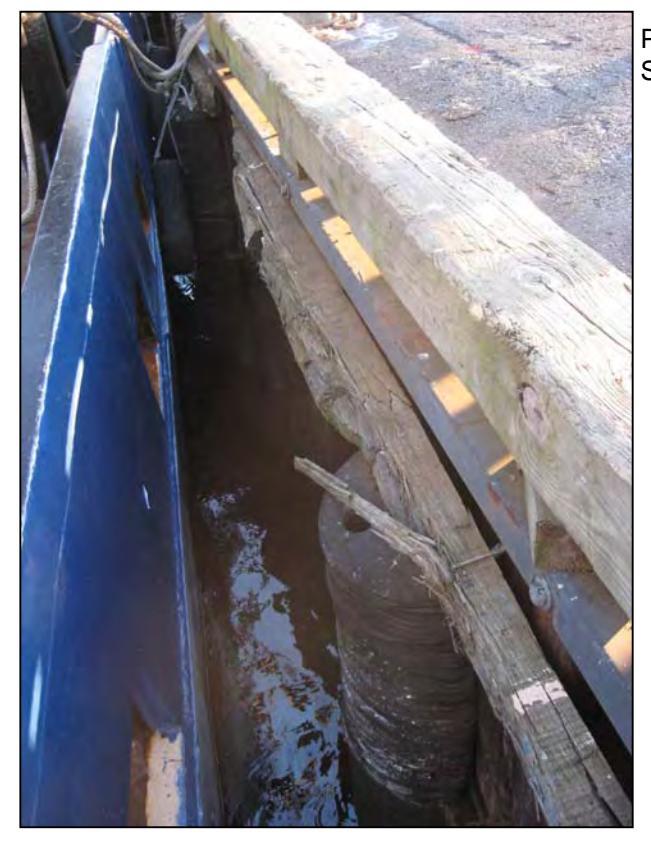
Photo No. 9: Damaged timber wale near Station 5+90.

Remove and replace damaged and worn timber wale. Currently the UHMW rub rail protects the wale, which will extend the life of the timber; however, if the current condition of the rub rail is not addressed, the timber wale may be damaged to the extent that it will be moved to the list of high priority repairs. The opinion of probable construction cost for this work is approximately \$46,500.

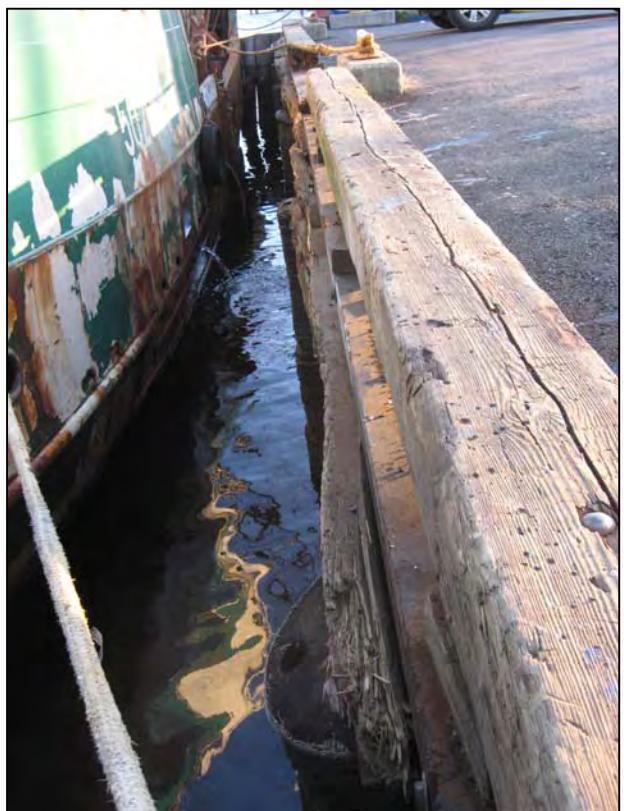
Photo No. 10: Damaged fender system from Station 6+00 to Station 6+60.

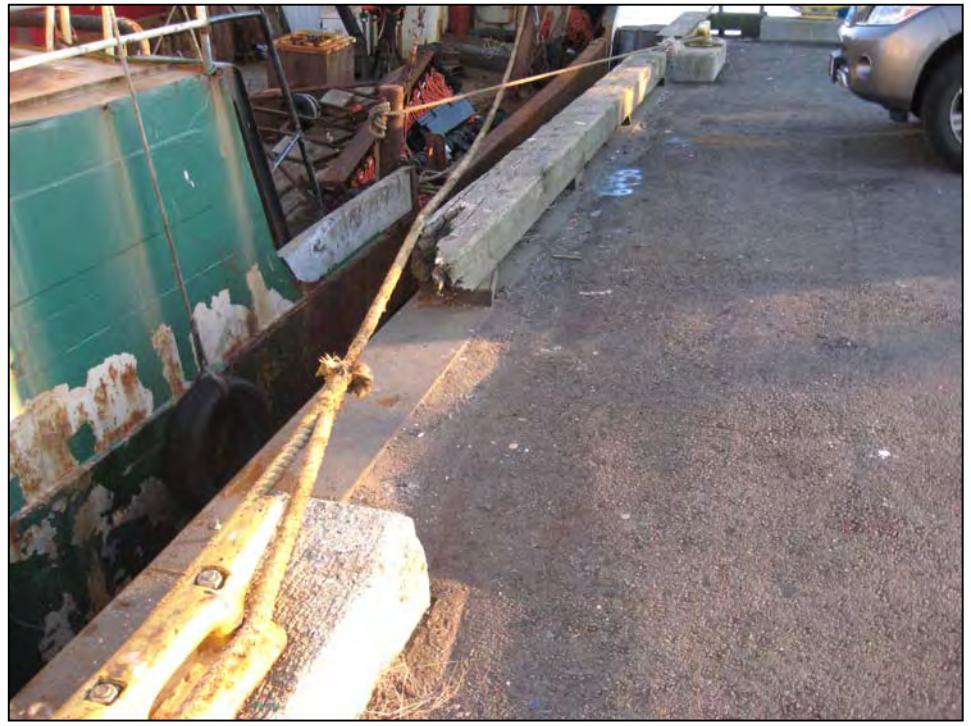
Photo No. 11: Broken and missing timber curb from Station 6+37 to Station 6+45.

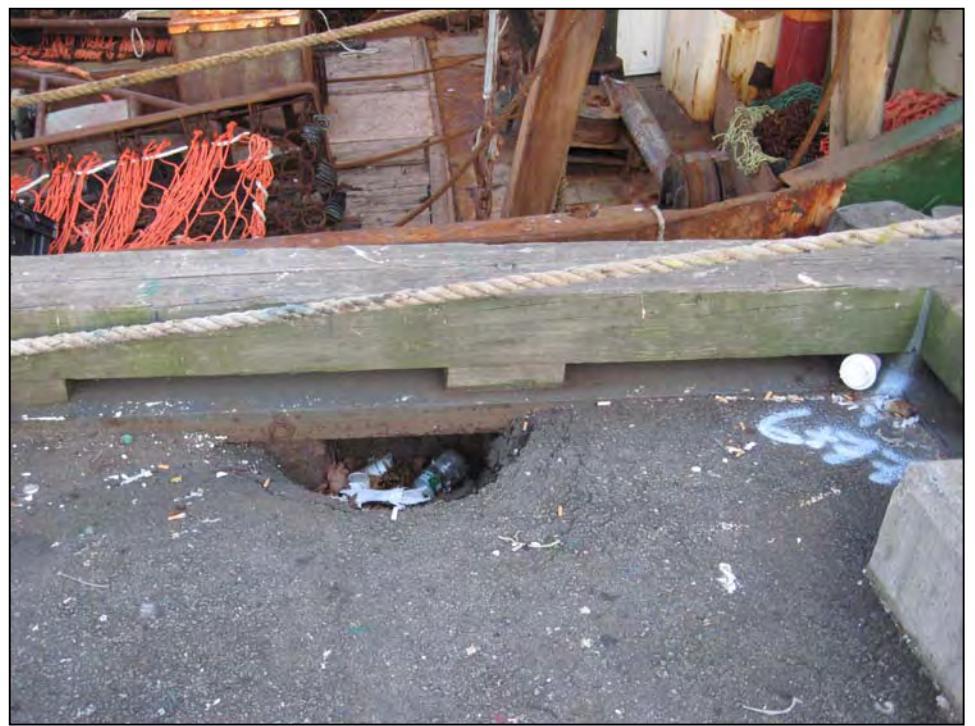
Large sinkholes were observed on both sides of the concrete block that supports the cleat at Station 5+72 as shown in Photos No. 5 and 6 in Appendix A: Photographs. A sinkhole observed at Station 6+70 was 12 inches wide by 30 inches long and was 16 inches deep as shown in Photo No. 12 in Appendix A: Photographs. These sinkholes correspond with corrosion holes in the sheetpile bulkhead that were observed during the underwater inspection.

Photo No. 12: Area of subsidence (16" deep) at Station 6+70.

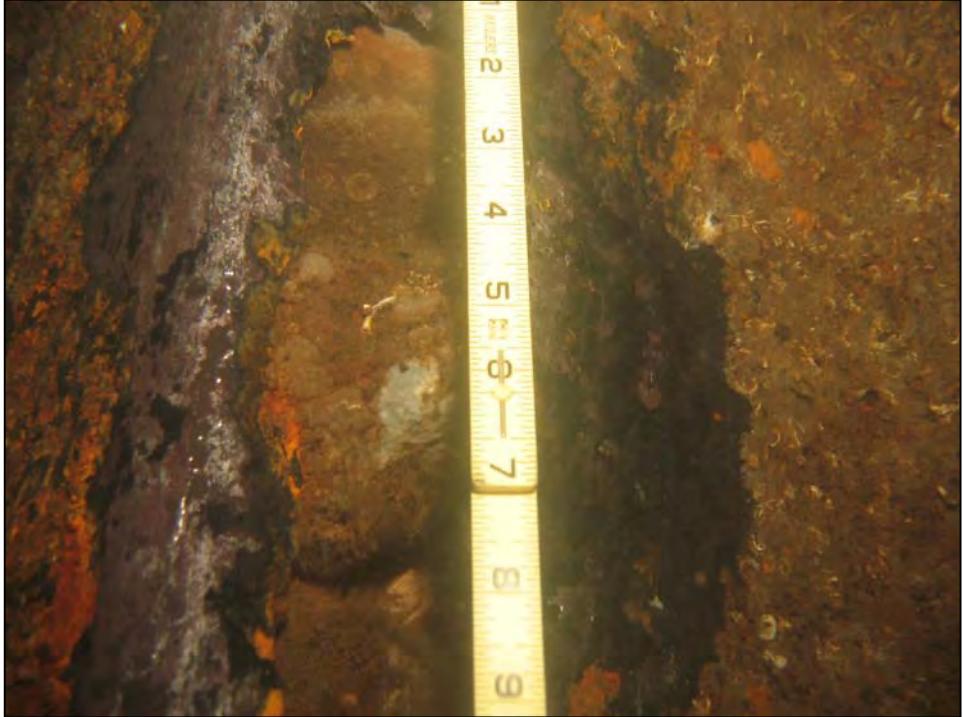
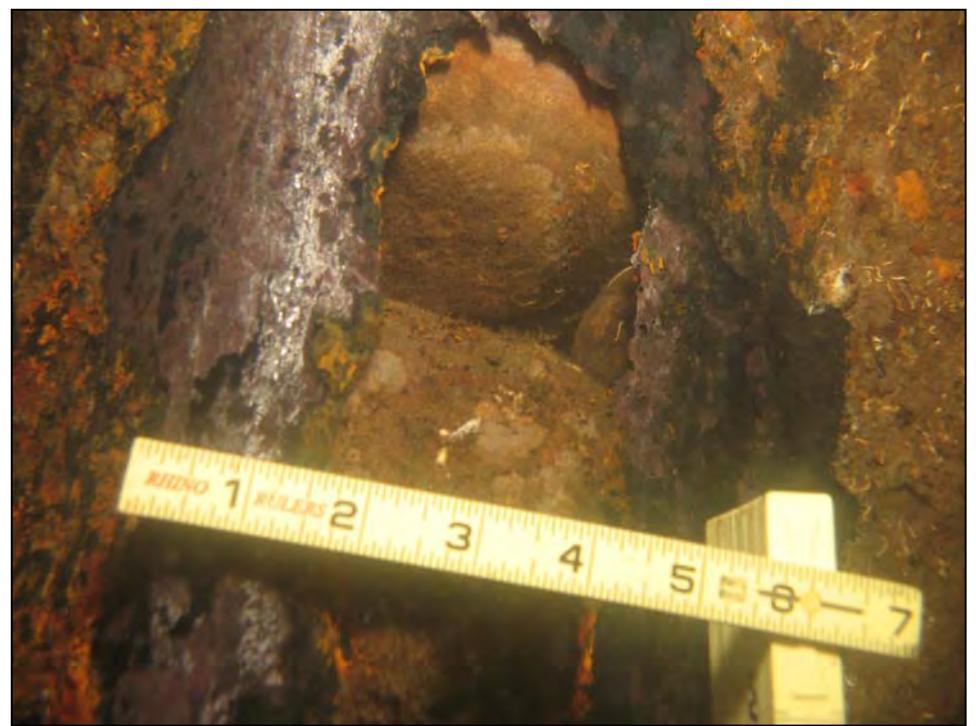
hole was located within the web of the steel sheetpile section and measured 1 foot long by 4 inches wide. Fill was observed escaping from this hole. It is understood that prior patching was performed at the head of the wharf in 1998.

Photo No. 13: Corrosion hole in the steel sheetpile at Station 6+71. (Photo by Childs Engineering Corp.)

Photo No. 14: Corrosion hole in the steel sheetpile at Station 6+71. (Photo by Childs Engineering Corp.)

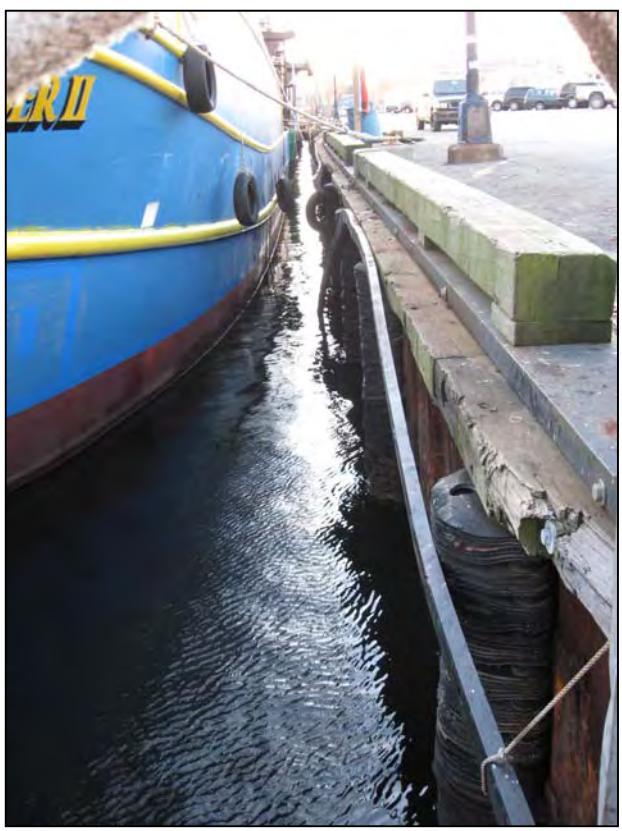
Photo No. 15: Loose UHMW from Station 6+80 to approximately Station 7+19.

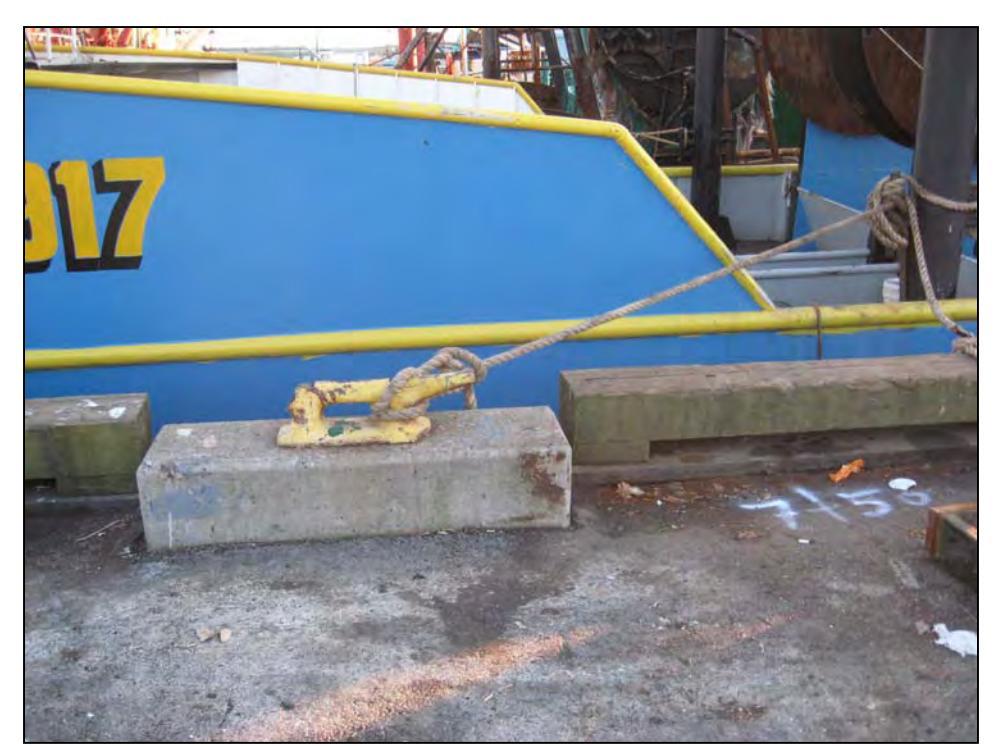
Photo No. 16: Broken cleat at Station 7+45.

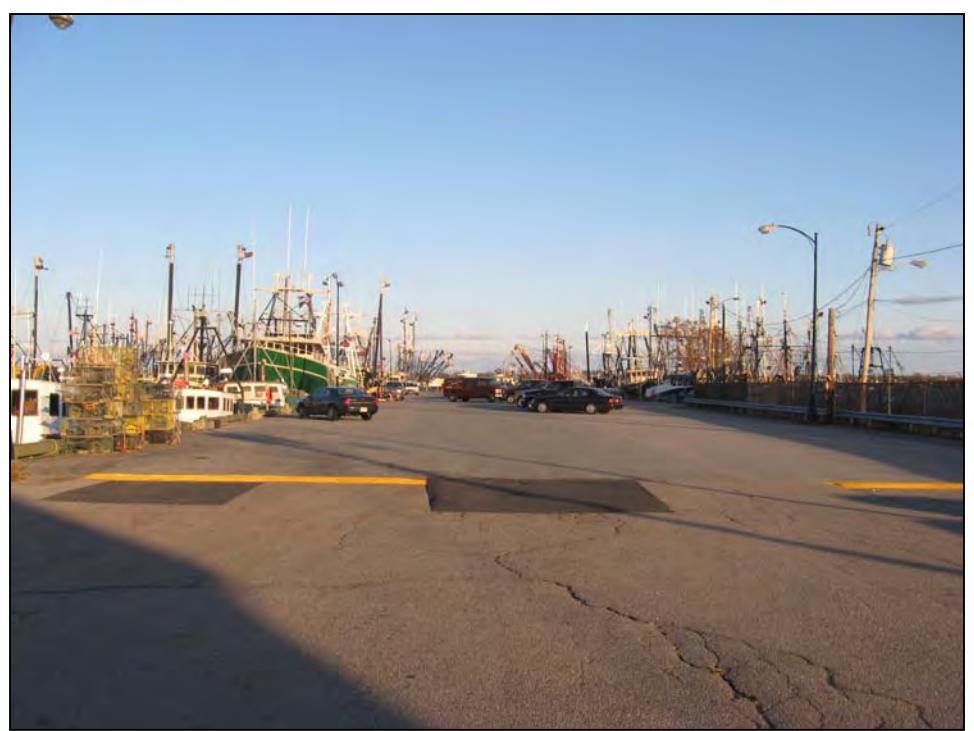
Photo No. 18: Overview of the bituminous deck.

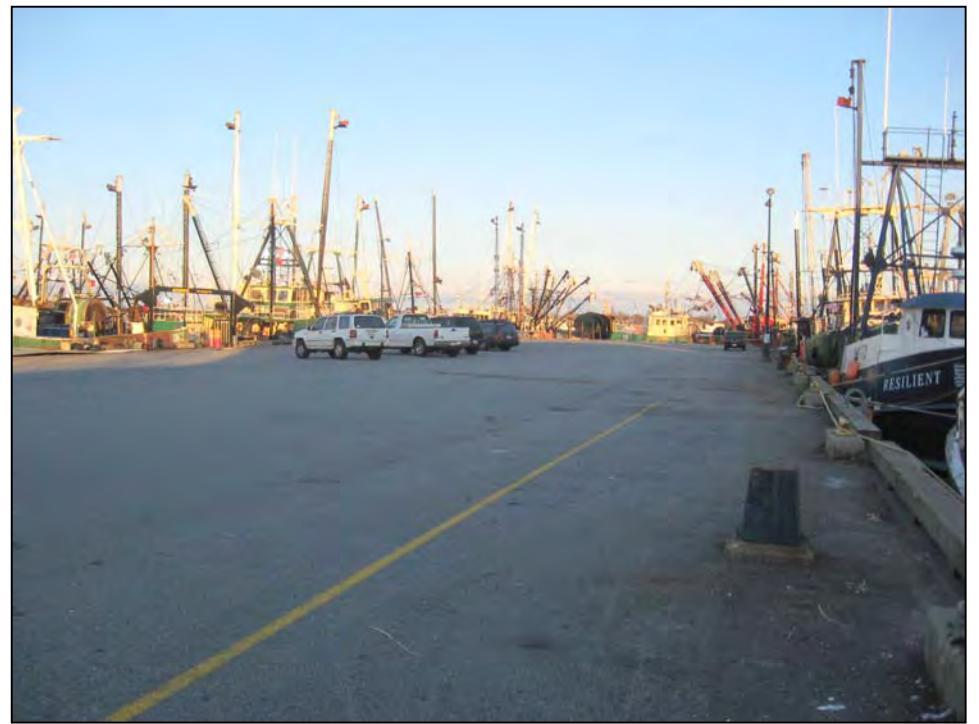
Photo No. 19: Overview of the pier from Station 10+63 looking East.

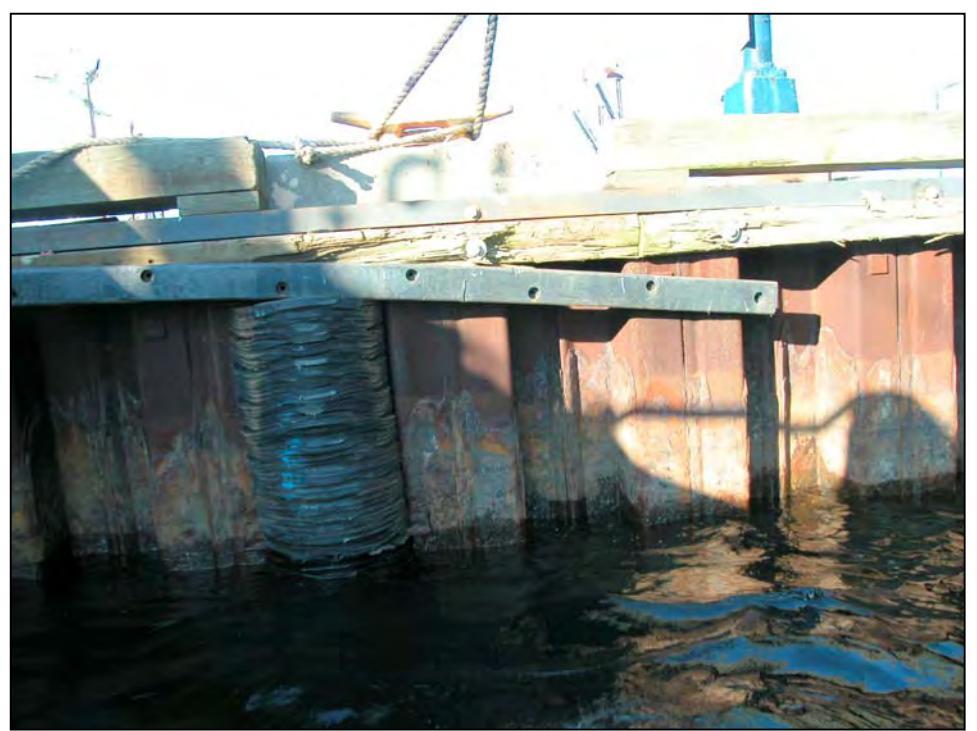
Photo No. 20: Typical view of the steel sheetpile bulkhead, rubber tire fender, loose UHMW rub rail, and damaged wale.

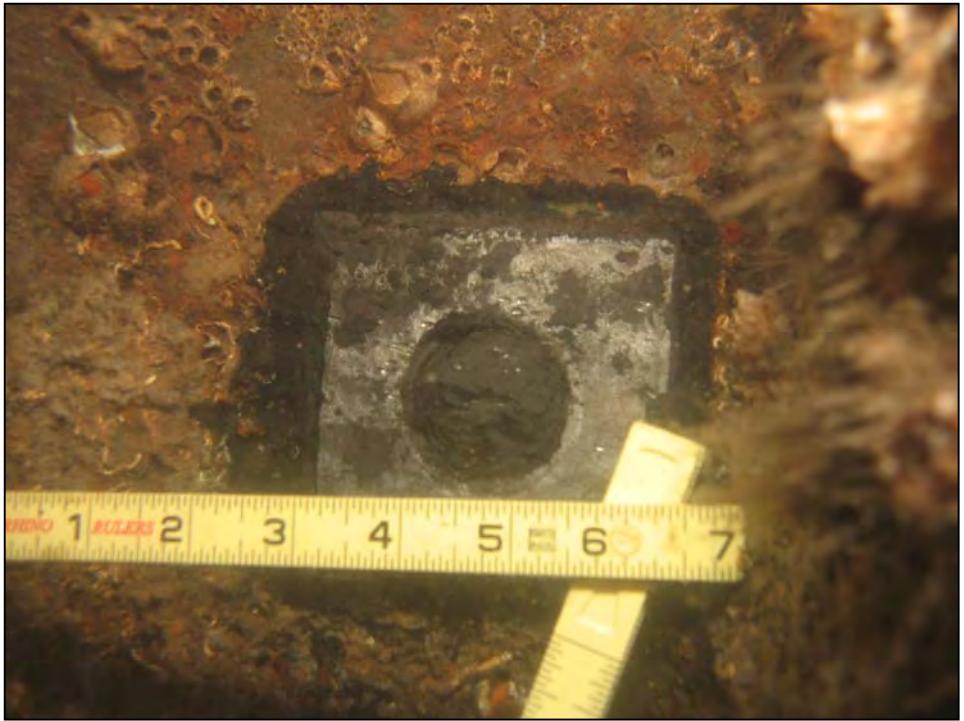
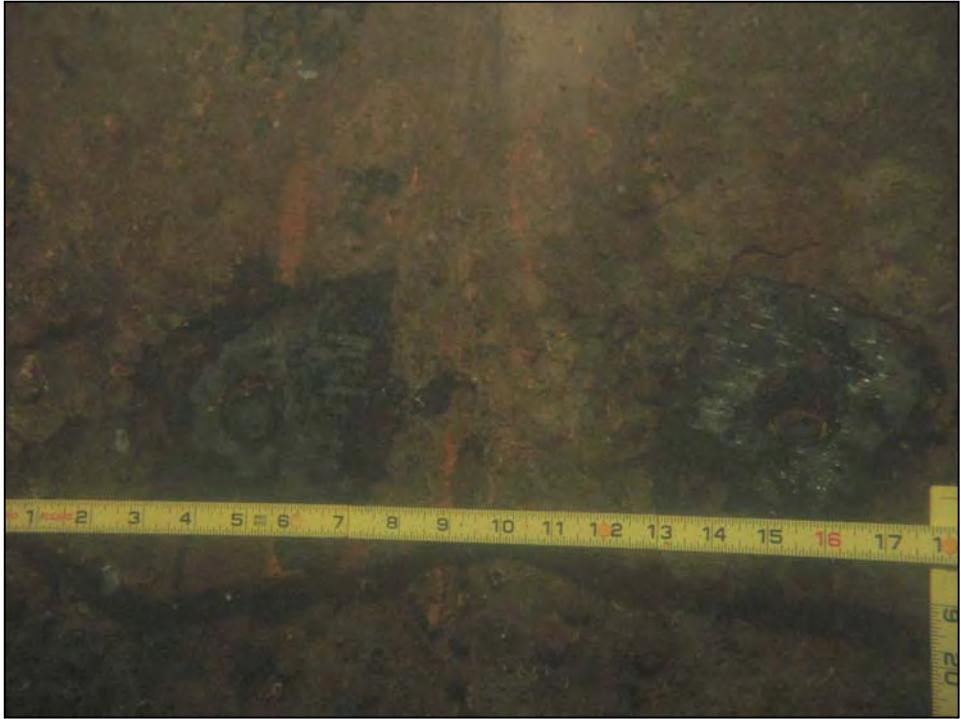
The steel sheet piling system at Leonard's Wharf is in poor condition. Major deficiencies observed include **severely corroded connection hardware** and **two large corrosion holes in the sheeting**. The bolts connecting the internal wale to the steel sheetpile between station 5+00 and 10+00 were observed to be severely corroded, with typically 70-100% section loss.

Photo No. 21: Typical underwater hardware. (Photo by Childs Engineering Corp.)

Photo No. 23: Typical underwater hardware. (Photo by Childs Engineering Corp.)

Replace the connection hardware to the lower wale. This will include excavation behind the bulkhead to expose the internal wale along the length of the bulkhead and the removal and replacement of all fastening bolts. The opinion of probable construction cost for this work is approximately \$204,000.

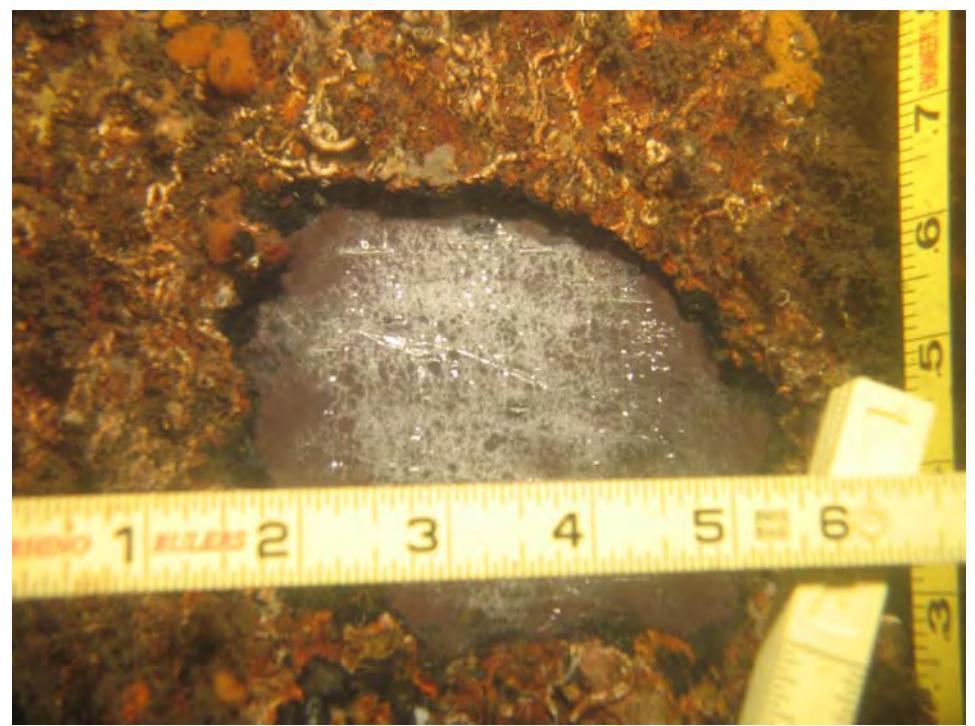
Photo No. 22: Typical underwater view of the steel sheetpile. (Photo by Childs Engineering Corp.)

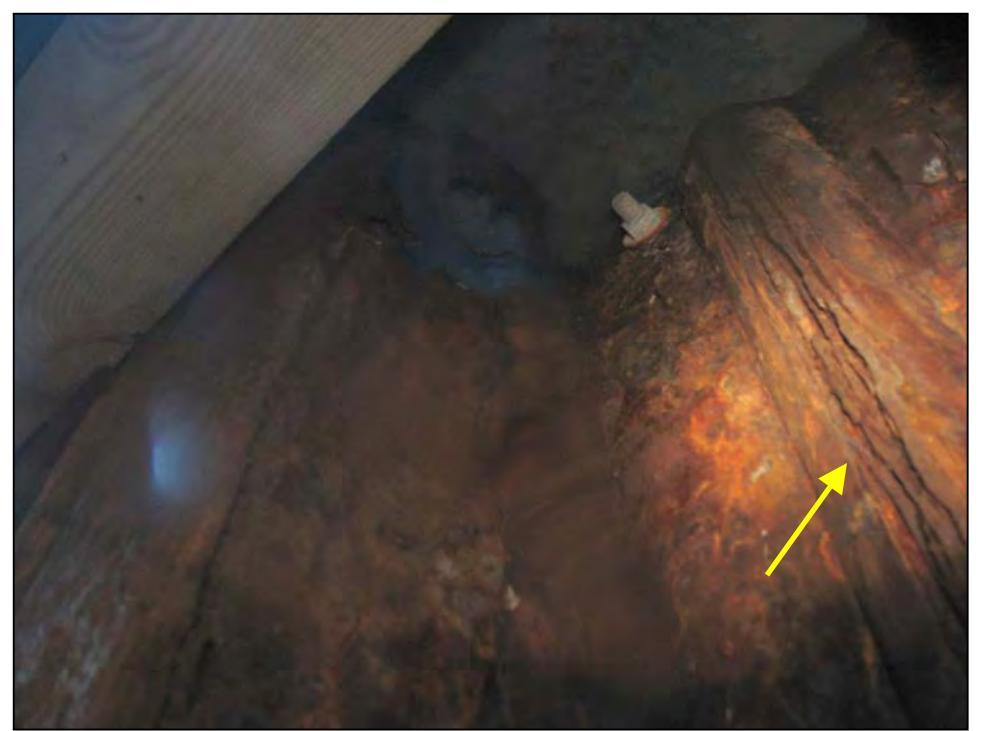
Typically, below the mean low water elevation the steel sheetpile bulkhead was observed to have a corrosion byproduct buildup of approximately 1/8 inch to 1/4 inch. The byproduct was apparently getting thicker closer to the mudline. Small pits were observed on the steel and are approximately 1/16 inch to 1/8 inch deep. It was also noted that the bottom 3 rungs of the safety ladders are all severely corroded and are either completely missing or are unusable.

Photo No. 24: Typical underwater view of the steel sheetpile. Note the corrosion of the steel. (Photo by Childs Engineering Corp.)

Install cathodic protection along the steel sheetpile. Sacrificial anodes minimize corrosion along the sheetpile by corroding at a higher rate than the metal sheetpile. The opinion of probable construction cost for this work is approximately \$183,000.
