Selected Inventory of Potential Wetland Restoration Sites in the Buzzards Bay Watershed

Phase II: Northern & Eastern Areas

March 2005

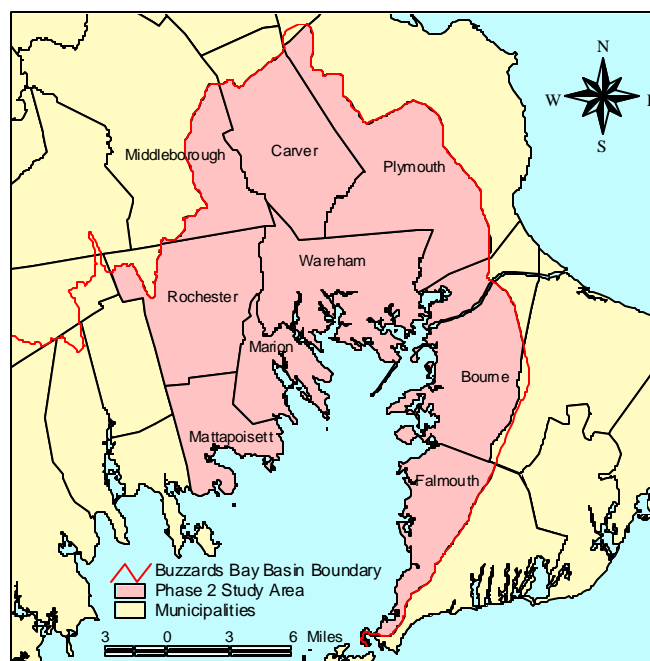
Figure 1. Selected Inventory Study Area

The area investigated for potential restoration sites included land in the Buzzards Bay watershed that is located within the following towns: Bourne, Carver, Falmouth, Marion, Mattapoisett, Middleborough, Plymouth, Rochester, and Wareham (Figure 1). The BBP's parcel GIS database was used to locate properties owned by the Commonwealth of Massachusetts, municipally owned land, privately owned abandoned cranberry bogs¹ and local land trust properties.

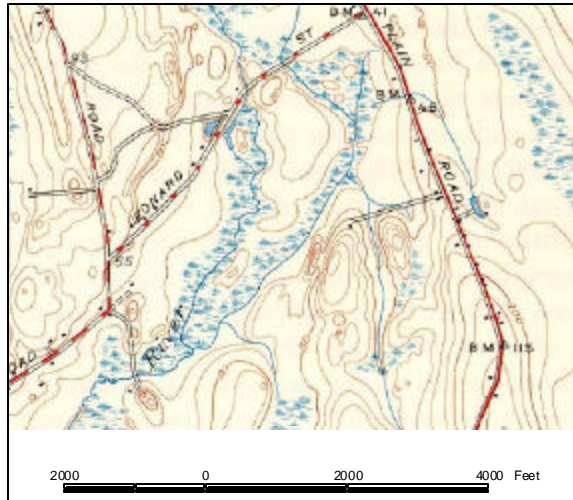
Figure 2: Portion of 1948 New Bedford North Quadrangle.

Historic USGS topographic maps dating from the late 1930s to the early 1940s were downloaded from <http://docs.unh.edu/nhtopos/MassachusettsList.htm>. These maps were georeferenced, and then where needed, a wetlands boundary was created from the georeferenced topographic maps. Wetland boundary changes were then evaluated by comparing the most recent USGS topographic wetlands (available from MassGIS) to the historical USGS topographic wetlands (Figures 2 & 3).

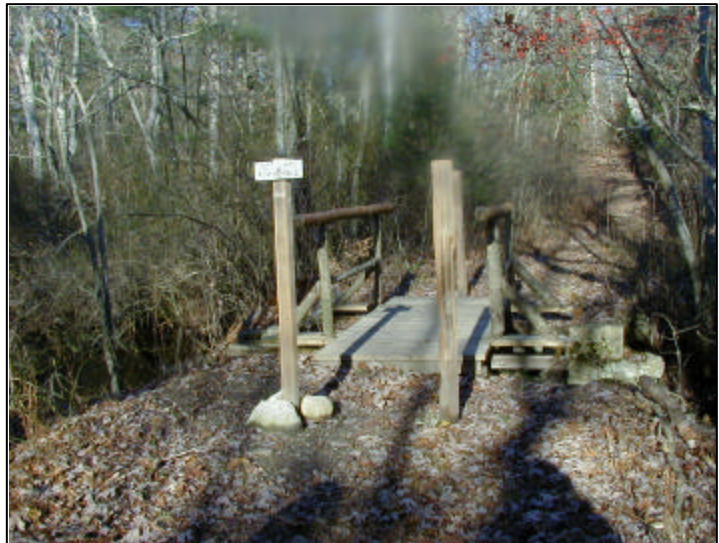
Figure 5: Footpath on Land Trust Property

Many sites on land trust and other passive recreation properties were existing footpaths. The BBP determined that these were not available for restoration, as the restoration activities would conflict with the existing use (Figure 5).

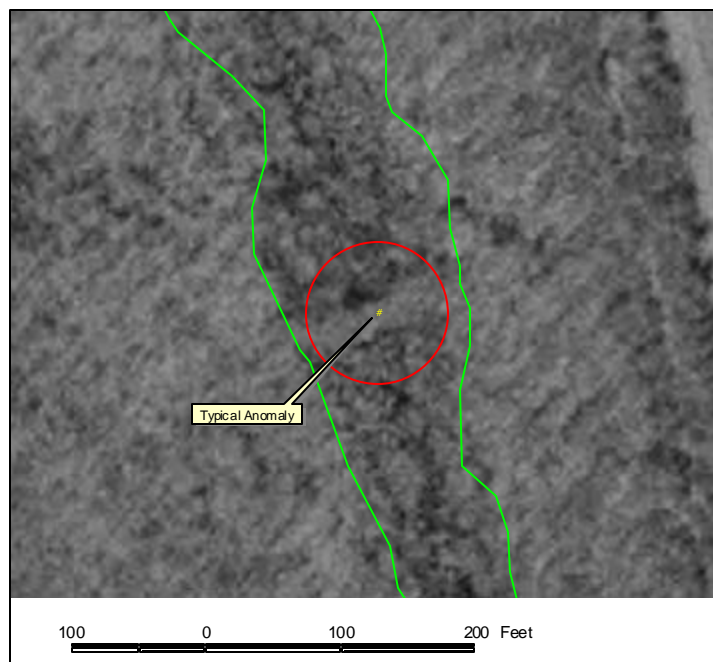
Figure 6: Anomalies in the Orthophotographs

Some anomalies that were viewed in the orthophotographs did not represent actual wetland alterations. The 0.5m resolution orthophotographs available from MassGIS are detailed enough to show a fallen tree as something different from the surrounding area. Site visits revealed that many anomalies found in the orthophotographs were not wetland alterations (Figure 6).

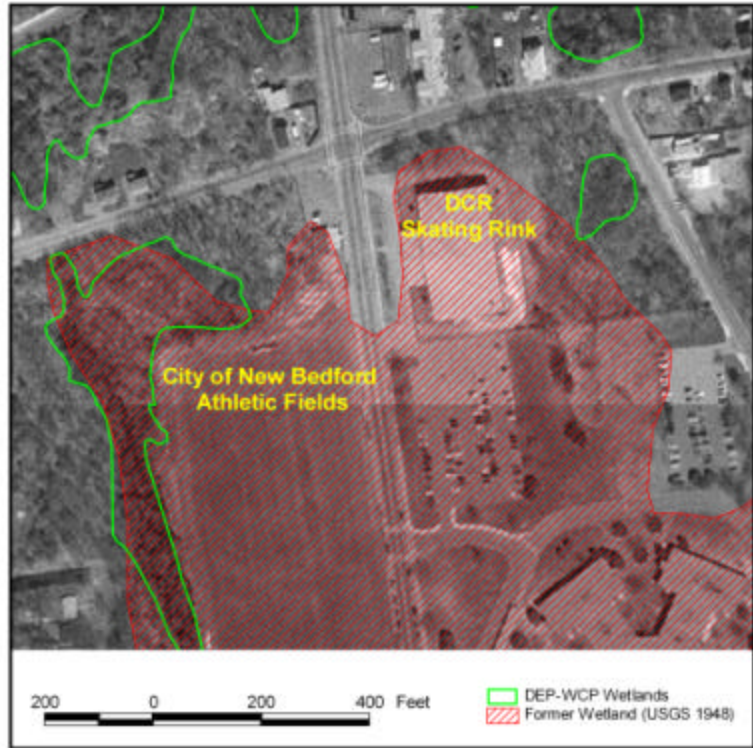
Figure 7: Public Facilities Located in a Former Wetland.

Several sites turned out to be existing public facilities. The BBP determined that many public facilities were not available for restoration, as the restoration activities would conflict with the existing use (Figure 7).

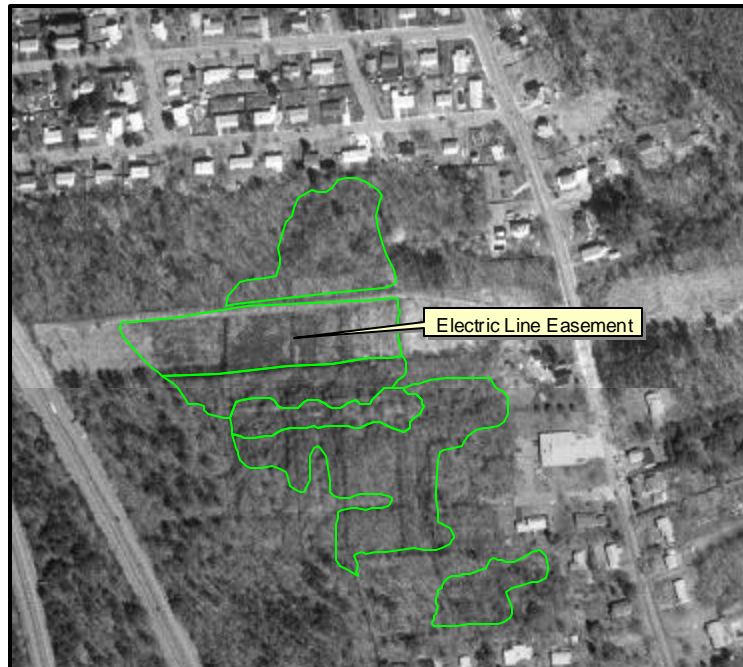
Figure 8. Electric Easement

In areas where there were gas, electric, water, and sewer utility lines, wetlands had been altered to satisfy the needs of the particular utility. The BBP determined that the utility line easements were not available for restoration, as the restoration activities would conflict with the existing use (Figure 8).

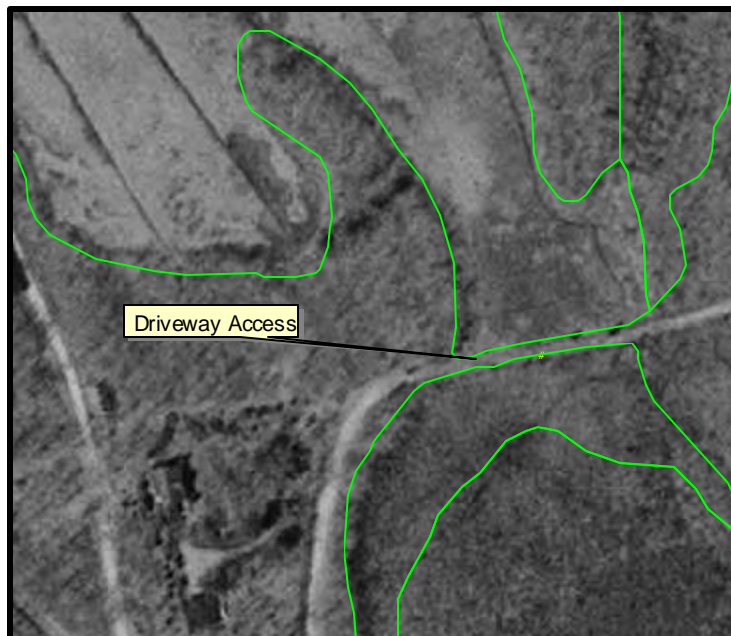
Figure 9: Access Road through Marsh.

Many of the fill sites visited turned out to be access roads. The BBP determined that the access roads were not available for restoration, as the restoration activities would conflict with the existing use (Figure 9).

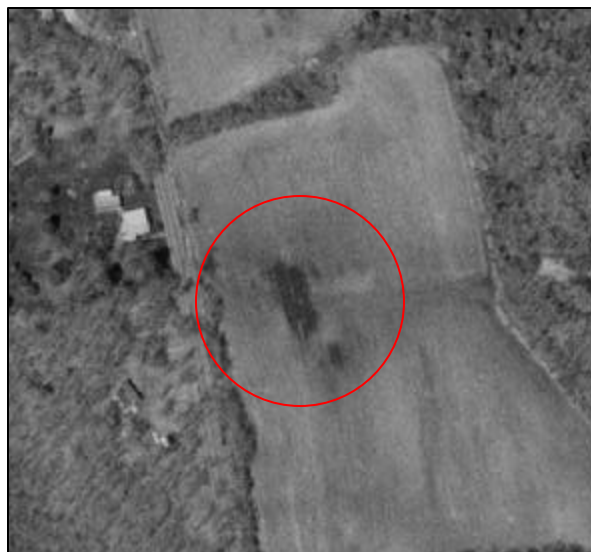
Figure 10: Wet spot that was actually a dry field.

Wet spots in fields may or may not be altered wetlands. Whether the wet spots shown below in figures 10 and 11 or on other orthophotographs were wetlands could only be determined through a site visit.
