On-Site Soils Investigation

Buttermilk Way Storm water Treatment Project – Buzzards Bay, MA

February 28th, 2012

Glenn Stanisewski, Resource Soil Scientist, USDA-NRCS, West Wareham, MA

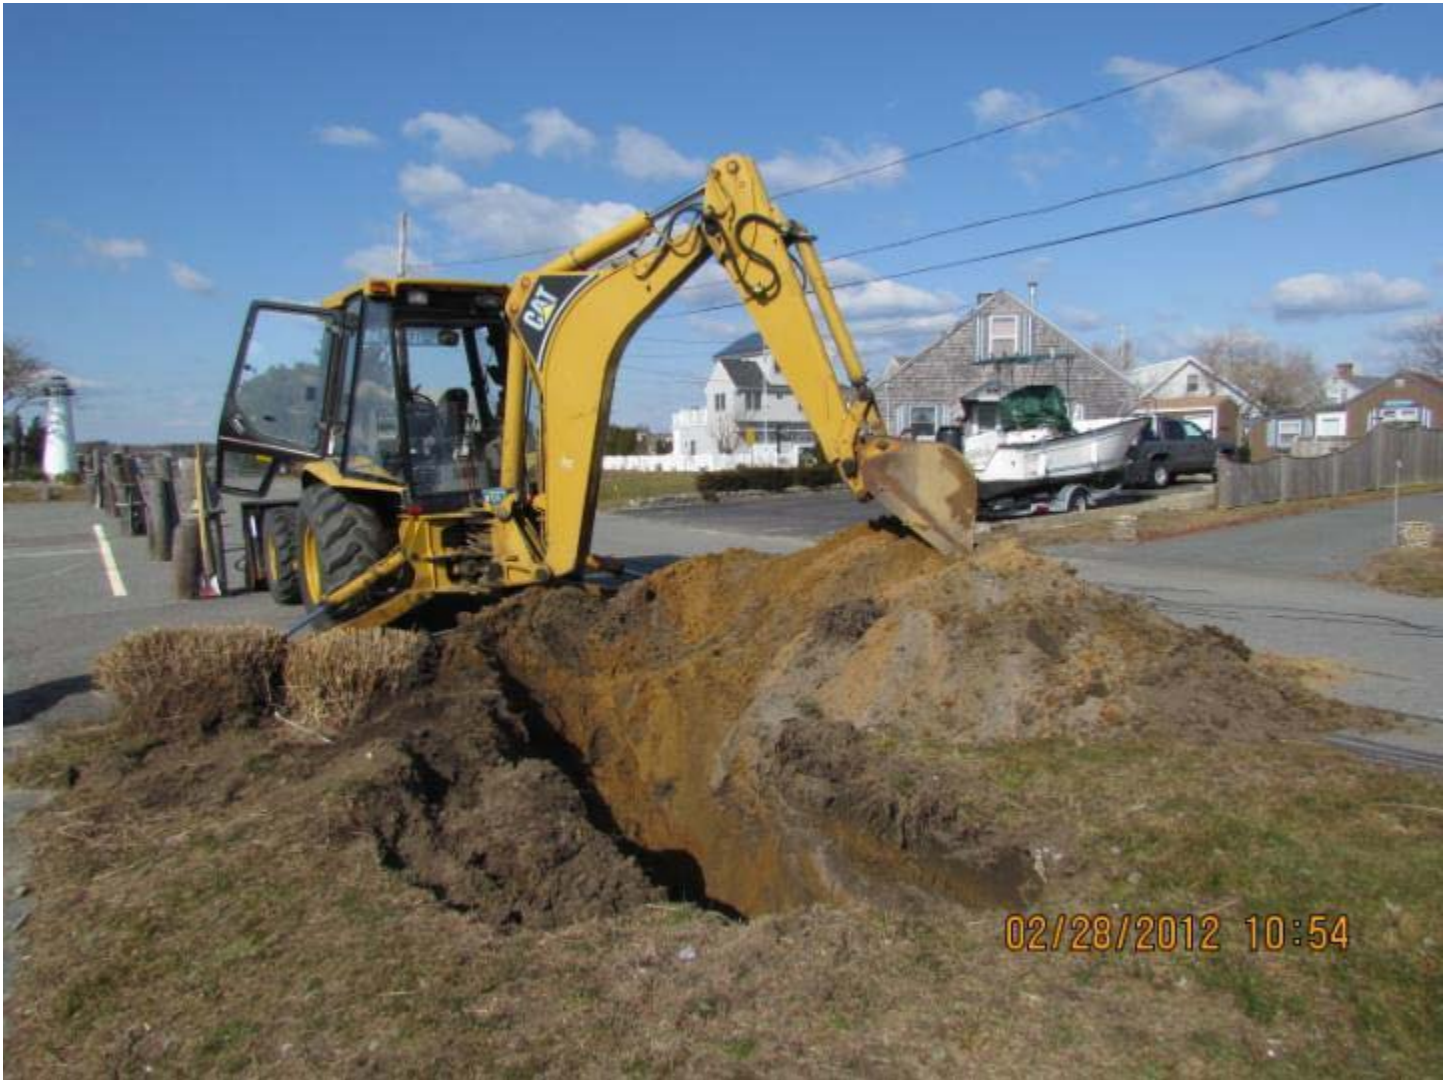
Figure 2: Soil pit #1 backhoe trench.

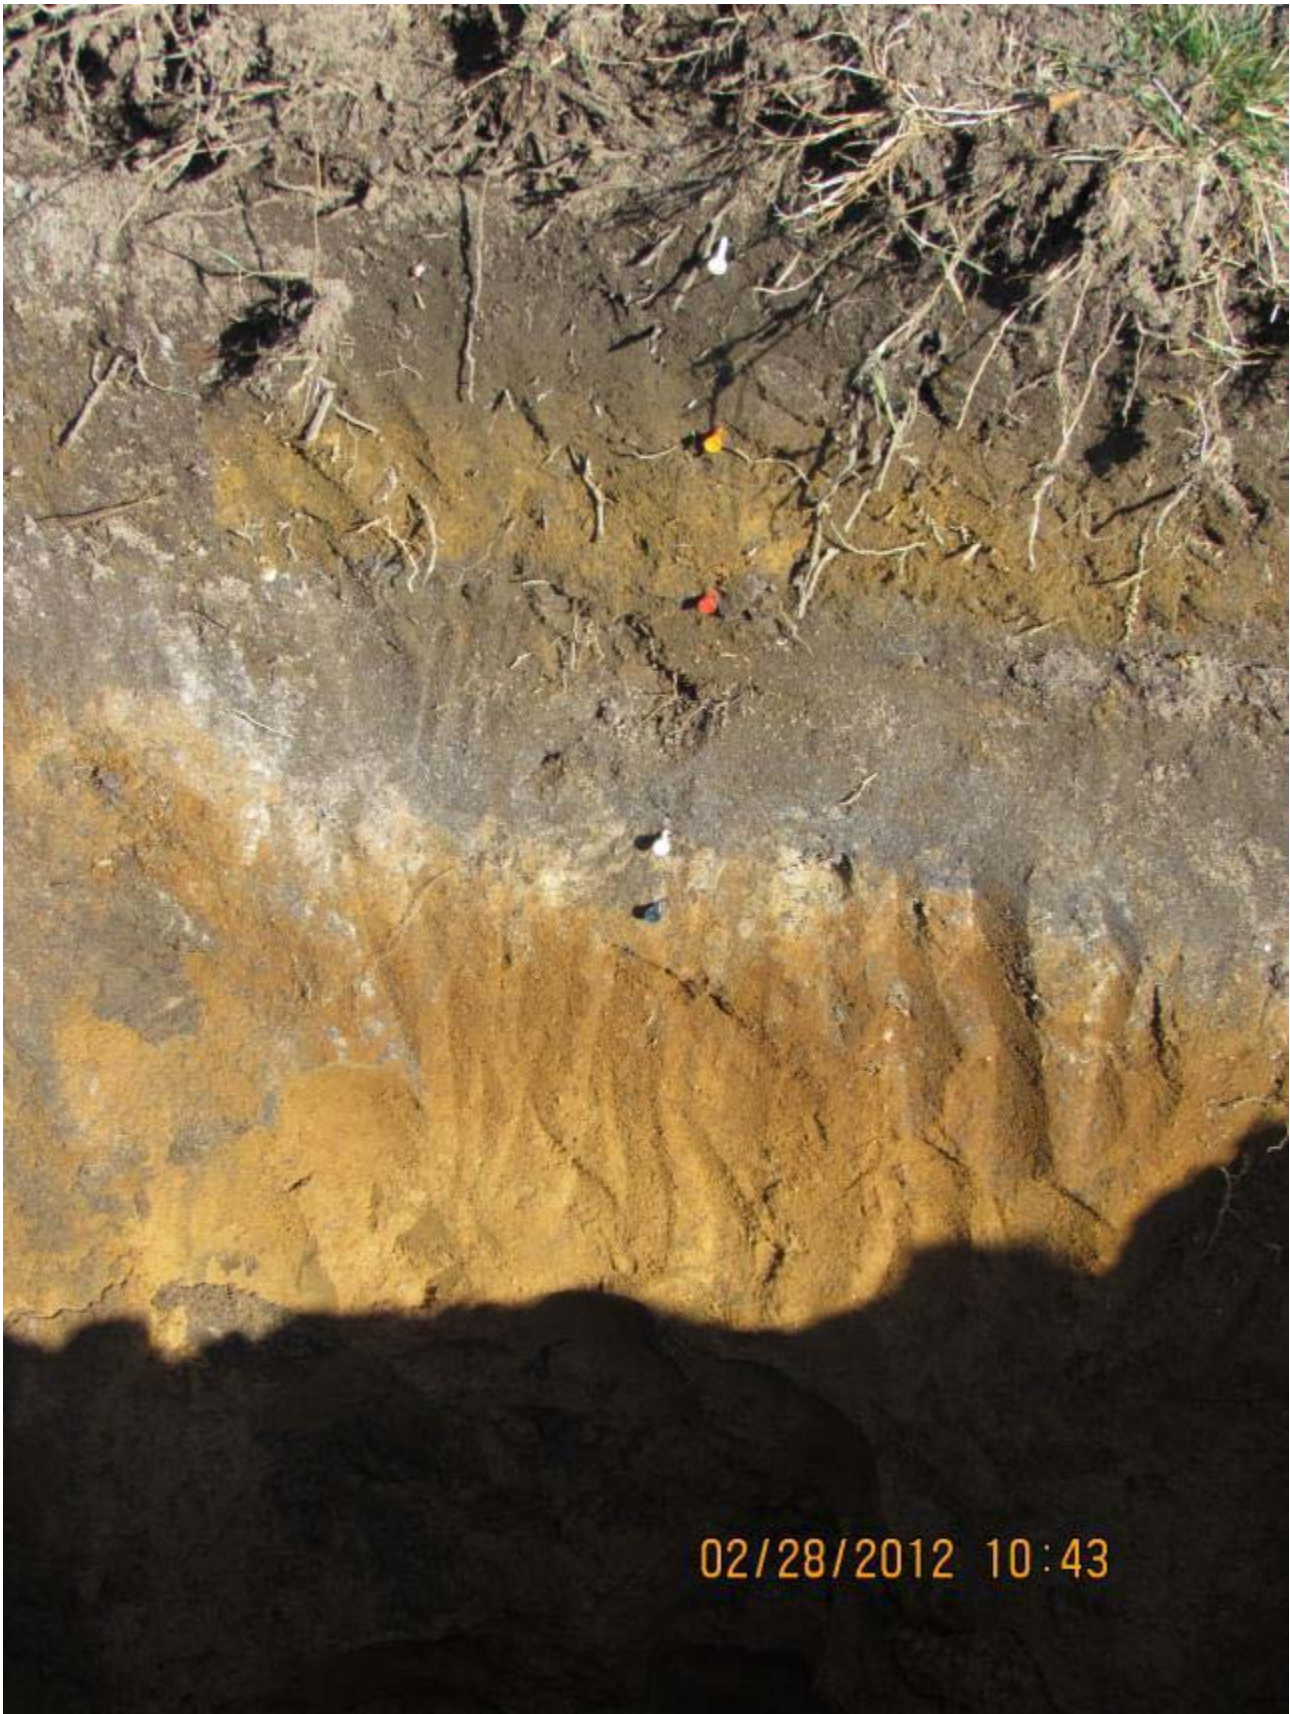
Additional Notes (% surface stones, rock outcrop, etc.): Standing water observed in the trench at 65 inches from the surface. There is approximately 1.5 ft. of sandy fill over a loamy coarse sand Carver soil type.

Figure 3: Soil pit #1 profile showing ^A1, ^A2, ^Bw, Ab, Eb, and Bwb horizons (top to bottom) separated by tees.

Discussion: The soil described at Site #1 had between 1.5 feet and 2.0 feet of sandy fill material over a natural sandy glacial outwash soil known as Carver. The fill material is associated with the construction of the Massachusetts Maritime Academy's Capt. Charles Hurley library and parking lot which included a lot of land leveling in addition to the fill material (mapped as 665 – Udipsamments, smoothed in the soil survey report).

There were no indications of a seasonal high water table in soil pit #1 to a depth of 65 inches. Saturation was observed in the trench at a depth of 65 inches. Like the Carver soil, this soil is Excessively well drained with a Soil Hydrologic Group A designation.

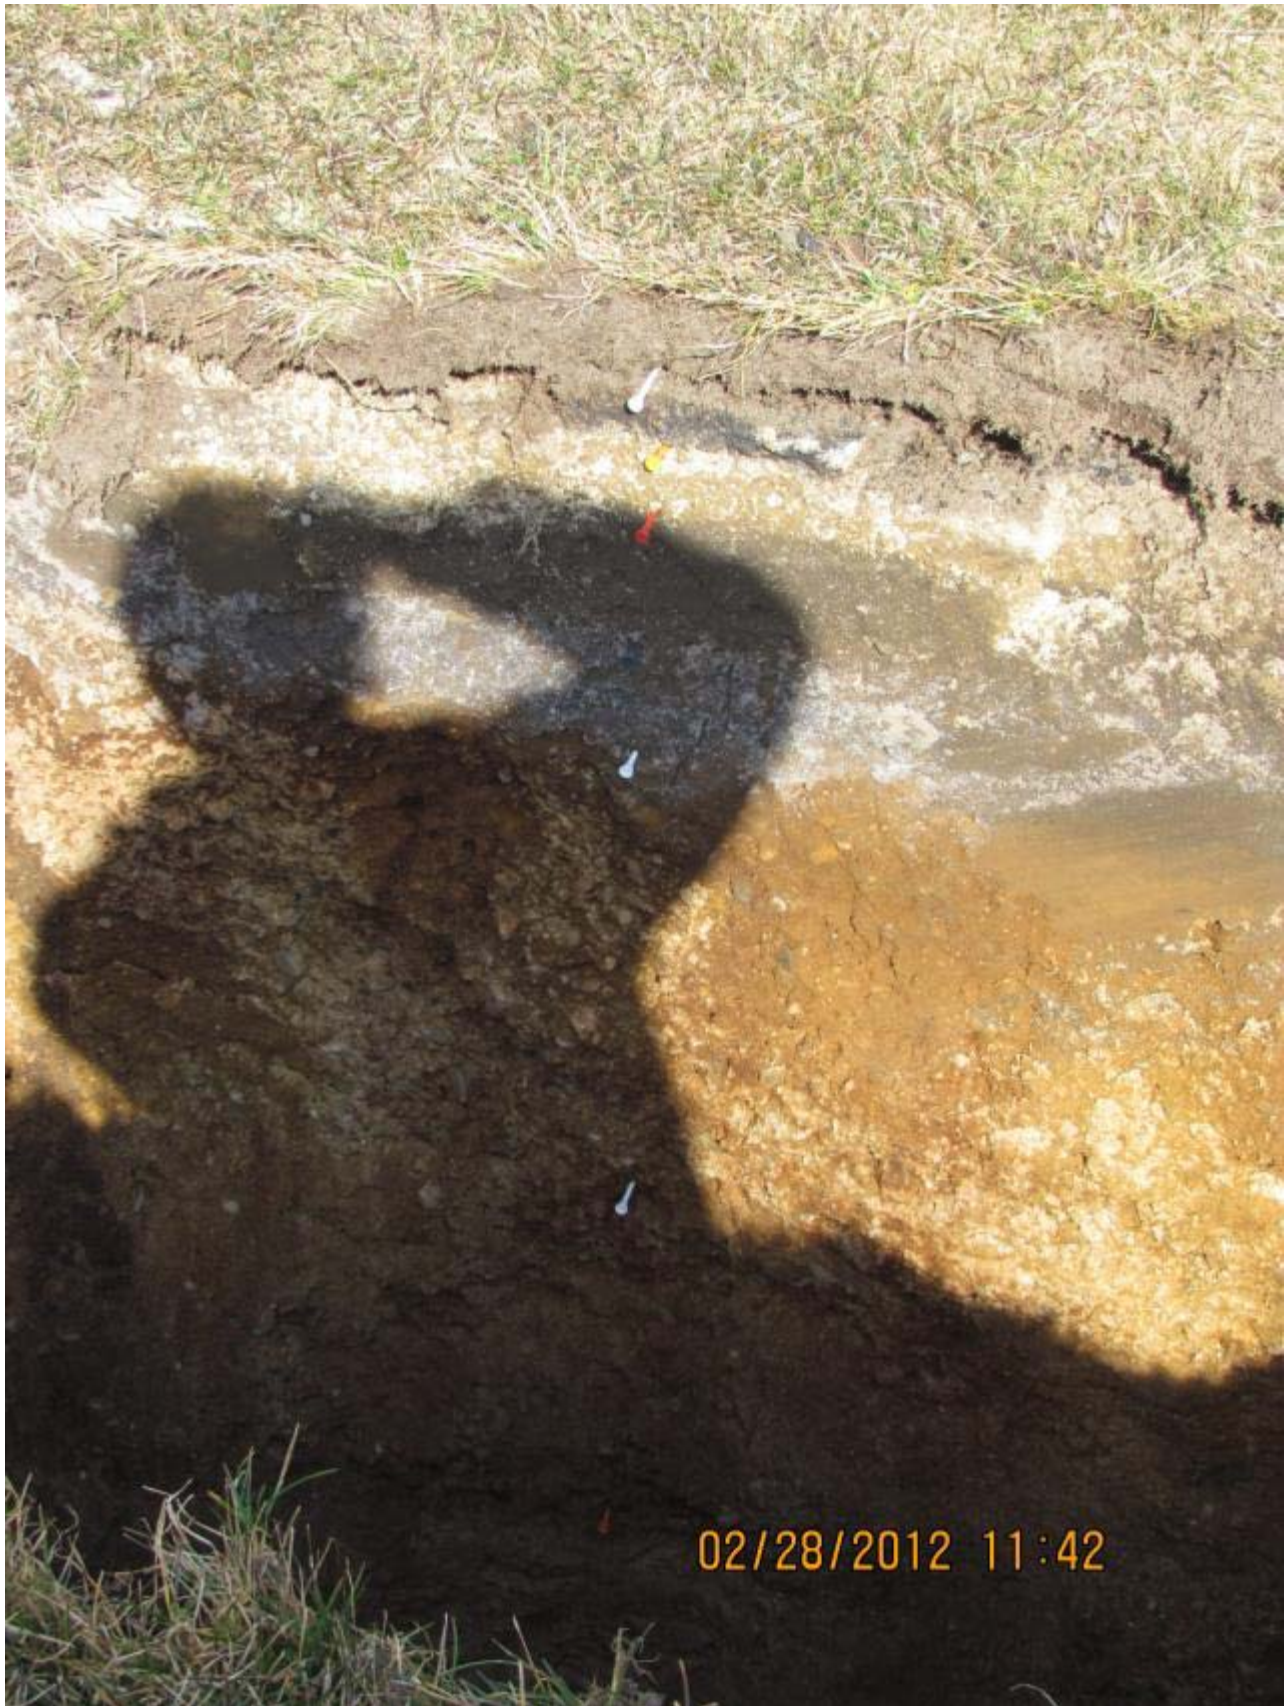
Additional Notes (% surface stones, rock outcrop, etc.): Saturation observed in trench at 89 inches from surface. Bhs horizon had many, prominent, fine, medium, and coarse 5YR 3/4 masses of iron accumulation.

Figure 6: Soil pit#2 profile showing $\wedge A$, $\wedge M$, $\wedge C$, A, AE, Bhs, C1 and C2 horizons (top to bottom) separated by tees.

There were no indications of a seasonal high water table in soil pit #2 to a depth of 65 inches. Saturation was observed in the trench at a depth of 89 inches. The natural soil profile had a subsurface Bhs horizon (at 16 -36 inches) that showed masses of iron accumulation consistent with spodic soil development. The natural soil profile fit the description of the Hinckley soil series that was identified on the soil survey map (mapunit 245A). Hinckley is an Excessively well drained sandy and gravelly glacial outwash soil with a Soil Hydrologic Group A designation.

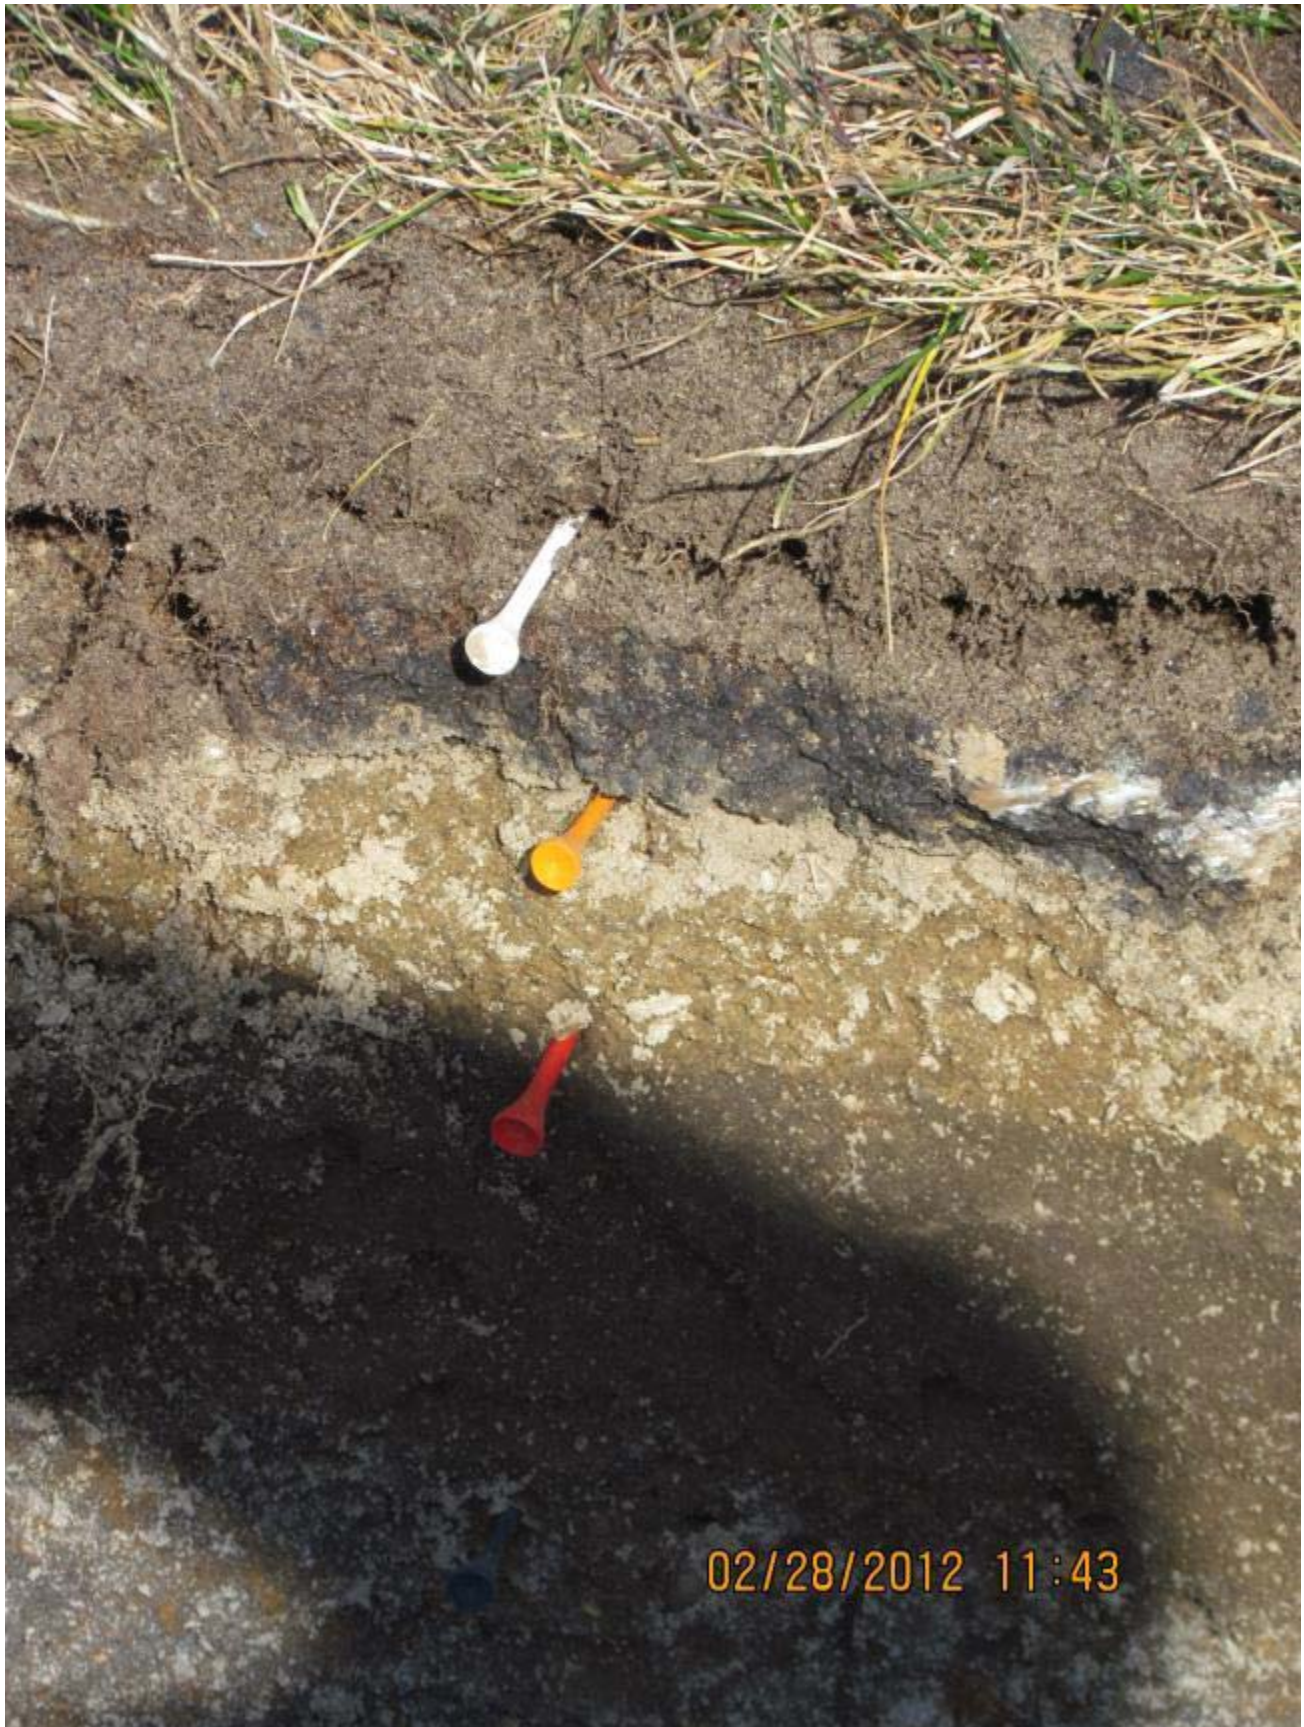
Figure 7: Close up of Soil Pit site #2 showing fill material (^A, ^M, ^C horizons) separated by tees.

The soil described at Site #2 was on the town's Right of Way (Beach Way) which is a public access point to the bay and a small beach area. The soil profile had a very thin layer of fill material (seven inches thick) that is associated with the construction of a paved walk way leading down to the beach. In recent years adjoining private landowners had installed sod over the asphalt covering it up (Figure 7).
