**BOUCHARD B120 RELEASE  
SHORELINE SEGMENT SUMMARY**

GeoInsight Project Number 3871-002

SEGMENT IDENTIFICATION: **W1C-10**

SEGMENT NAME: **Silver Shell Beach**

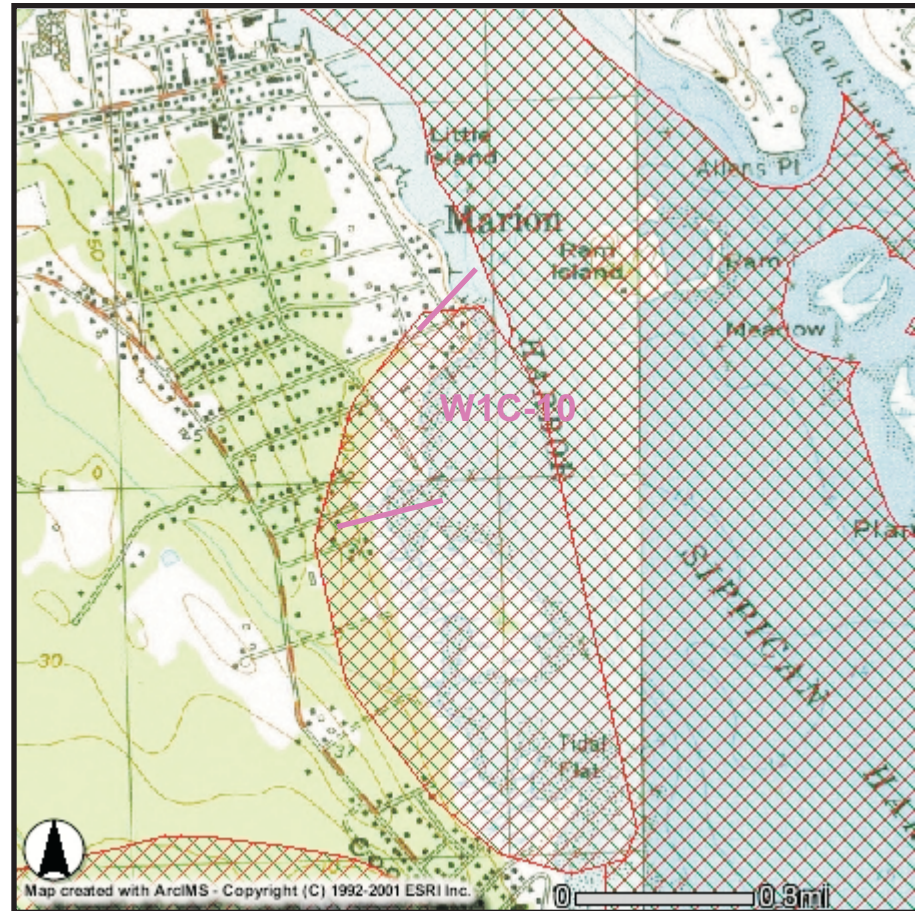
NATURAL HERITAGE AND ENDANGERED SPECIES MAP

Priority Habitats of Rare Species: At segment and adjacent to segment: Buzzards Bay aquatic environment.

Estimated Habitats of Rare Wildlife: At segment and adjacent to segment: Buzzards Bay aquatic environment.

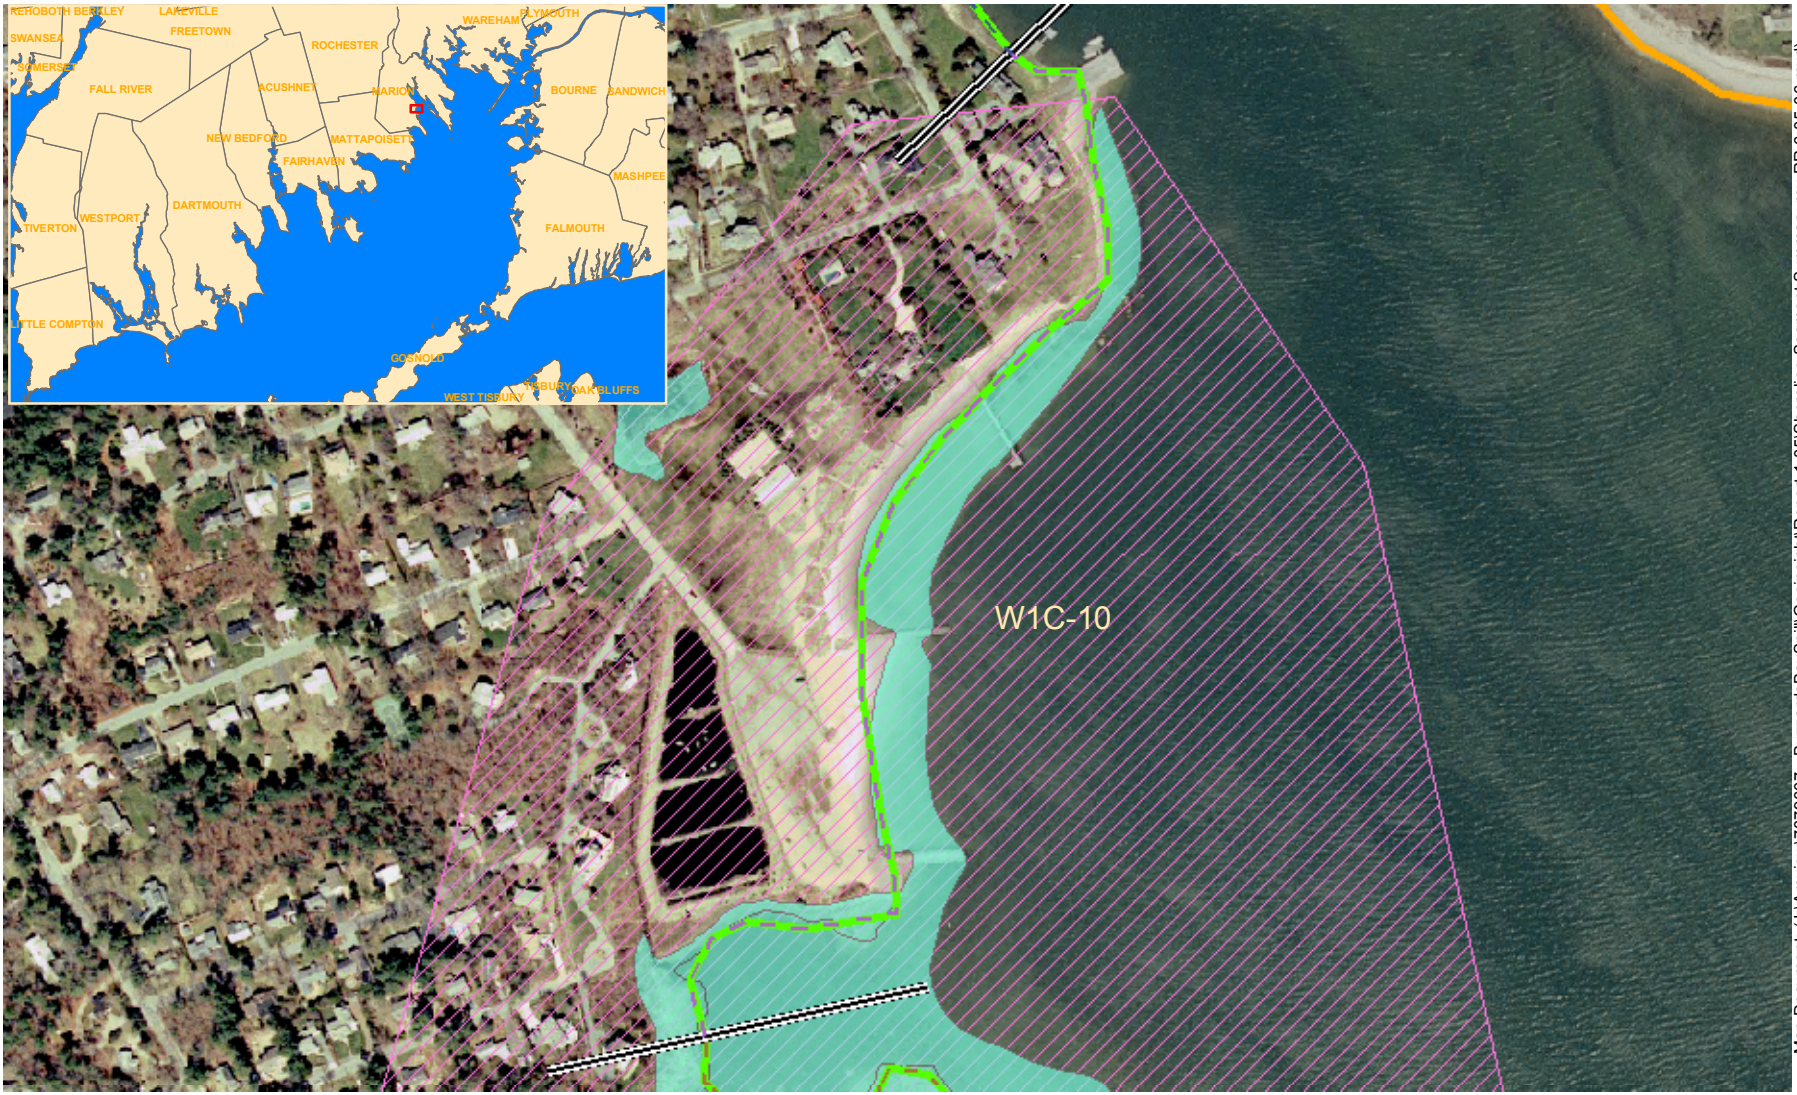
**W1C-10**  
**Silver Shell Beach, Marion**  
**Comprehensive Activities**  
**Bouchard B No. 120 Oil Spill**  
**Buzzards Bay, MA**

**Trench Location**
