**BOUCHARD B120 RELEASE
SHORELINE SEGMENT SUMMARY**

GeoInsight Project Number 3871-002

SEGMENT IDENTIFICATION: **W1F-01**

SEGMENT NAME: **Brandt Beach**

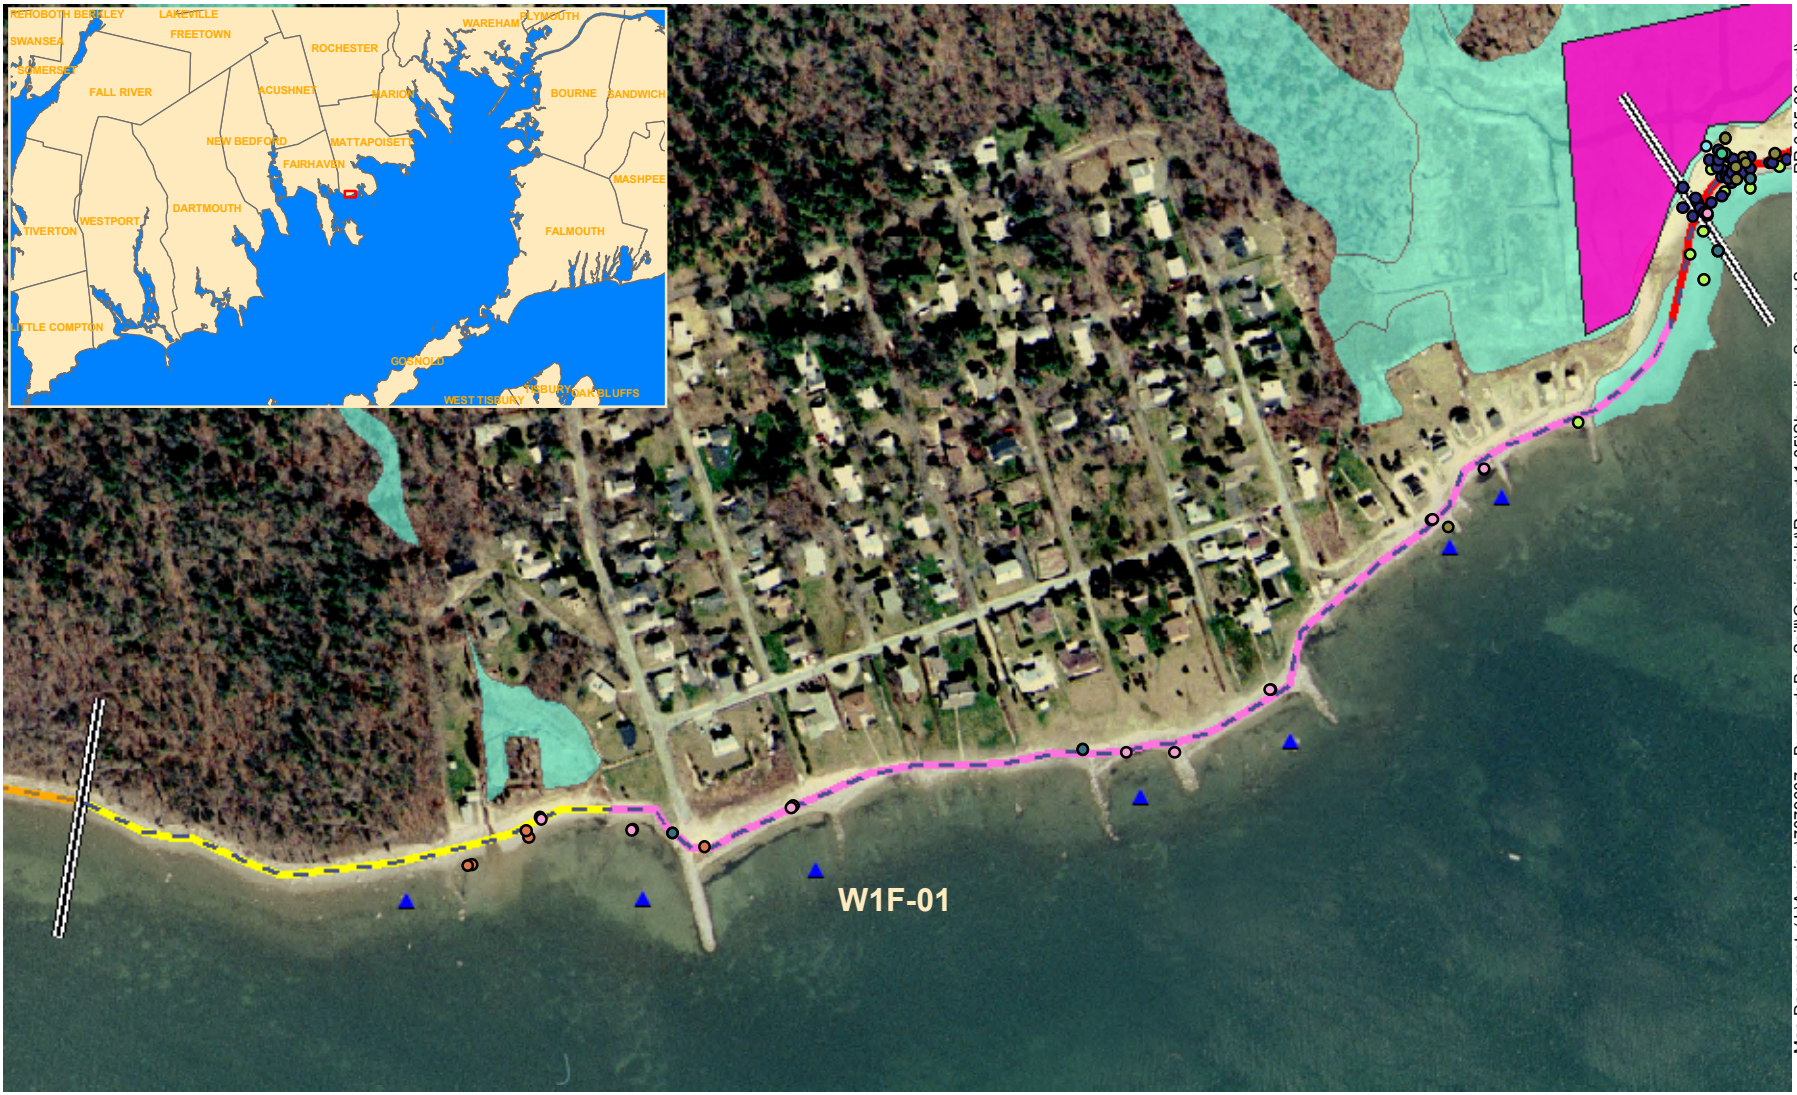
W1F-01
Brandt Beach, Mattapoisett
Comprehensive Activities
Bouchard B No. 120 Oil Spill
Buzzards Bay, MA

DATE	SUMMARY OF INFORMATION RECORDED BY INSPECTION TEAM
05/07/2003	Area of heavy oil coating (approximately 1 to 9 feet wide by 98 to 344 feet long with 1% to 50% surface oil coverage) was observed. Several areas of pavement, tarballs, and tar patties (ranging between 1 foot to 20 feet in diameter) were observed along the segment. Oiled wrack was also observed in the upper intertidal zone. Additional cleanup activities were warranted.
05/11/2003	Heavy and pooled oil observed near beach. Tarballs and tar patties also observed. The observed surface oil coverage was 11% to 50%. One area (approximately 6 to 9 feet wide and 100 feet long) observed with oiled wrack mixed with tar patties and pavement. One area (approximately 3 by 1,000 feet) with tarballs and tar patties (approximately less than 1% surface oil coverage) was observed. Cleanup crew was on-site during the inspection.
05/23/2003	Continued maintenance and ongoing cleanup activities observed.

DATE	SUMMARY OF INFORMATION RECORDED BY INSPECTION TEAM
11/05/2003	Site reconnaissance and potential buried oil inspection: Trace surficial splatter observed.
11/07/2003	Site reconnaissance: Portion of segment (primarily Howards Beach) was inspected during cleanup activities conducted at W1F-02. Evidence of oil was not recorded.
01/05/2004	Site reconnaissance and potential buried oil inspection: Splatter primarily scoured to a stain was observed on boulders. One tarball under a rock was removed.
02/19/2004	IRA citizen report of oil and field response: A citizen called GeoInsight on 02/19/2004 to report evidence of oil. GeoInsight and the citizen inspected a portion of the segment. Hardened tarballs (ranging approximately 0.5 to 6 inches in diameter) unrelated to the B120 release were observed concentrated in two areas on the rocky shoreline.
03/30/2004	Site reconnaissance: Evidence of oil was not recorded for this segment.

04/05/2004	Site reconnaissance and potential buried oil inspection: Very trace splatter (pea- to quarter-size) scoured to a stain on cobbles was observed primarily in upper intertidal zone.
