BOUCHARD B120 RELEASE SHORELINE SEGMENT SUMMARY

GeoInsight Project Number 3871-002

SEGMENT IDENTIFICATION: **W1F-03**

SEGMENT NAME: **Brandt Island East**

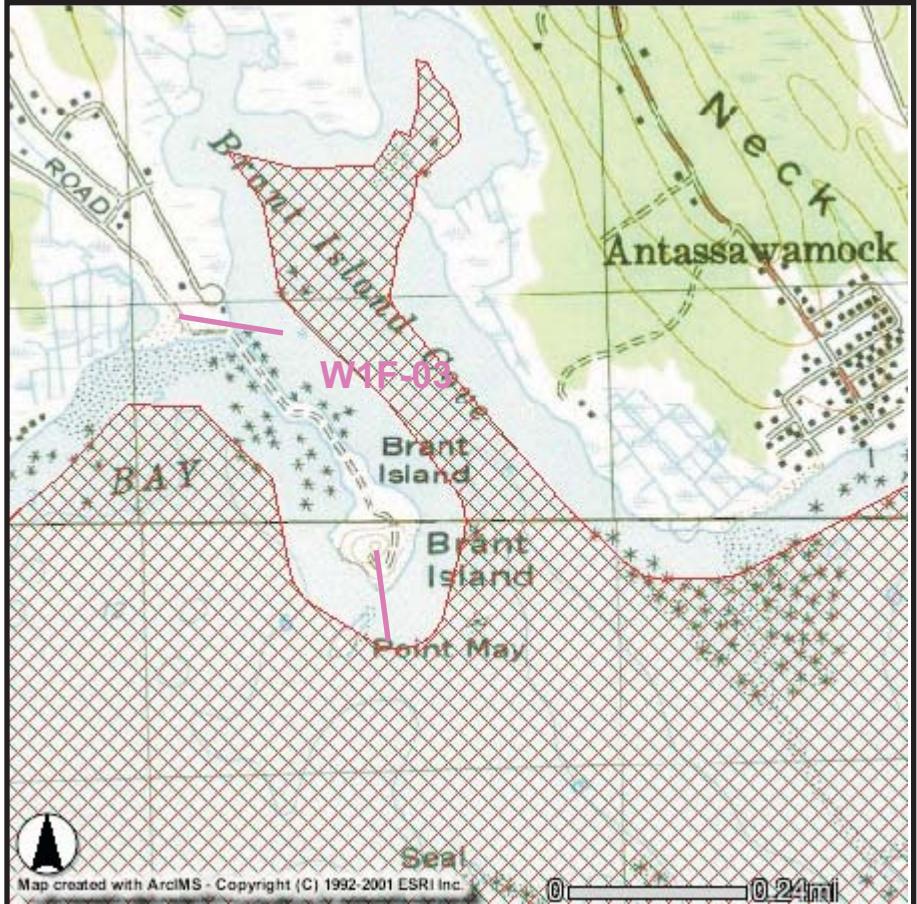
NATURAL HERITAGE AND ENDANGERED SPECIES MAP

Priority Habitats of Rare Species: Adjacent to segment: Buzzards Bay aquatic environment.

Estimated Habitats of Rare Wildlife: Adjacent to segment: Buzzards Bay aquatic environment.

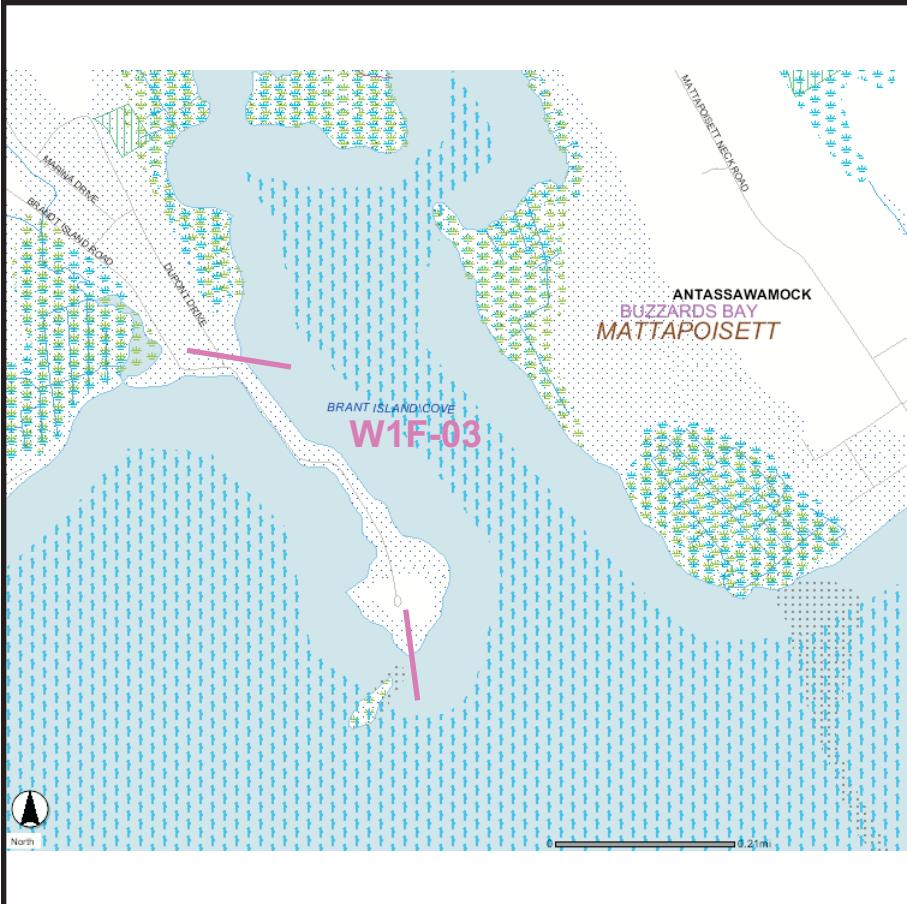
2IE PRIORITY RESOURCE MAP

Floodplains: At segment: 100-year floodplain.
