**BOUCHARD B120 RELEASE
SHORELINE SEGMENT SUMMARY**

GeoInsight Project Number 3871-002

SEGMENT IDENTIFICATION: **W1F-06**

SEGMENT NAME: **Mattapoissett Neck South**

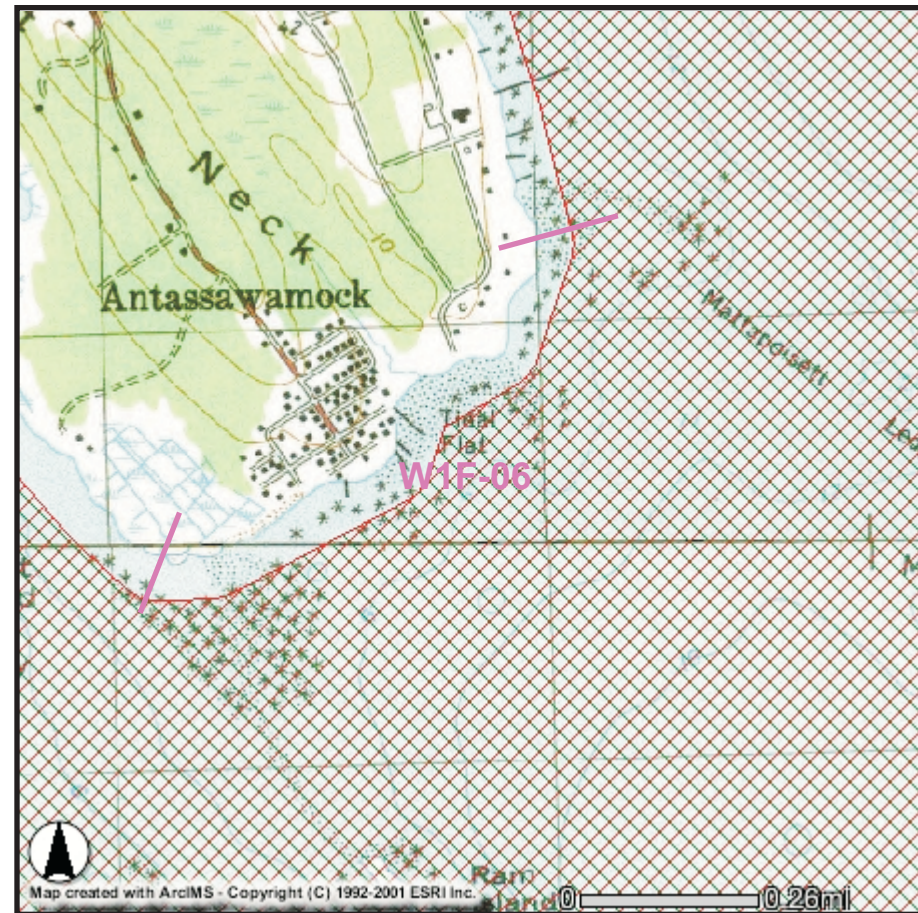
NATURAL HERITAGE AND ENDANGERED SPECIES MAP

Priority Habitats of Rare Species: Adjacent to segment: Buzzards Bay aquatic environment.

Estimated Habitats of Rare Wildlife: Adjacent to segment: Buzzards Bay aquatic environment.

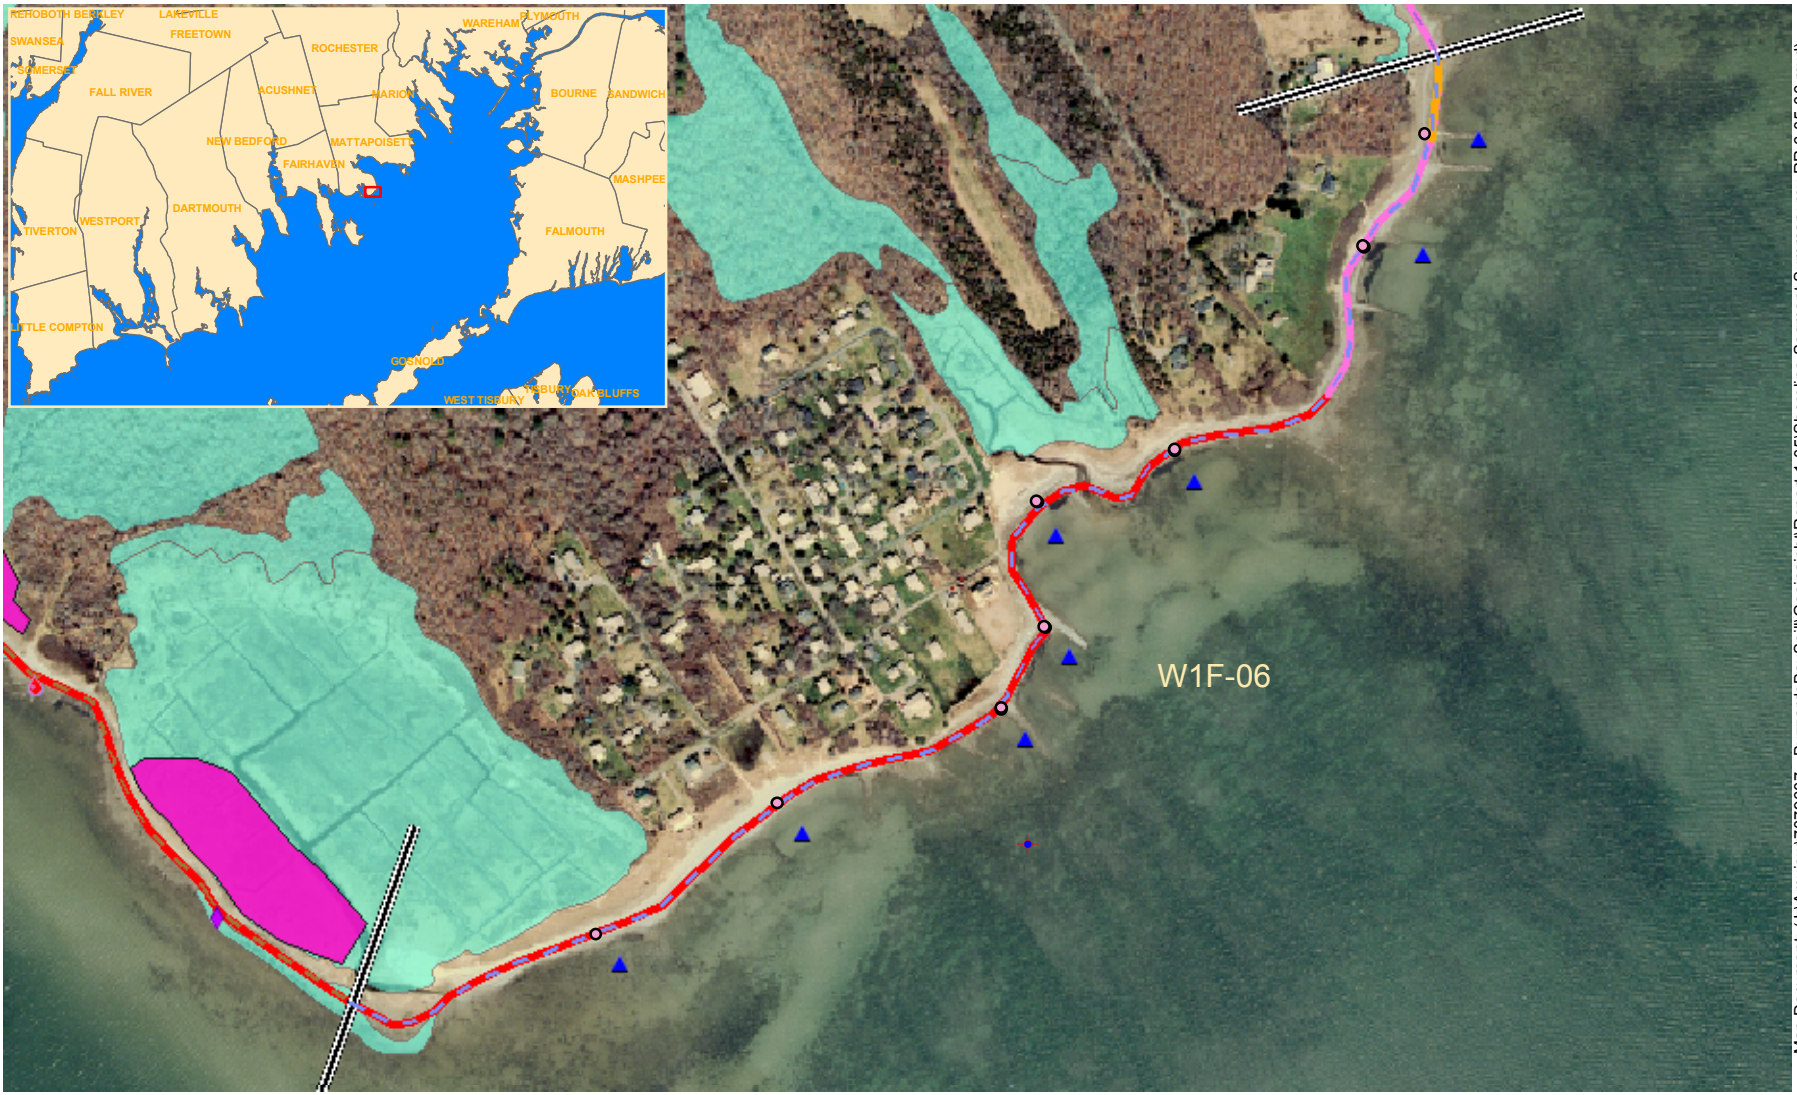
W1F-06
Mattapoisett Neck South,
Mattapoisett
Comprehensive Activities
Bouchard B No. 120 Oil Spill
Buzzards Bay, MA

DATE	SUMMARY OF INFORMATION RECORDED BY INSPECTION TEAM
12/03/2003	Site reconnaissance: Trace splatter was observed.
07/27/2004	Site reconnaissance, potential buried oil inspection, and shellfish bed evaluation: Eight trenches were excavated 8 to 18 inches deep and 5 to 35 feet long, and 7 areas were raked offshore. Oil was not observed in seven of the trenches. Small particles of oil were observed in one trench. Two additional trenches were excavated on either side. A slight sheen and small particles of oil were observed in these trenches. A 1 to 2 millimeter lens of sand with a rainbow sheen was observed along the east bank of the channel in the middle intertidal zone near N41°37.692' W70°49.507' on Howard Beach**. Surrounding trenches had very infrequent pinhead particles

of oil and minor sheening. Four to six patches of pin-head size splatters embedded in the marsh in the middle intertidal zone at N41°37.621' W70°49.564' were removed. A few granular tarballs along the banks of the Howard Beach channel (ranging 2 millimeters to 1 inch in diameter) were removed from the surface and in the trenches.

07/29/2004 Site reconnaissance, potential buried oil inspection, and shellfish bed evaluation: 8 trenches (approximately 5 to 8 feet long and 3 to 10 inches deep) were advanced and 8 areas were raked offshore. Trace splatter was observed on cobbles and boulders, primarily in the middle intertidal zone. Pieces of non-B120 road tar were observed on the rocky shoreline near the point.

08/26/2004 Site reconnaissance: West portion of the segment was inspected at the point. Two samples of weathered oil (W1F06-W01 and W1F06-W02) were collected at N41°37.474' W70°48.619' and N41°37.468' W70°48.597', respectively. Sporadic clusters of died splatter (approximately dime-size to 3 inches in diameter) were observed.
