BOUCHARD B120 RELEASE SHORELINE SEGMENT SUMMARY

GeoInsight Project Number 3871-002

SEGMENT IDENTIFICATION: **W1F-07**

SEGMENT NAME: **Mattapoisett Shores**

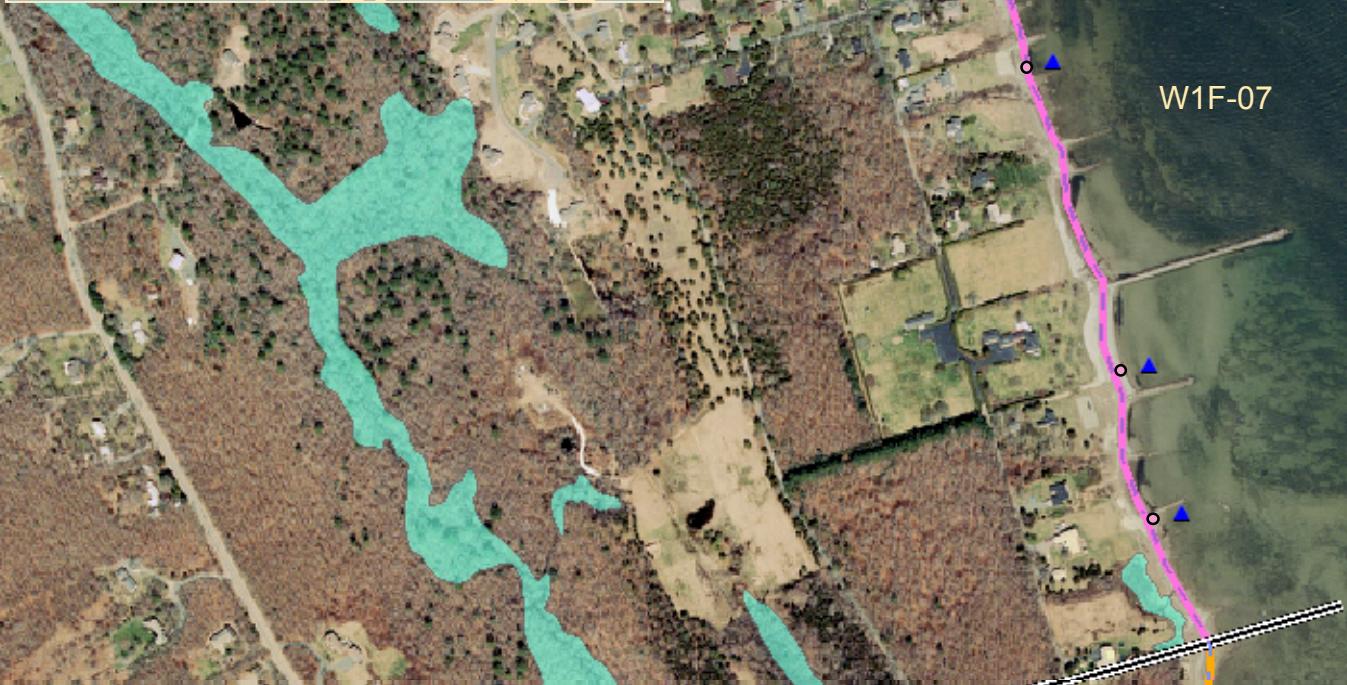
E N T R I X
W1F-07
Mattapoisett Shores,
Mattapoisett
Comprehensive Activities
Bouchard B No. 120 Oil Spill
Buzzards Bay, MA

DATE	SUMMARY OF INFORMATION RECORDED BY INSPECTION TEAM
07/29/2004	Site reconnaissance, potential buried oil inspection, and shellfish bed evaluation: 5 trenches (approximately 5 to 8 feet long and 3 to 10 inches deep) were excavated and 5 areas were raked offshore. Evidence of oil was not observed.
