CONSERVATION POND FINAL REPORT

Presented to:
Cynthia Coffin and the Bourne Board of Health

By Melissa Mills
AmeriCorps~Cape Cod Member Leader 2002-2003
August 2003

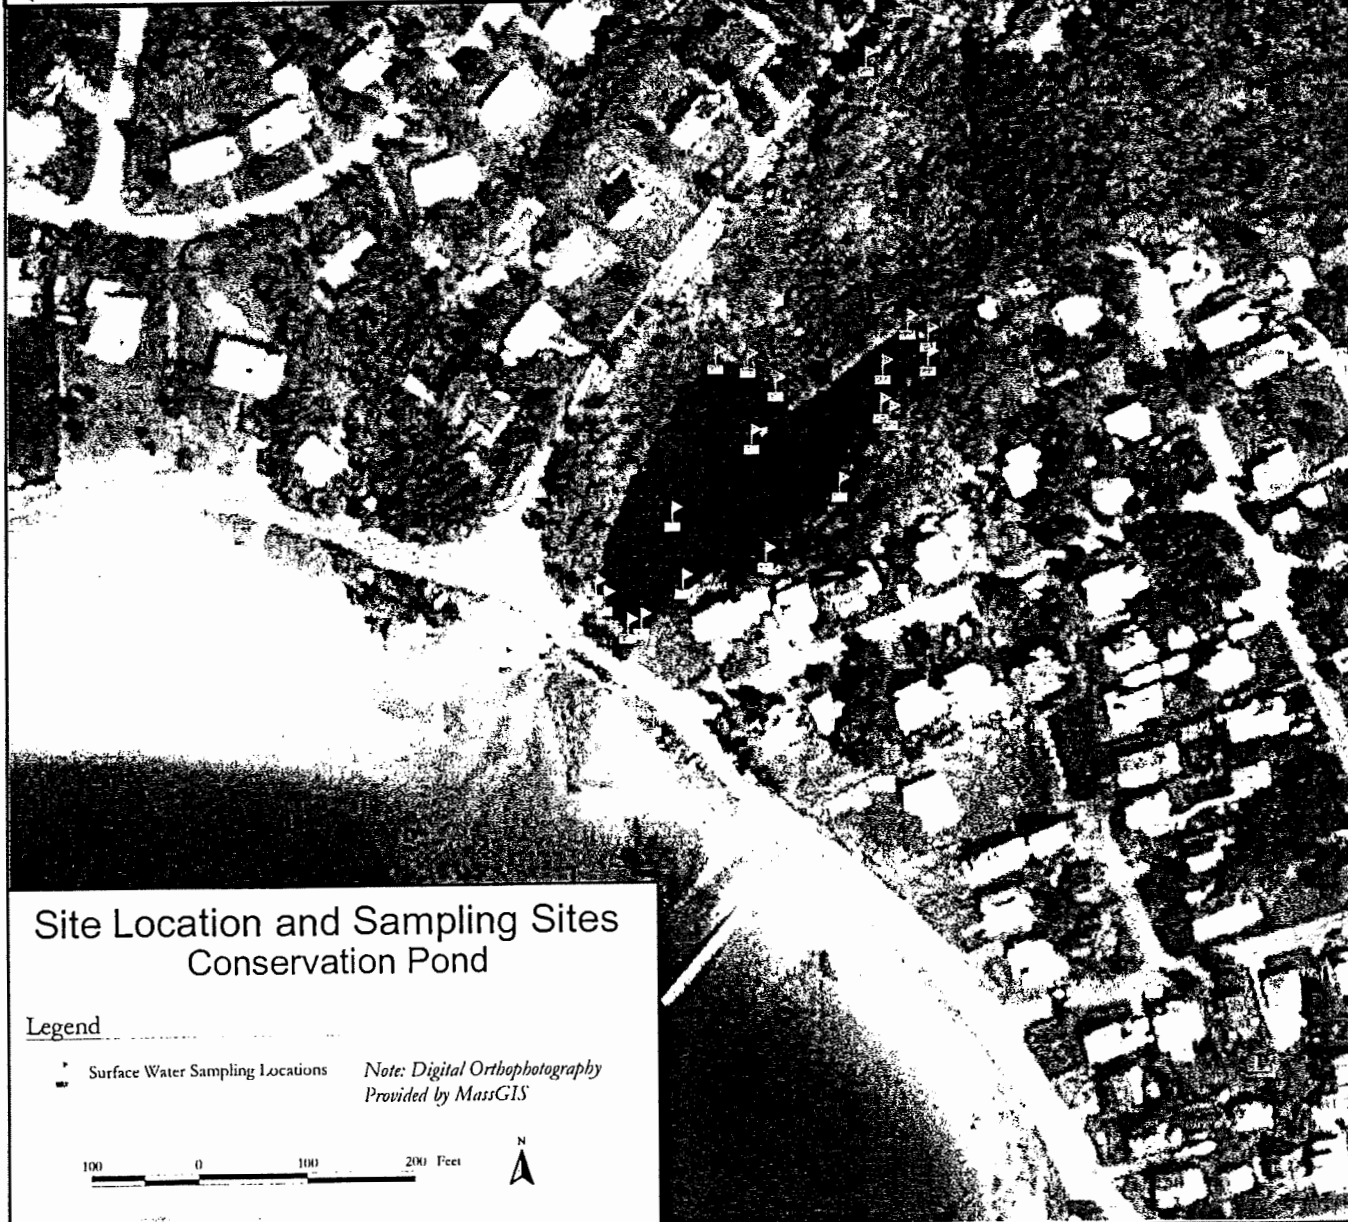
Site Location and Sampling Sites Conservation Pond

GIS map of sampling locations.

Surface Water Sampling Locations

The surface water and stormwater sampling were undertaken on Thursdays only to coincide with the AmeriCorps schedule and the schedule of the Barnstable County Laboratory. Samples were taken at locations around the pond corresponding with previous sampling done by the Bourne Selectmen's Pollution Task Force and in additional locations of concern for a comprehensive survey. This included background samples near the boat ramp in Hen Cove and samples at all inflows and outflows of the pond. Both hand drawn and Geographic Information System (GIS) maps shown in Appendix C detail the various sampling locations.

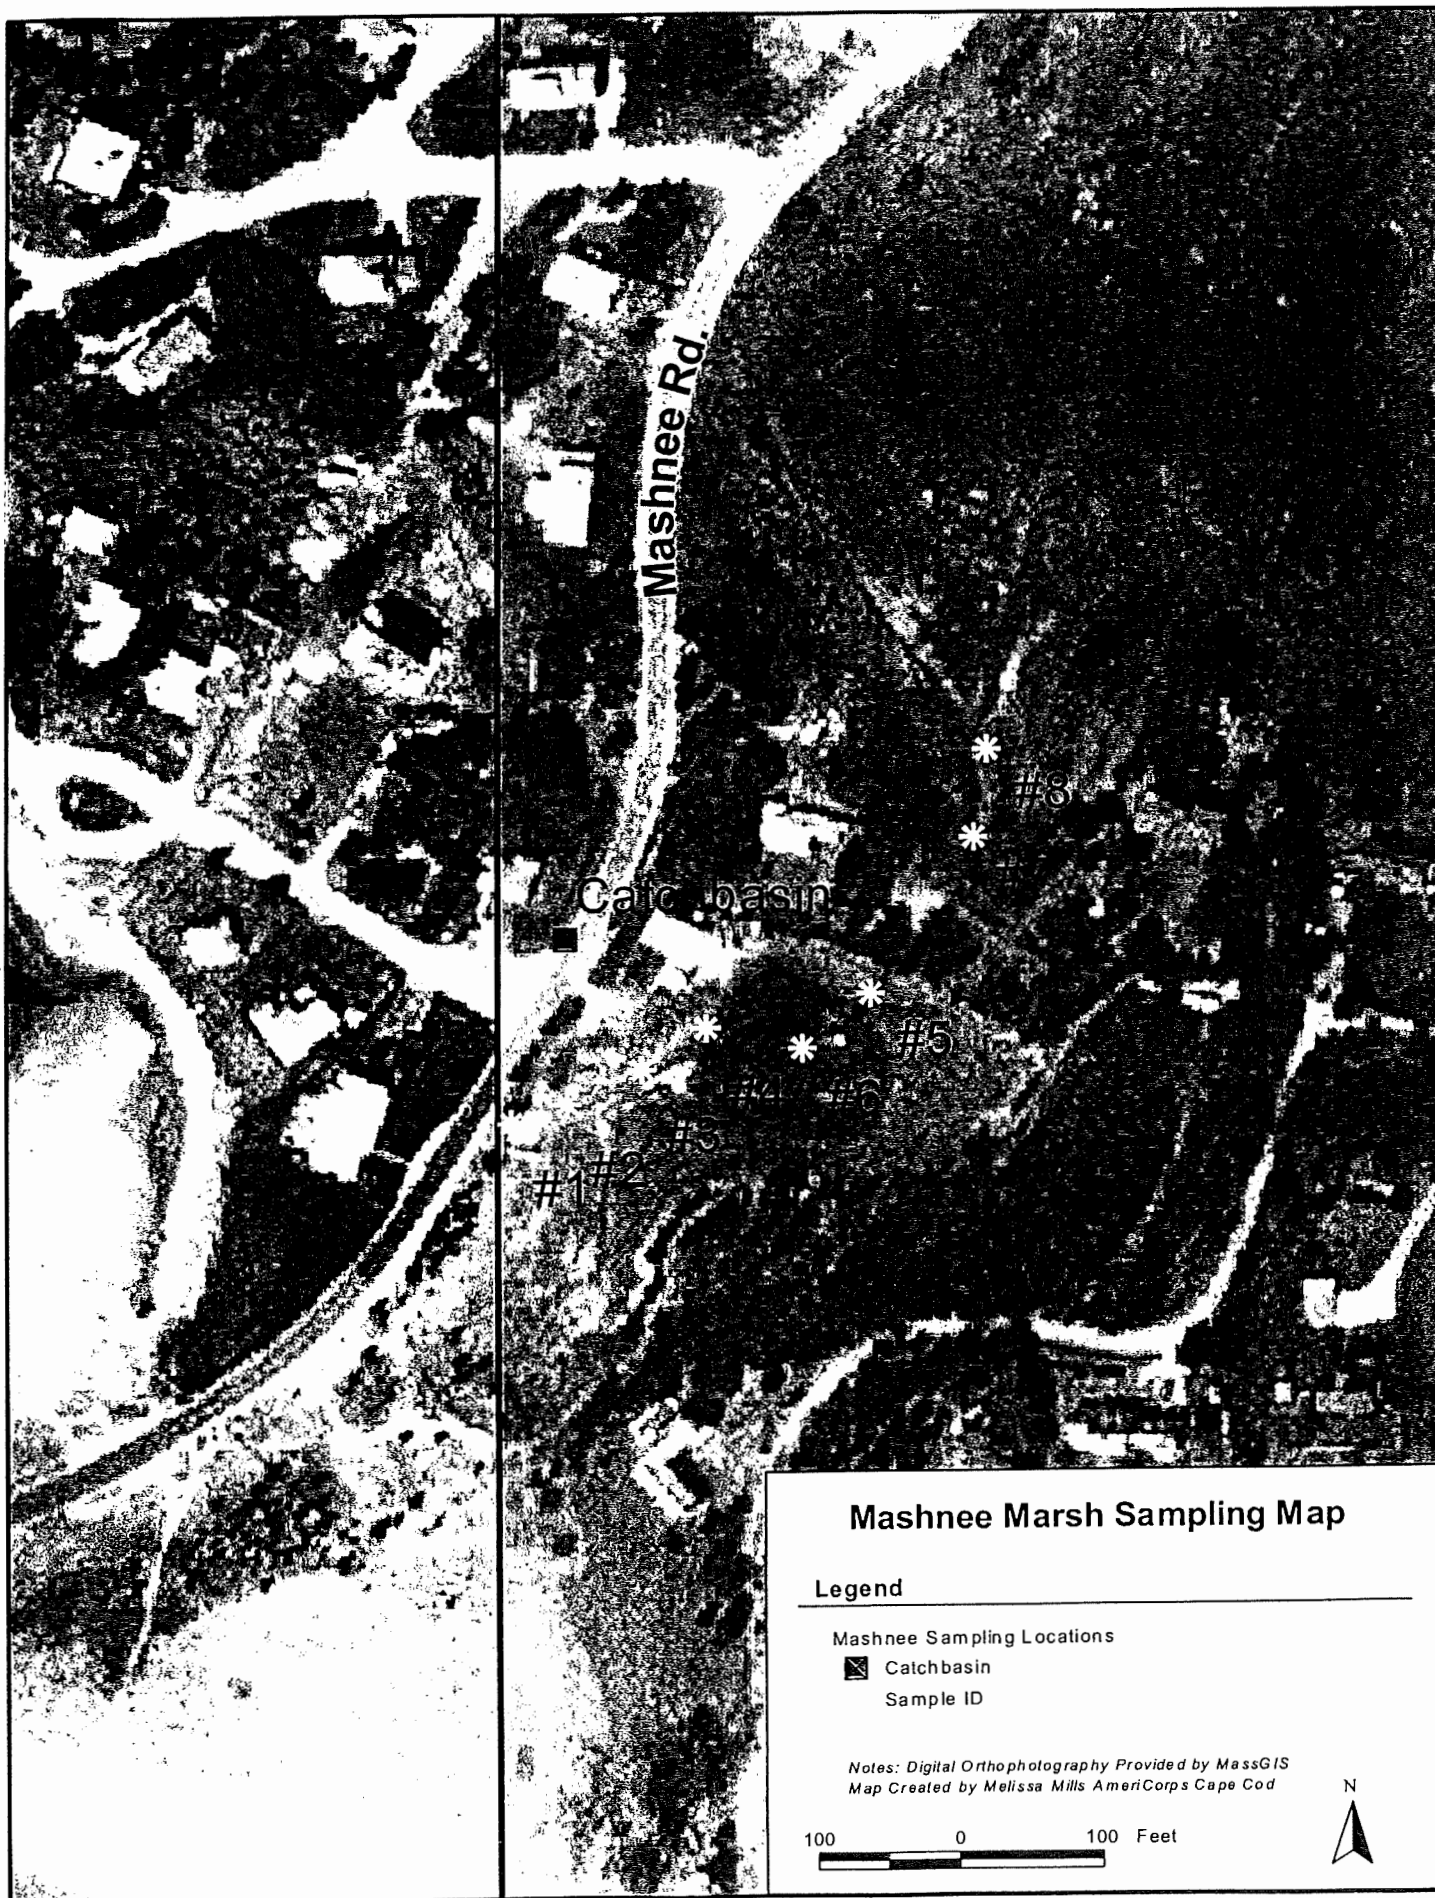
Mashnee Marsh Sampling Map

Mashnee Sampling Locations
