Citizen Concern Response Memorandum W2A-10
February 2, 2006

GeoInsight Project 3871-002

Re: Bouchard Barge B120 Oil Release
Buzzards Bay, Massachusetts

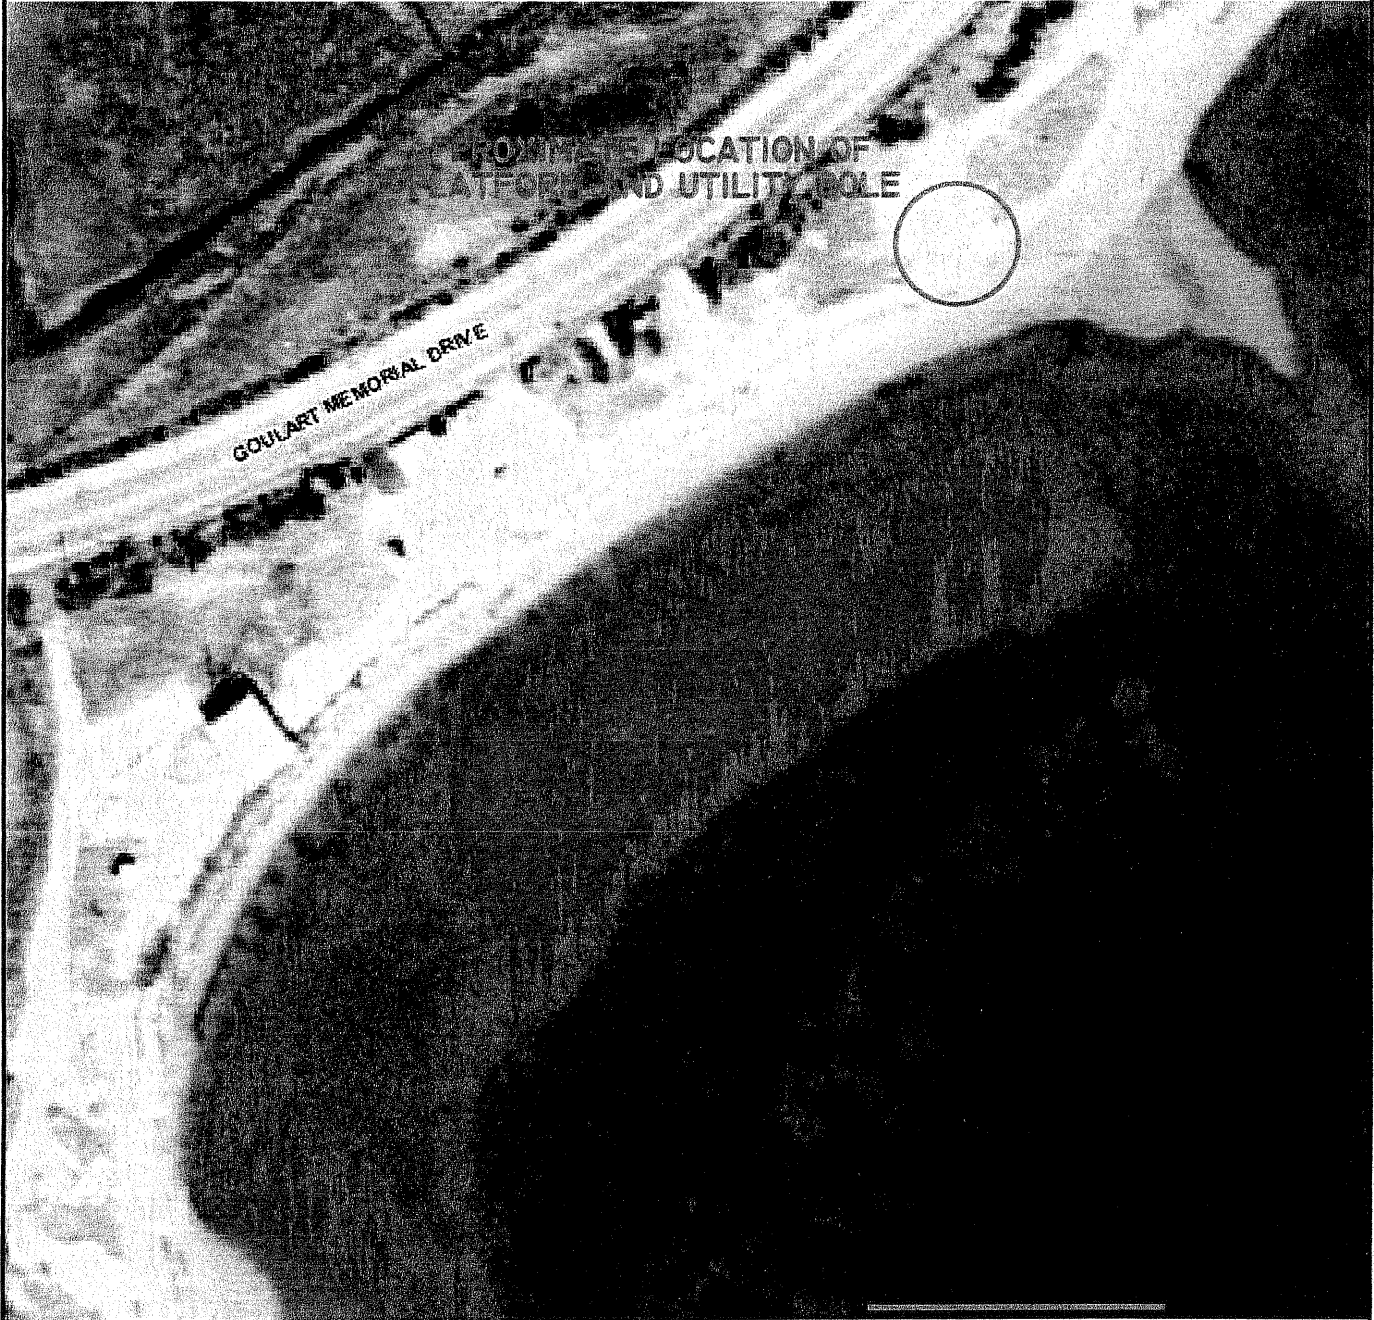
An aerial photograph of the area taken in April 2001 prior to the B120 oil spill, and available at the Massachusetts Geographic Information System (MassGIS) online map viewer at <http://www.mass.gov/mgis/mapping.htm>, is attached as Figure 1. Selected photographs of the area are also attached to this letter. The shoreline profile data are shown on Figures 2 through 4, and the approximate locations of the profiles are shown on Figure 5.
