PARE PROJECT NO. 08216.00

**INSPECTION REPORT
COAL POCKET PIER
NEW BEDFORD WATERFRONT
FACILITIES INSPECTIONS
NEW BEDFORD, MASSACHUSETTS**

MARCH 2009

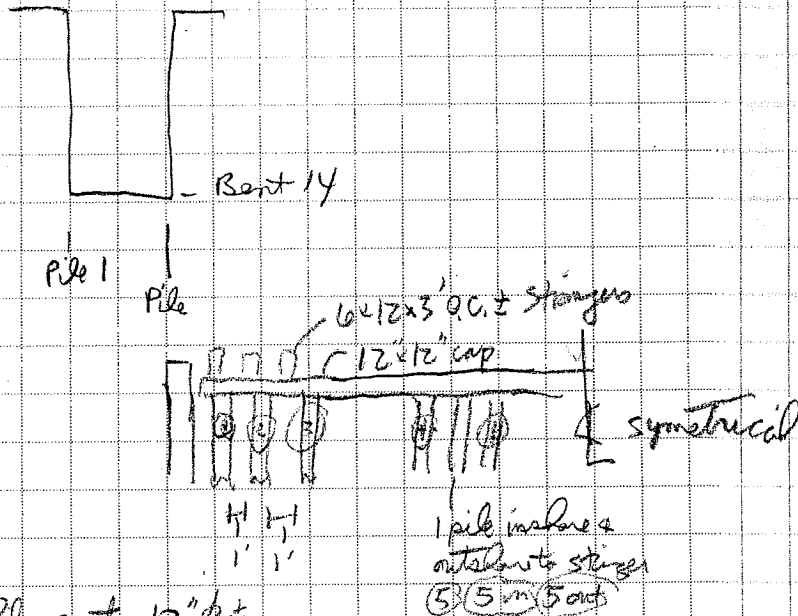
Bent 13 Pile 1 2' lg Pile post 12" φ ±
Hvy MB @ ML hollow only 2" shell left bottom 3'

Pile 2 - Hvy MB 6" φ remains up 3'
