Evaluation of surface water quality impacts
and potential threats to drinking water supplies
from a piggery in Rochester, MA

Joseph E. Costa, Ph.D.

Buzzards Bay Project National Estuary Program

Technical Report

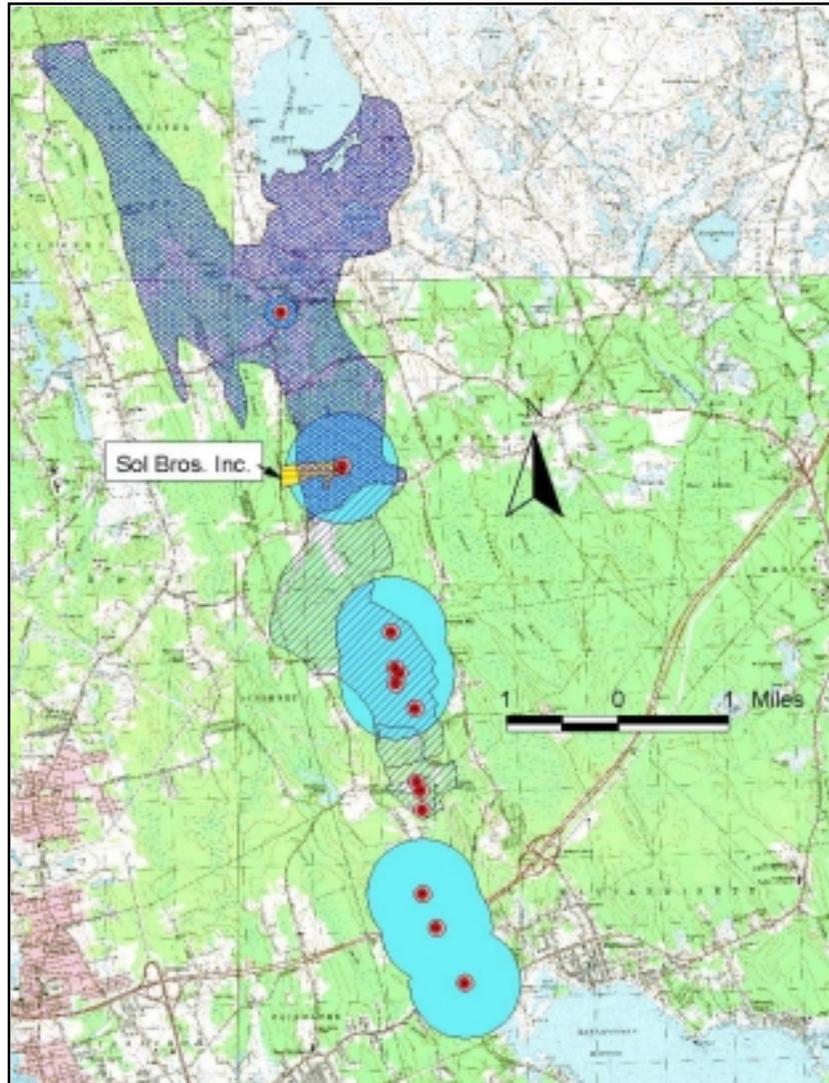
Figure 2. Public wells along the Mattapoisett River Valley (red dots) with Zone IIs (blue crosshatched) and Interim Wellhead Protection Areas (solid light blue) areas shown). The two wells adjacent to the Sol Brothers, Inc. property appear as one point at this scale.

The Mattapoissett River Valley contains 14 public drinking water supply wells (Fig. 2). These wells are recharged by river and groundwater in the areas adjoining the wells.

With the given delineation of the Zone II, the presumption is that the Sol Brothers, Inc. operation has the potential to degrade only the Perry Hill wells, and not other wells to the south. However, a Zone II delineation represents the recharge area of a well during peak pumping and drought or low precipitation conditions. During wet weather high water table conditions, it is also conceivable that any potential ground water plumes from the Sol Brothers property may enter the Zone II of the Town of Marion Wolf Island Road Wells, which begins 2000
