Tidal Restriction Site Profiles Buzzards Bay Watershed

Bourne
Dartmouth
Falmouth
Fairhaven
Marion
Mattapoisett
New Bedford
Wareham
Westport

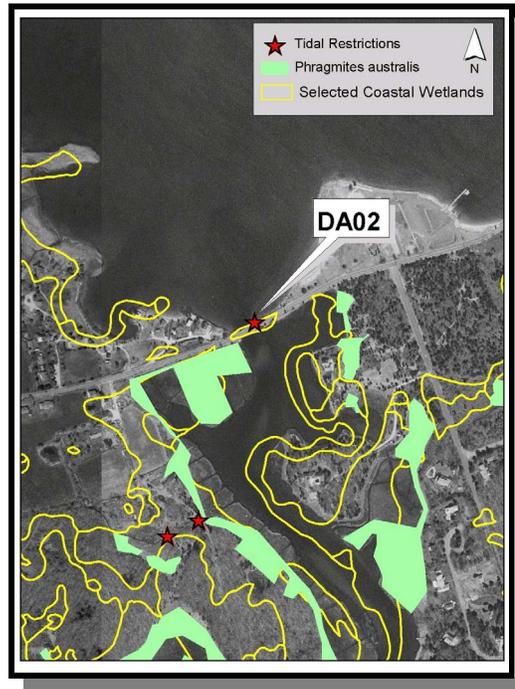
Bridge condition: good

This bridge was originally built in 1938, and it has recently been rebuilt. Deepening of the channel or adding additional culverts may improve flushing upstream.

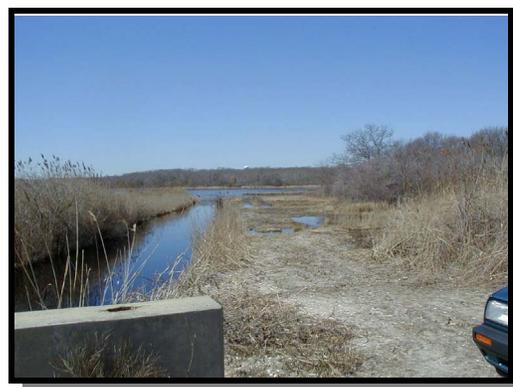
View of marsh

Culvert condition: fair

This site has been selected for remediation by the New Bedford Harbor Trustees Council along with DA05.

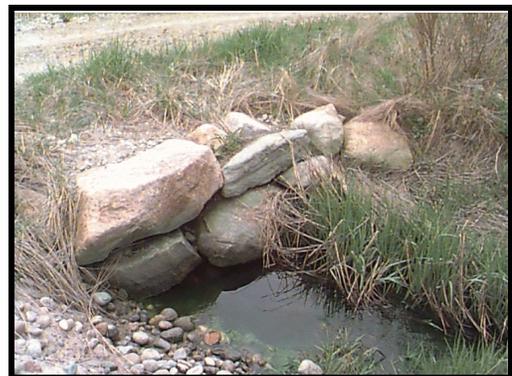
South side of culvert

Culvert condition: poor
Road width: 12 feet
Culvert length: 14.4 feet
Acres of wetlands affected: 6.3 acres
Acres of *Phragmites* present: 2.2 acres

The Buzzards Bay Project has initiated discussions with the Massachusetts Audubon Society and the Town of Dartmouth concerning the replacement of the undersized culvert with two 24" culverts.

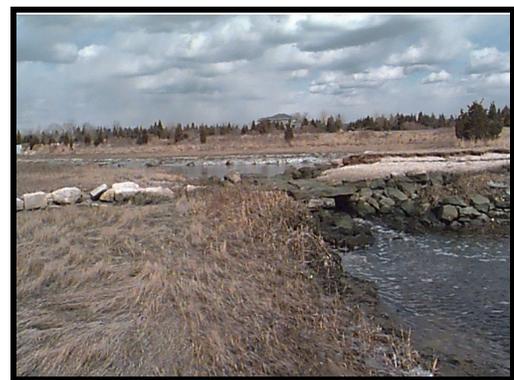
Upstream view

Culvert condition: poor

The replacement of the existing stone path with a footbridge would increase the tidal flow yet still allow pedestrian access to the property.

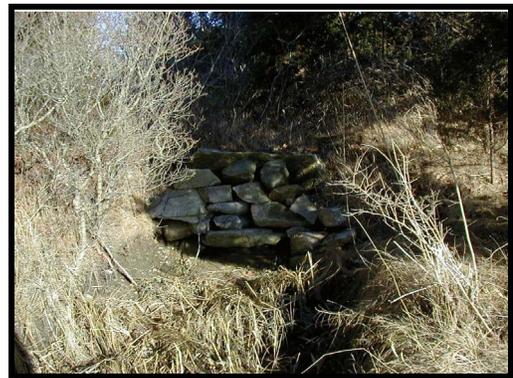
Upstream view

Culvert condition: poor

Since this road is no longer used, the removal of the old road and culvert would be fairly simple.

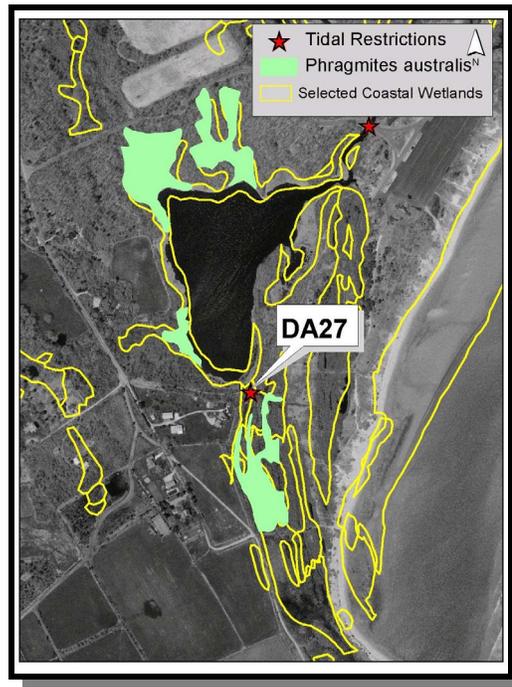
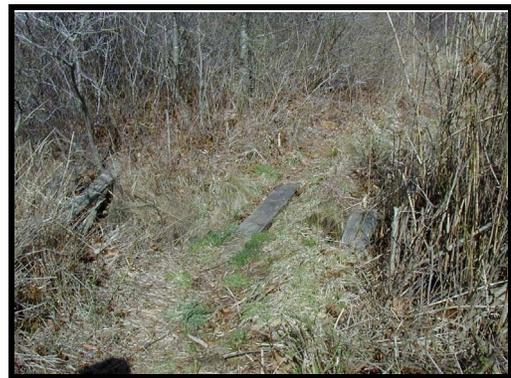
View of path

Culvert condition: no culvert - breached dike

A culvert needs to be installed at this site. This would be an excellent AmeriCorp project. All materials could be brought in by hand. All work could be performed with hand tools.

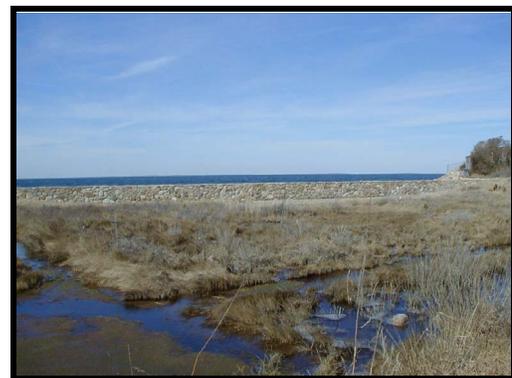
View from behind wall

Culvert condition: culvert not visible
Stone wall width: 3 feet
Estimated culvert length: 24 feet
Acres of wetlands affected: 14.8 acres
Acres of *Phragmites* present: 14.8 acres

Due to the low lying areas, this site should be investigated to determine if a self regulating tide gate is needed. The impacted marsh is the same area affected by FA03, FA04, FA05, FA06, FA40, and FA41. A study that looks at all restrictions affecting this marsh system is recommended.

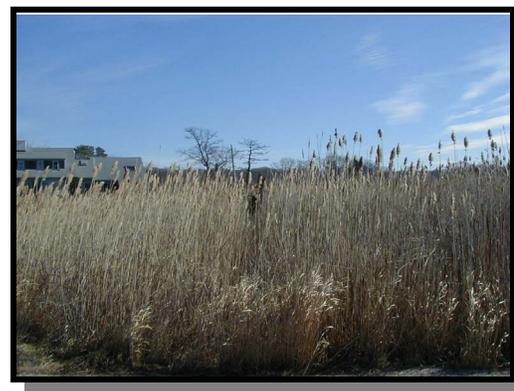
Upstream view

There is a lot of *Phragmites* on the upstream side of this culvert. The culvert has filled in on the east side with soil and is not visible, as it is covered by rocks. A larger culvert is required. The impacted marsh is the same area affected by FA02, FA03, FA04, FA06, FA40, and FA41. A study that looks at all restrictions affecting this marsh system is recommended.

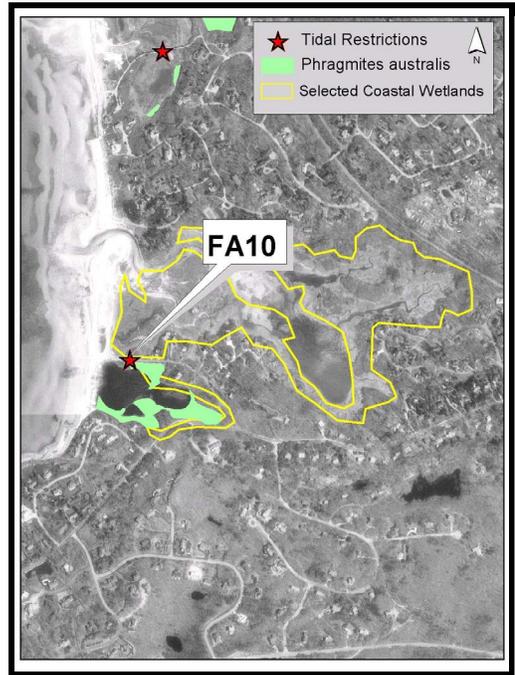
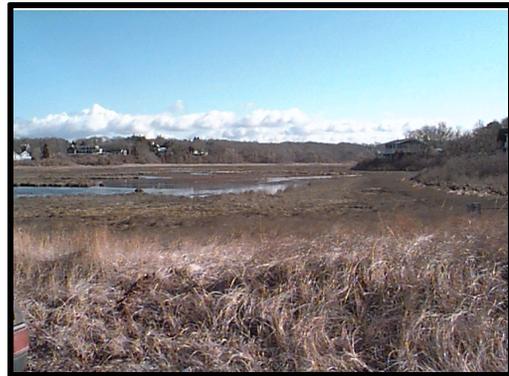
View of marsh

FA10 is a beach access road near Little Sippiwisset Marsh that was installed with no culvert (see map on page 99). The lack of a culvert has prevented tidal flows from the north and has caused ponding of water on the south side of the road.

This is a barrier beach road with no culverts. The pond that formed on the blocked side may have created specialized habitat which may now deserve protection. This freshwater/brackish habitat should be studied before the installation of a culvert is considered.

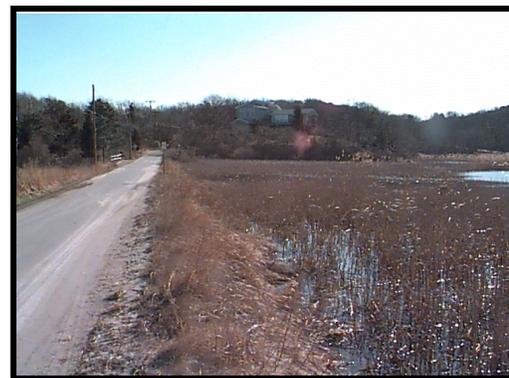
View of road

Culvert condition: no culvert
Road width: 15 feet
Proposed culvert: 30 feet
Acres of wetlands affected: 1.9 acres
Acres of *Phragmites* present: 1.9 acres

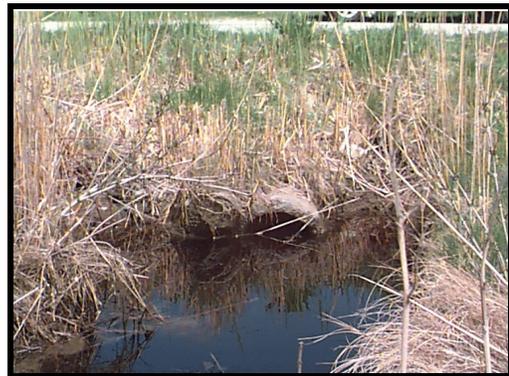
Downstream view

Culvert condition: fair

This site has generated interest among several state agencies. The ditch through the upland to FH18 should also be reshaped to handle an increased flow when the culvert is replaced with a larger one.

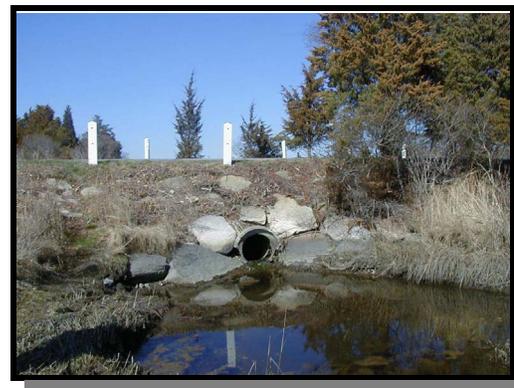
View of south side of Mattapoisett Neck Road

Culvert condition: poor

MT04 has been selected as a GROWetlands site. The Massachusetts Wetland Restoration Program has engaged an engineering firm to study this marsh and the three restrictions: MT03, MT04 & MT05.

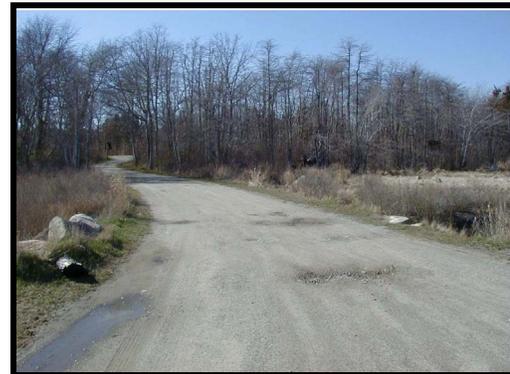
Entrance road to beach

Culvert condition: good

Due to the lack of paving and utilities and the shallow culvert depth, this culvert would be easy to replace. There has been somewhat of a breach in the barrier beach to the south at MT17, which allows tidal waters to the same wetland.

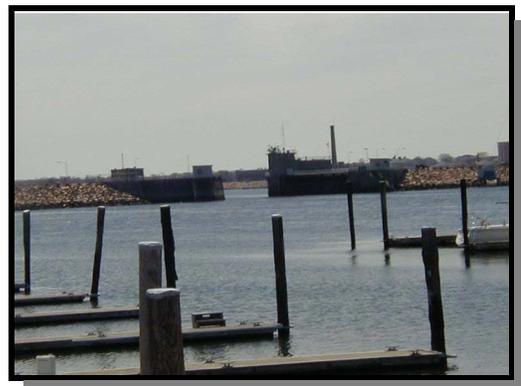
Opening in hurricane dike from the Fairhaven Shipyard & Marina

Dike condition: excellent
Restriction width: 120 feet
Restriction length: 144 feet
Acres of wetlands affected: 83.4 acres
Acres of *Phragmites* present: 12.0 acres

The New Bedford Harbor Trustees Council is investigating the possibility of increasing tidal flow to New Bedford Harbor. Rather than altering the hurricane barrier entrance, installation of a large culvert west of the entrance is being considered.

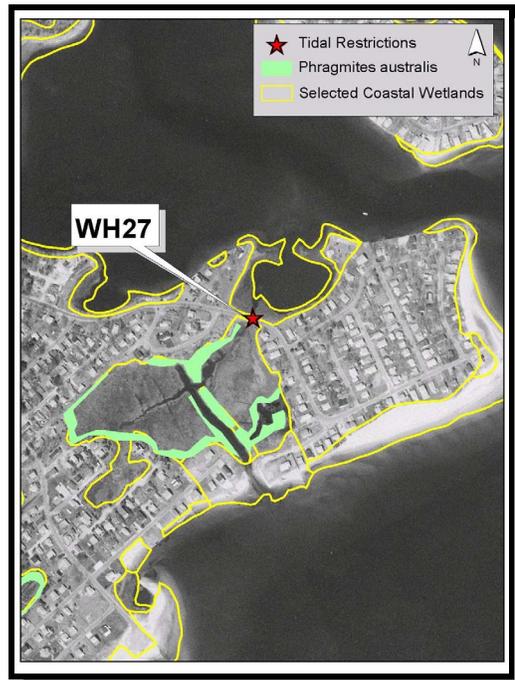
Culvert condition: good

Due to the shallow culvert depth, this would be an easy culvert to replace. The location of any utilities (gas, water, and sewer are present in the street) could add appreciably to the final costs.

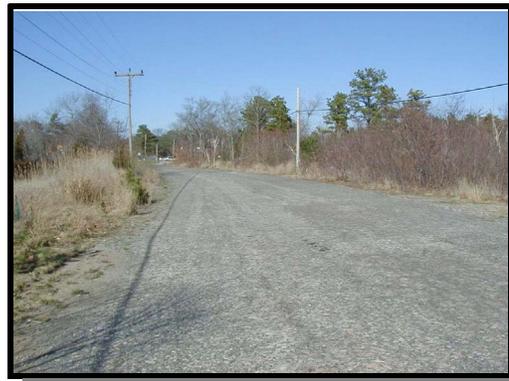
Old section of Route 6

This project must be remediated in conjunction with WH29. Although there are no properties accessed by this section of road, the road contains water mains and active electric/telephone poles precluding road removal. The marsh to the south was flooded for several days by salt water after Hurricane Bob in 1991. All freshwater vegetation in the marsh was killed as a result of that flooding.

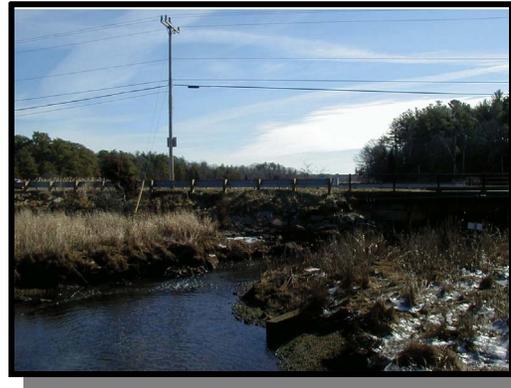
Improvements to flushing under this old road, should be done in conjunction with improvements at WH41. The removal of this old road remnant would be fairly easy to accomplish as there is ready access for heavy equipment. Due to the site topography it would not be necessary to remove the material off-site. Wetland Protection Act permits must be issued by both Wareham and Plymouth.

Downstream view from WH40, looking at WH41

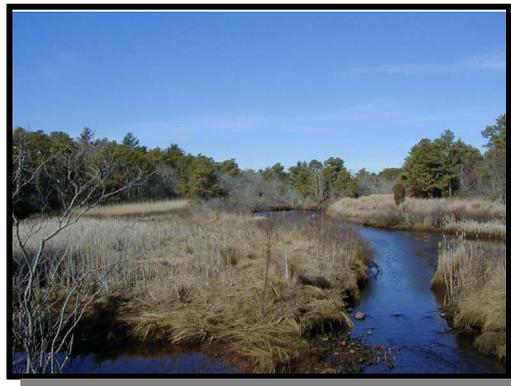
Upstream view, above WH40

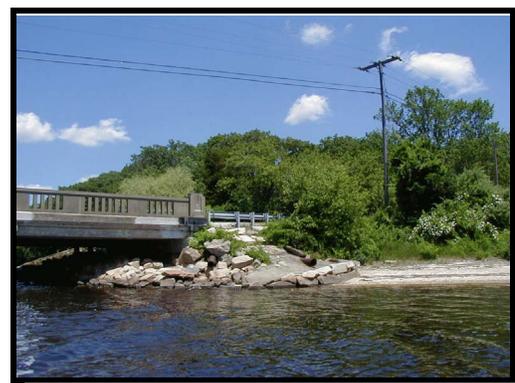
This tidal restriction is caused by fill material deposited under Hix Bridge, which impedes tidal flow and creates a damming effect (see map on page 141). Large granite blocks were toppled in the river as a result of the destruction of the old Hix Bridge by the Hurricane of '38 and from the demolition of the bridge in 1939.

Close up view

The Town of Westport is planning to rebuild this bridge. The U.S. Army Corps of Engineers is conducting a tidal flushing study to determine the benefits of increased tidal flushing. There may be problems associated with the removal of the granite blocks. A detailed report on this site is available on the Buzzards Bay Project's website, www.buzzardsbay.org.

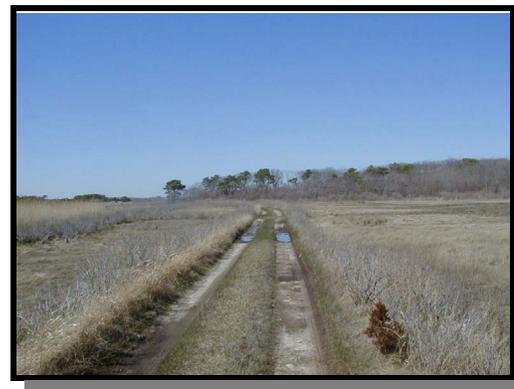
View of driveway

The addition of new culverts at the site may require new mosquito ditching. Any new culverts would be fairly easy to place. If the driveway is improved by an increase of fill, new ditching may not be required.
