**Massachusetts Division of Marine Fisheries  
Technical Report TR-16**

## **A Survey of Anadromous Fish Passage in Coastal Massachusetts**

### **Part 2. Cape Cod and the Islands**

May 2004

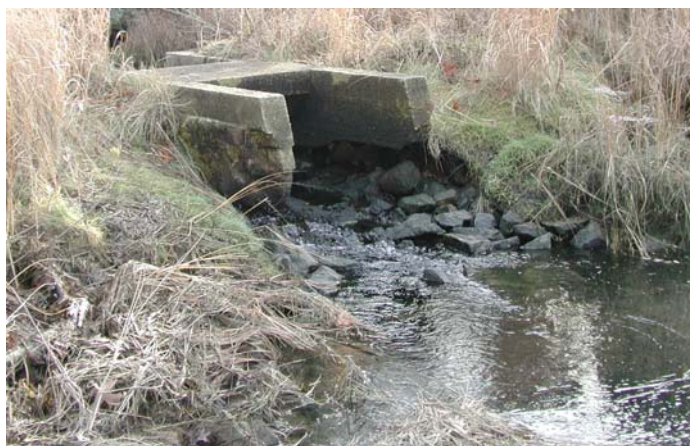
Pocasset River Control Structure at low tide

Design	Material	Length (ft)	Inside W (ft)	Outside W (ft)	# of Baffles	Baffle H (ft)	Notch W (ft)	Pool L (ft)	Condition/Function
Weir-pool	Concrete with a wooden baffle	8.5	2.9	4.1	1	0.4	-	-	Poor Not passable

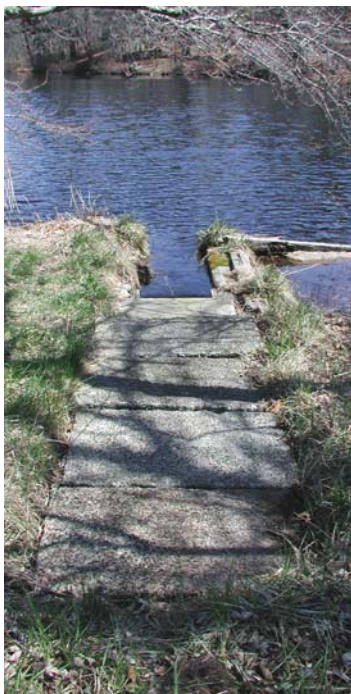
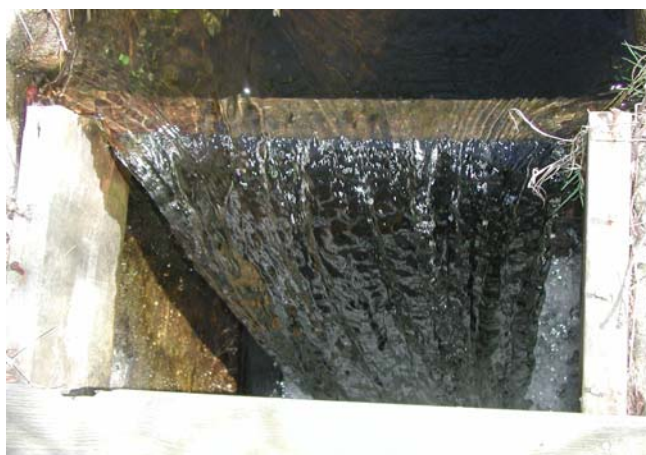
<b>River Mile</b>	<b>Type</b>	<b>Material</b>	<b>Spillway W (ft)</b>	<b>Spillway H (ft)</b>	<b>Impoundment Acreage</b>	<b>Year Built</b>	<b>Owner</b>	<b>GPS</b>
1.4	Dam	Concrete with wooden boards	1.9	4.6	1.9	-	Town of Bourne	41° 41' 48.248" N 70° 36' 18.352" W

Spillway of County Road Dam

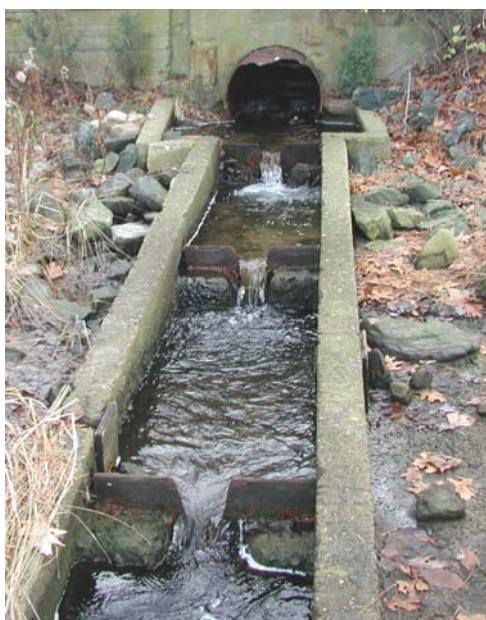
Bay Road Culvert and fishway

Design	Material	Length (ft)	Inside W (ft)	Outside W (ft)	# of Baffles	Baffle H (ft)	Notch W (ft)	Pool L (ft)	Condition/Function
Notched weir-pool	Concrete with steel plates	77.0	2.2	3.1	14	Variable (~1.8)	0.8- concrete; 0.5- metal	6.5	Poor Inefficient passage

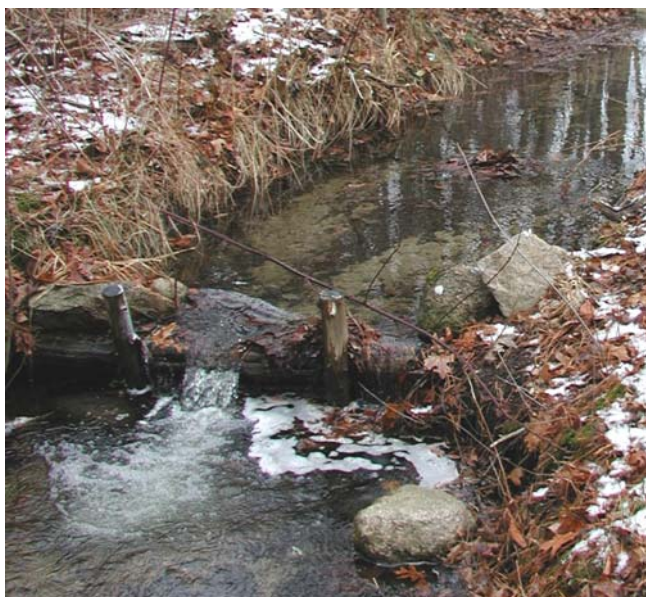
Stream baffle below Chester Street

Design	Material	Length (ft)	Inside W (ft)	Outside W (ft)	# of Baffles	Baffle H (ft)	Notch W (ft)	Pool L (ft)	Condition/ Function
Stream baffle	Wood and stone	175.0	2	Varied (stream width)	9	Varied (0.6)	Varied (0.7)	Varied (10-41)	Good Passable

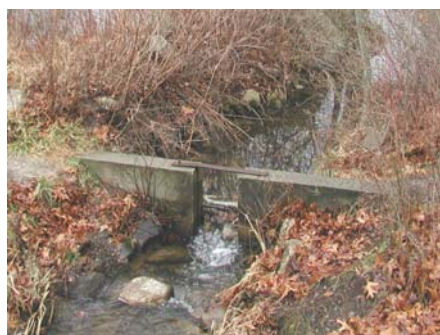
Herring Brook Dam

Design	Material	Length (ft)	Inside W (ft)	Outside W (ft)	# of Baffles	Baffle H (ft)	Notch W (ft)	Pool L (ft)	Condition/Function
Stream baffle	Concrete, wood and stone	594	1.4	Stream width	12	Varied (1)	1.4	Varied (51-120)	Poor Inefficient

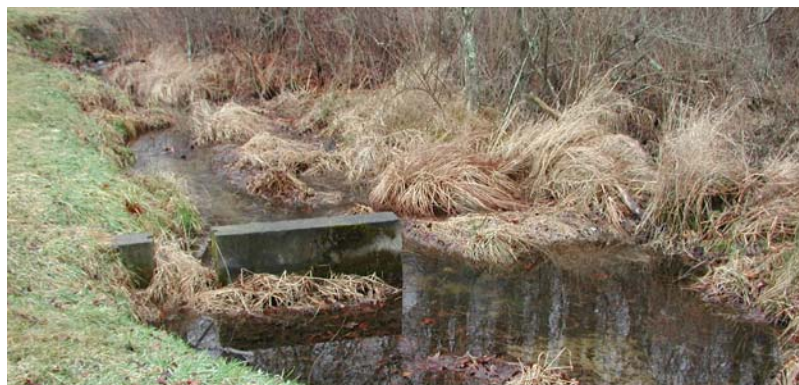
Bypassed stream baffles

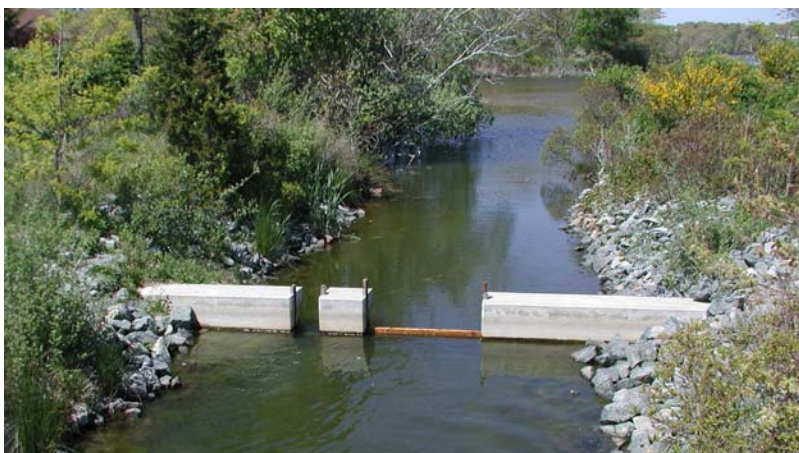
Oyster Pond control structure and fishway

Design	Material	Length (ft)	Inside W (ft)	Outside W (ft)	# of Baffles	Baffle H (ft)	Notch W (ft)	Pool L (ft)	Condition/Function
Notched weir	Concrete with wooden baffles	-	15	Edge of channel (15)	1	1.3	1.0	-	Excellent Passable

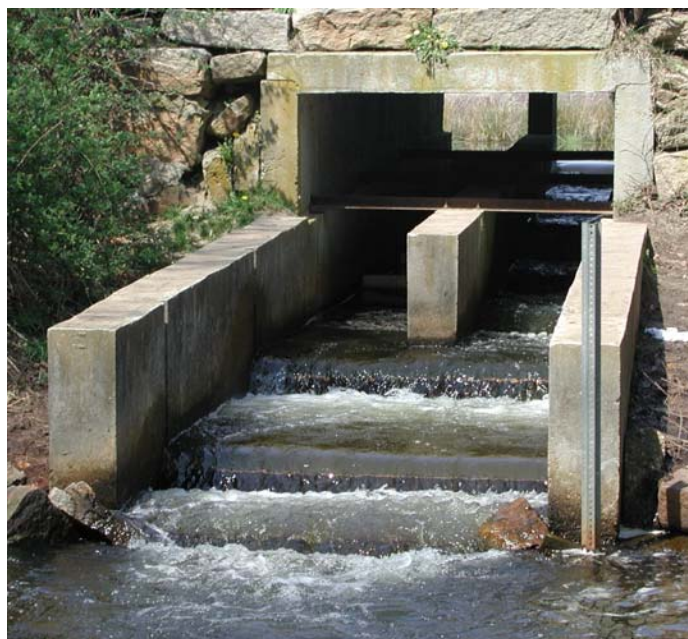
Fishway and dam at John Parker Road

Design	Material	Length (ft)	Inside W (ft)	Outside W (ft)	# of Baffles	Baffle H (ft)	Notch W (ft)	Pool L (ft)	Condition/Function
Weir-pool	Concrete with wooden baffles	33.0	6.0	8.0	7	1.5	-	8.0	Fair Passable

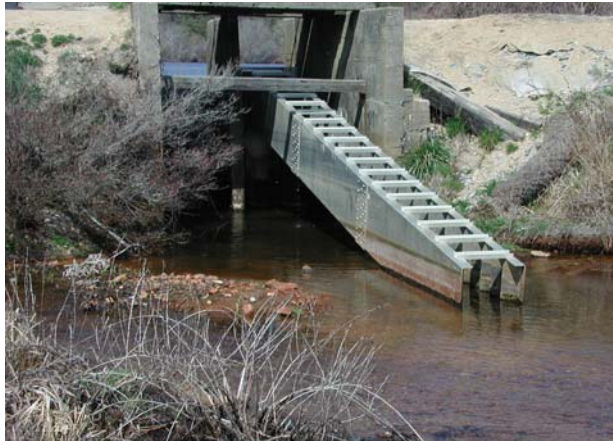
Pond 14 dam and Alaskan Steeppass ladder

<b>Design</b>	<b>Material</b>	<b>Length (ft)</b>	<b>Inside W (ft)</b>	<b>Outside W (ft)</b>	<b># of Baffles</b>	<b>Baffle H (ft)</b>	<b>Notch W (ft)</b>	<b>Pool L (ft)</b>	<b>Condition/Function</b>
Alaskan Steeppass	Aluminum	30.0	1.8	-	-	-	-	-	Excellent Passable
Weir-pool	Concrete with wooden baffles	8.5	2.9	4.3	2	~0.6	-	7.0	Good Passable

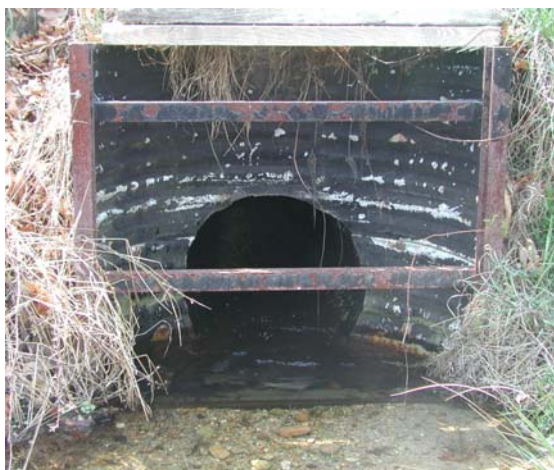
John Parker Road bog sluice

Design	Material	Length (ft)	Inside W (ft)	Outside W (ft)	# of Baffles	Baffle H (ft)	Notch W (ft)	Pool L (ft)	Condition/Function
Stream baffle	Stone and metal with a wooden baffle	126.3	3-4	Stream edge	1	0.5	0.6	N/A	Fair Inefficient passage

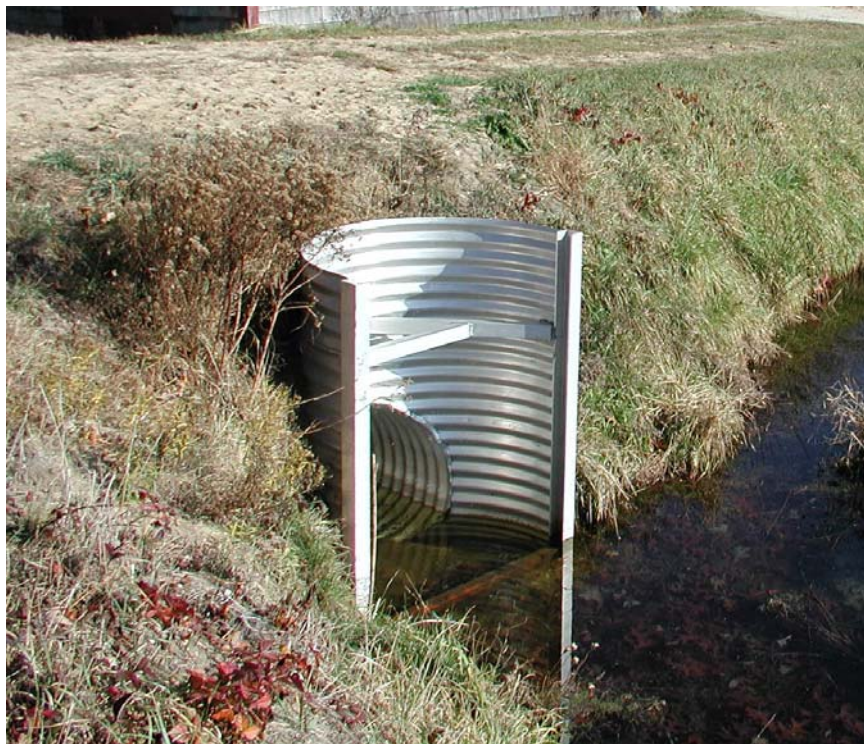
Flax Pond Culvert and fishway

Design	Material	Length (ft)	Inside W (ft)	Outside W (ft)	# of Baffles	Baffle H (ft)	Notch W (ft)	Pool L (ft)	Condition/ Function
Weir pool	Steel with wooden baffles	32	2.6	2.6	2	2	-	32	Excellent Passable

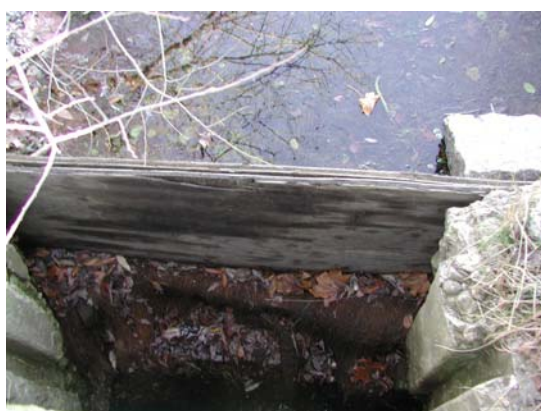
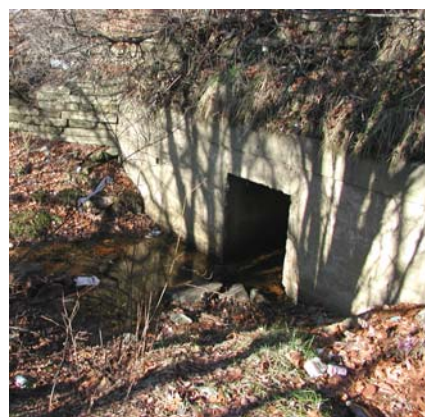
Mill Pond Dam Spillway

Downstream end of culvert from Mill Pond Dam

Design	Material	Length (ft)	Inside W (ft)	Outside W (ft)	# of Baffles	Baffle H (ft)	Notch W (ft)	Pool L (ft)	Condition/Function
Stream baffle	Stone	131.0	Varied (1.0-3.7)	Stream edge	5	Varied (0.3-1.3)	1.0	Varied (13-27)	Poor Not passable

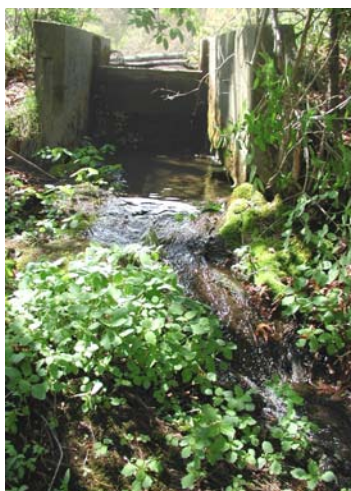
Carriage Shop Road Dam

Design	Material	Length (ft)	Inside W (ft)	Outside W (ft)	# of Baffles	Baffle H (ft)	Notch W (ft)	Pool L (ft)	Condition/ Function
Stream baffle	Concrete and granite	100.0	3.0	Stream edge	6	1.5	0.8	10	Poor Not passable

This is one of two outlet streams from Johns Pond, a 317 acre natural water body. The first obstruction to fish passage is a small dam at Carriage Shop Road. A series of stream baffles once enabled fish to enter the pond but are now badly deteriorated. The second barrier is a control box below Johns Pond which regulates flow from a subsurface outlet in the pond.

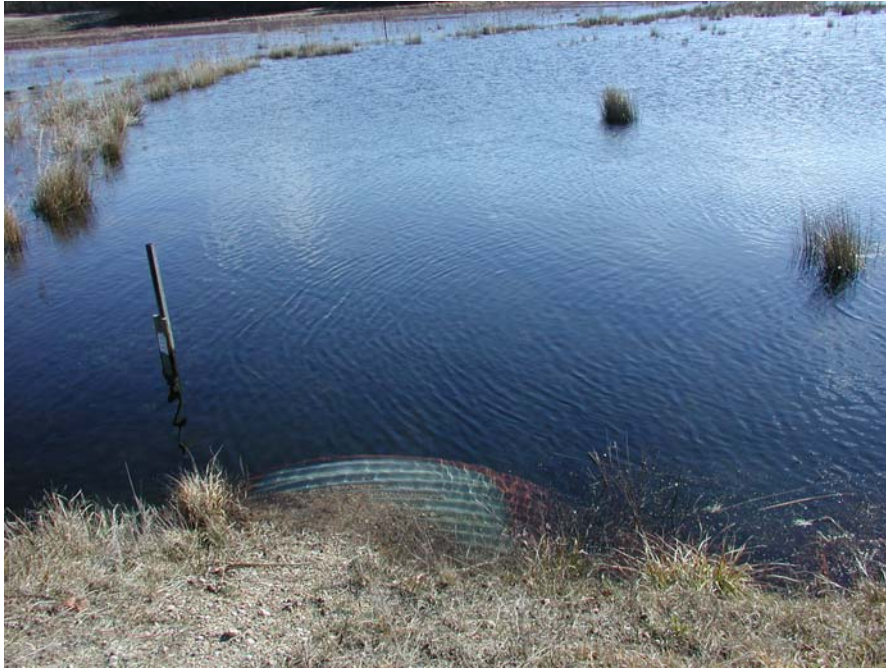
Second Bog Sluice, submerged.

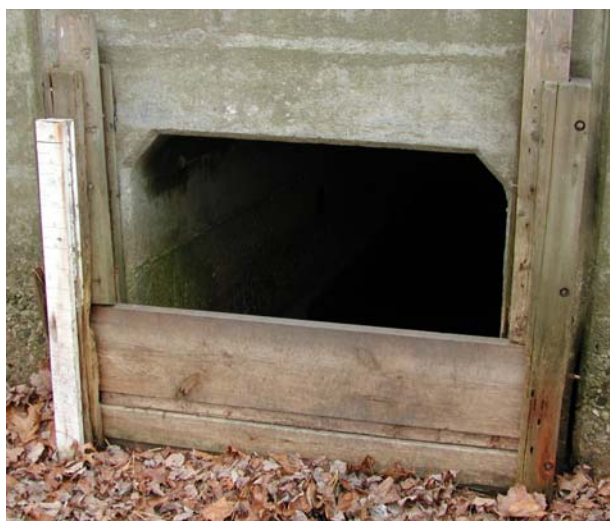
Wequaquet Lake Control Structure/Ladder

Design	Material	Length (ft)	Inside W (ft)	Outside W (ft)	# of Baffles	Baffle H (ft)	Notch W (ft)	Pool L (ft)	Condition/Function
Weir-pool	Concrete	60	3.0	-	2	1.4	-	60	Fair Inefficient passage

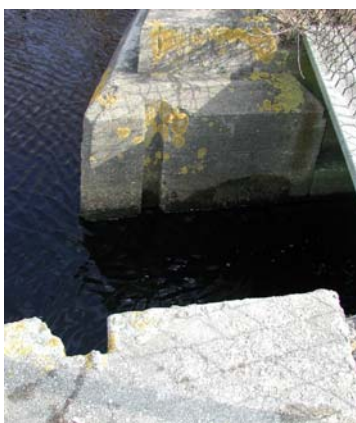
Mill Pond Dam (at Baxter Grist Mill)

Design	Material	Length (ft)	Inside W (ft)	Outside W (ft)	# of Baffles	Baffle H (ft)	Notch W (ft)	Pool L (ft)	Condition/Function
Weir-pool	Concrete with wooden baffles	39.0	3.6	4.9	5	2.0	2.2	6.0	Good Passable

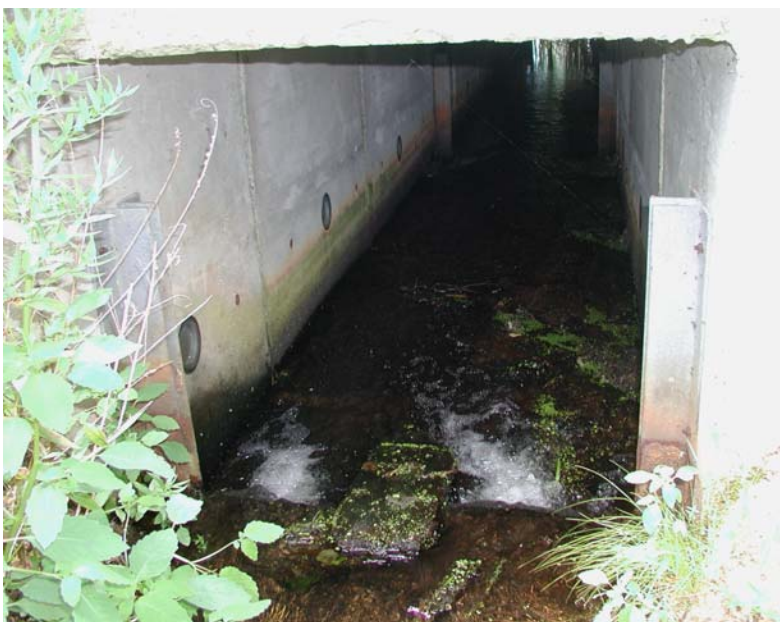
Dam/Ladder above Mill Pond

Design	Material	Length (ft)	Inside W (ft)	Outside W (ft)	# of Baffles	Baffle H (ft)	Notch W (ft)	Pool L (ft)	Condition/Function
Box culvert with baffles	Concrete with metal slots and wooden baffles	49.0	4.0	5.0	1	0.6	-	N/A	Excellent Passable

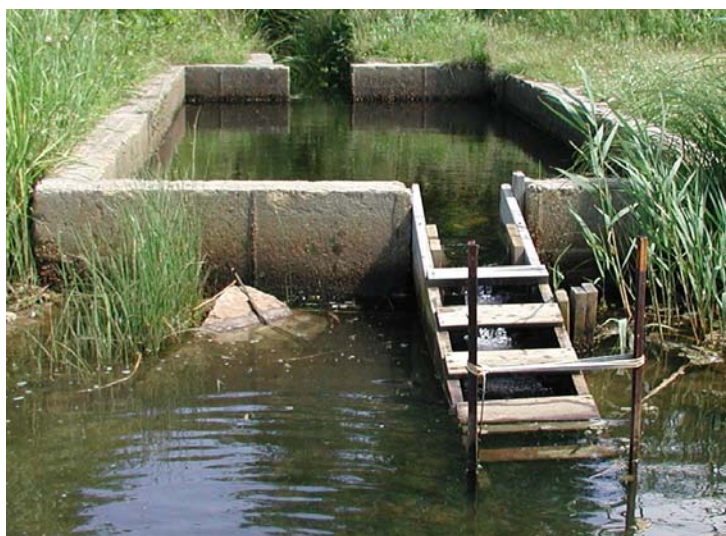
Seine Pond Inlet

Design	Material	Length (ft)	Inside W (ft)	Outside W (ft)	# of Baffles	Baffle H (ft)	Notch W (ft)	Pool L (ft)	Condition/Function
Notched weir-pool	Wood and concrete	7.7	1.2	1.4	3	0.4	0.6	0.8	Good Passable

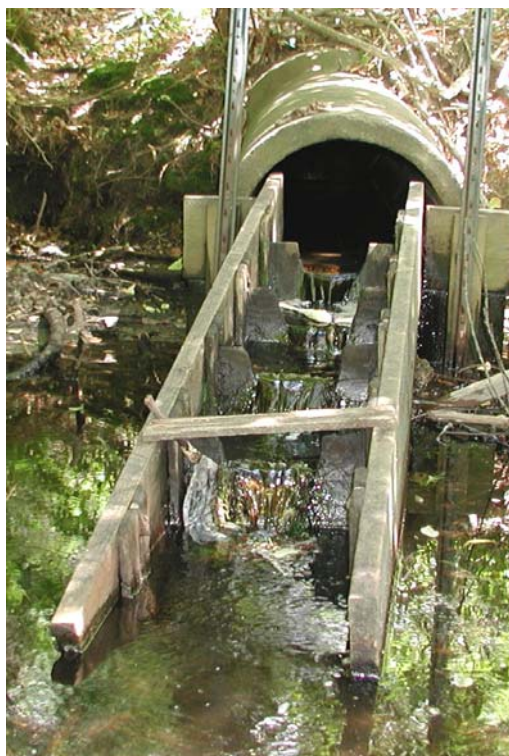
Clear Brook Road Culvert and Ladder

Design	Material	Length (ft)	Inside W (ft)	Outside W (ft)	# of Baffles	Baffle H (ft)	Notch W (ft)	Pool L (ft)	Condition/ Function
Notched weir-pool	Wood	8.0	2.0	2.4	4	0.4	0.7	1.2	Good Inefficient passage

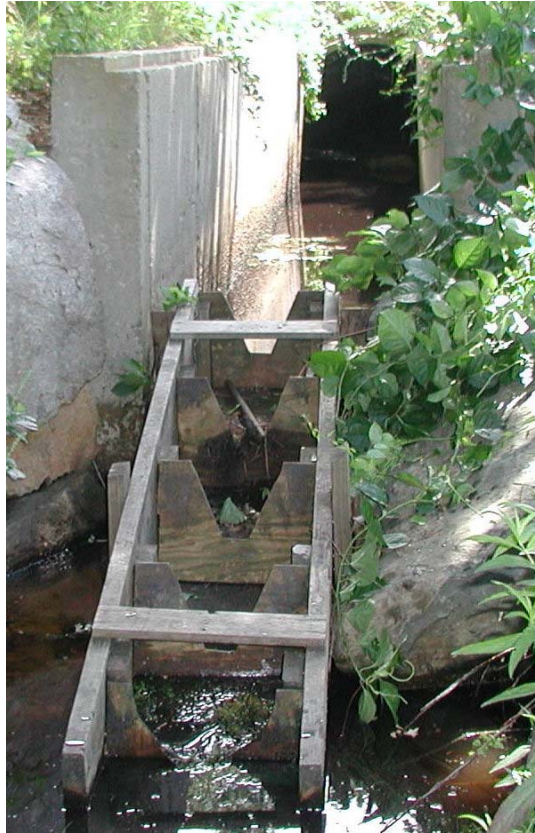
Forest Road Culvert and Ladder

<b>Design</b>	<b>Material</b>	<b>Length (ft)</b>	<b>Inside W (ft)</b>	<b>Outside W (ft)</b>	<b># of Baffles</b>	<b>Baffle H (ft)</b>	<b>Notch W (ft)</b>	<b>Pool L (ft)</b>	<b>Condition/ Function</b>
Notched weir-pool	Wood	8.0	2.0	2.4	5	0.4	0.8	1.2	Good Inefficient passage

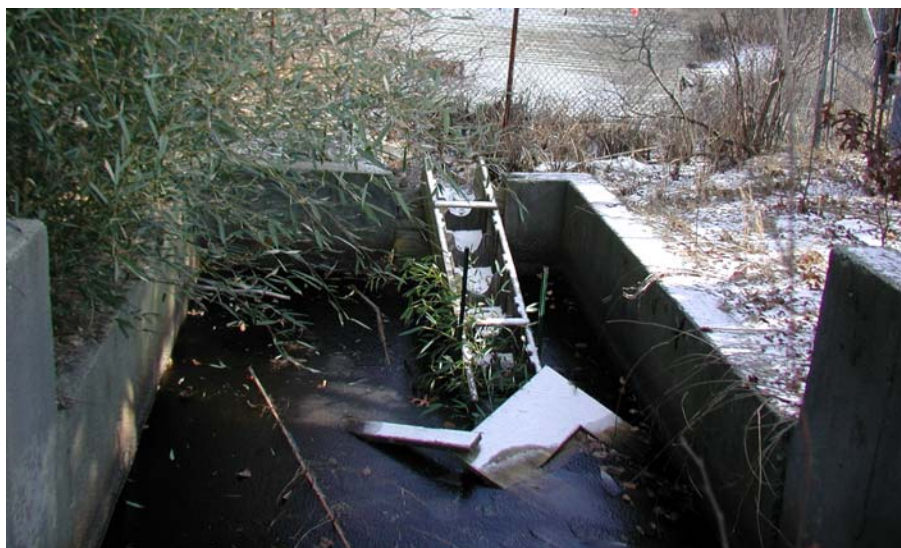
Long Pond Control Structure and Ladder

Design	Material	Length (ft)	Inside W (ft)	Outside W (ft)	# of Baffles	Baffle H (ft)	Notch W (ft)	Pool L (ft)	Condition/Function
Notched weir-pool	Wood	8.0	2.0	2.2	5	0.4	0.6	1.3	Good Inefficient passage

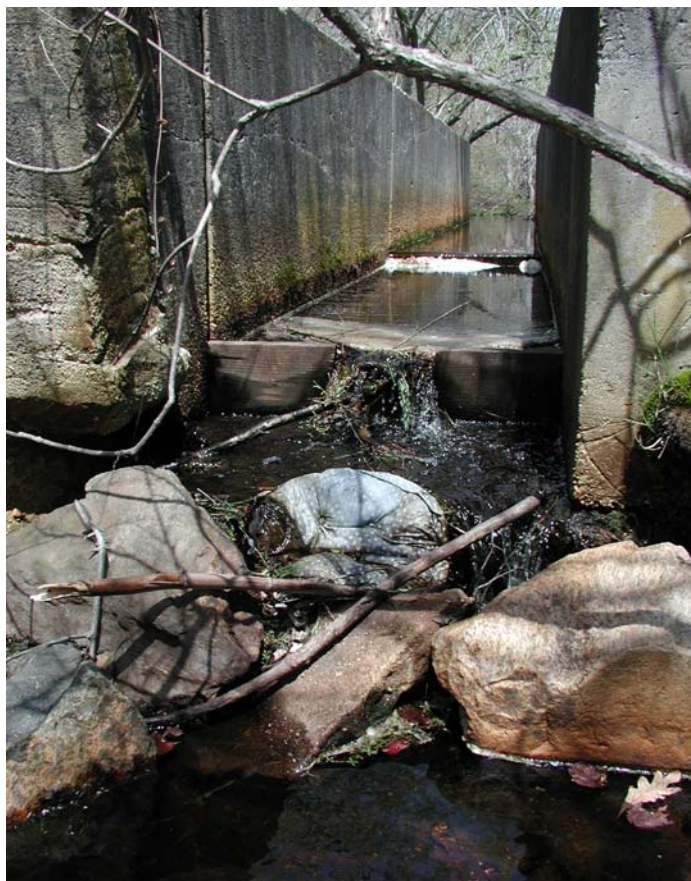
Winslow Gray Road Dam and Ladder

Design	Material	Length (ft)	Inside W (ft)	Outside W (ft)	# of Baffles	Baffle H (ft)	Notch W (ft)	Pool L (ft)	Condition/ Function
Weir-pool	Concrete with wooden baffles	38.0	2.8	4.4	2	0.7	-	11.0	Good Inefficient passage

Plashes Brook is a small tributary to the lower Parkers River. A concrete control structure at Winslow Gray Road forms a 1.9 acre impoundment. Wooden baffles incorporated into the structure create a fishway which allows herring to reach the impoundment. In order to reach the headwater, 44 acre Plashes Pond, fish would have to negotiate a complex system of cranberry bogs with numerous impassable culverts. While access to Plashes Pond is desirable, the difficulty of ensuring passage through the bogs reduces it to a low priority site.

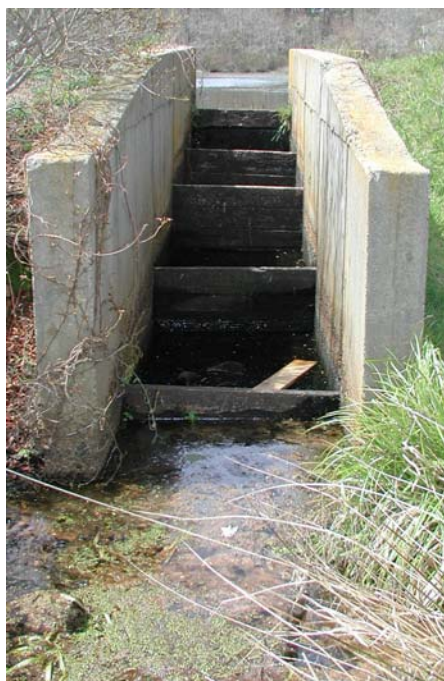
Miss Thachers Pond Dam and Ladder

Design	Material	Length (ft)	Inside W (ft)	Outside W (ft)	# of Baffles	Baffle H (ft)	Notch W (ft)	Pool L (ft)	Condition/ Function
Weir-pool	Concrete with wooden baffles	19.0	2.8	4.0	5	Varied (0.8-2.6)	-	3.8	Good Inefficient passage

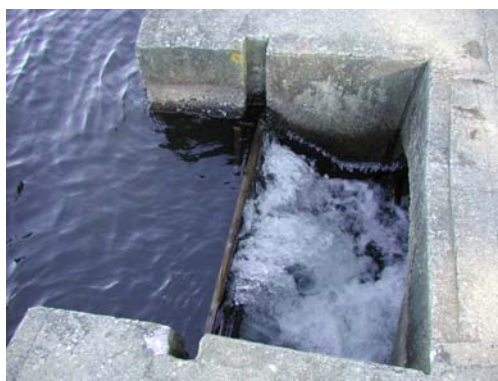
Spillway at West Reservoir Dam

Design	Material	Length (ft)	Inside W (ft)	Outside W (ft)	# of Baffles	Baffle H (ft)	Notch W (ft)	Pool L (ft)	Condition/Function
Weir-pool	Concrete and metal with wooden baffles	88.0	4.7	6.7	10	Varied (2.4 - 4.4)	-	Varied (6 - 16)	Good Passable

This system provides 1119 acres of spawning habitat in its three headwater ponds and downstream impoundments. An efficient weir-pool fishway provides access at West Reservoir dam and a second weir-pool ladder at Hinckleys Pond allows fish to reach that habitat. From Hinckleys Pond fish have unimpeded access to Seymours and Long Ponds providing flow is sufficient. The primary limiting factor to production in this system is the frequent low water conditions that may prevent juvenile herring from making a successful downstream migration. The installation of outlet retention structures and frequent dredging of deposited materials from the outlets of Seymours and Long Ponds would improve this situation.

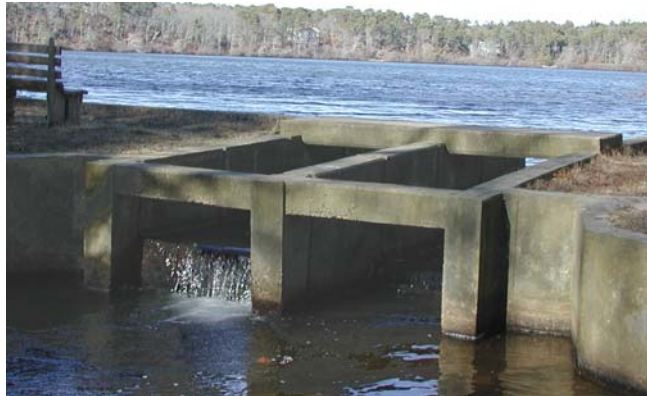
Hinckleys Pond Control Structure and Ladder

Design	Material	Length (ft)	Inside W (ft)	Outside W (ft)	# of Baffles	Baffle H (ft)	Notch W (ft)	Pool L (ft)	Condition/Function
Weir-pool	Concrete with wooden baffles	18.0	4.0	6.0	5	1.2	-	8.0	Excellent Passable

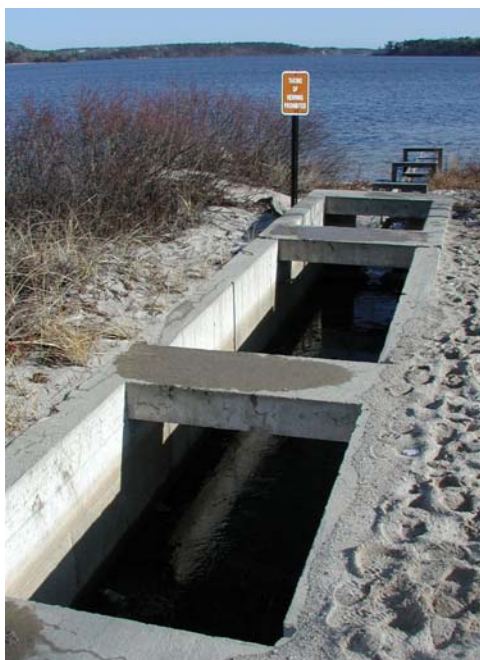
Long Pond Control Structure/Ladder

Design	Material	Length (ft)	Inside W (ft)	Outside W (ft)	# of Baffles	Baffle H (ft)	Notch W (ft)	Pool L (ft)	Condition/Function
Weir-pool	Concrete and wood	100	Varied (1.6 and 4.0)	Varied (1.8 and 5.4)	2	Varied (0.9 and 1.2)	-	25	Good Passable

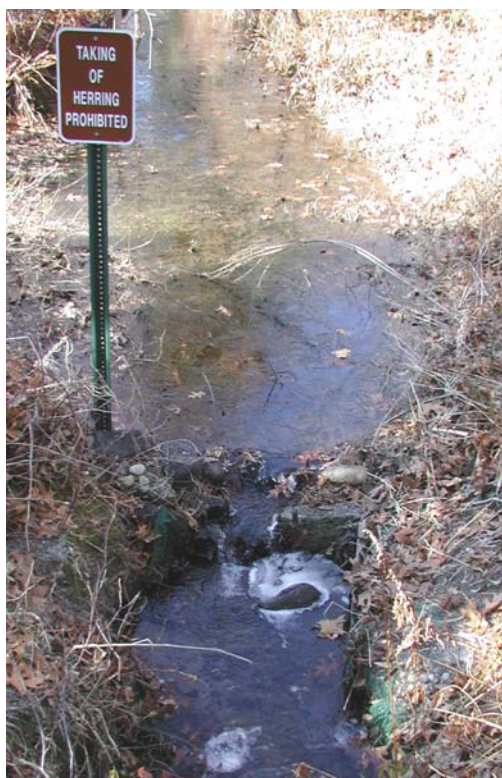
First Stream Baffle leading to Skinequit Pond

Design	Material	Length (ft)	Inside W (ft)	Outside W (ft)	# of Baffles	Baffle H (ft)	Notch W (ft)	Pool L (ft)	Condition/Function
Stream baffle	Stone	1075	Varied (3 - 5)	Varied (3 - 5)	4	Varied (0.4 - 1.0)	Varied 1.3-3.0	Varied (50 - 300)	Poor Inefficient passage

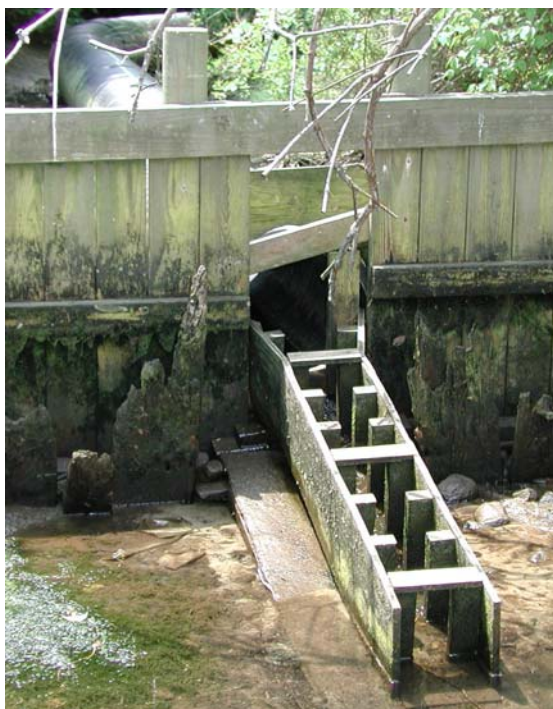
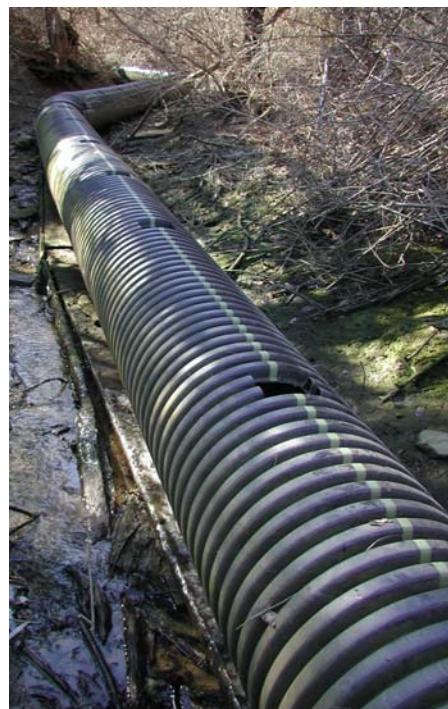
Vertical Slot at Stillwater Pond Elevation Change

Notched Weir-pool at Stillwater Pond Elevation Change

Design	Material	Length (ft)	Inside W (ft)	Outside W (ft)	# of Baffles	Baffle H (ft)	Notch W (ft)	Pool L (ft)	Condition/Function
Vertical slot	Wood	8.0	1.0	1.0	8	1.0	0.3	1.0	Poor Inefficient passage
Notched weir-pool	Corrugated plastic pipe with wooden baffles	147.0	1.4	1.4	28	0.8	0.5	5.0	Good Passable

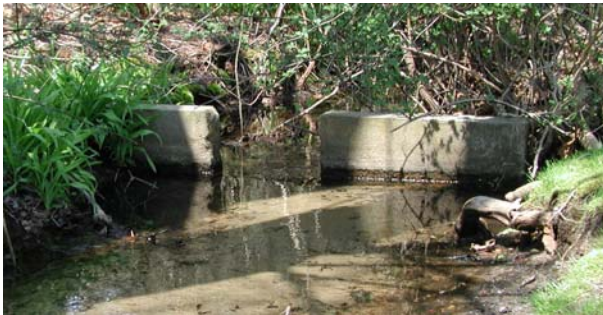
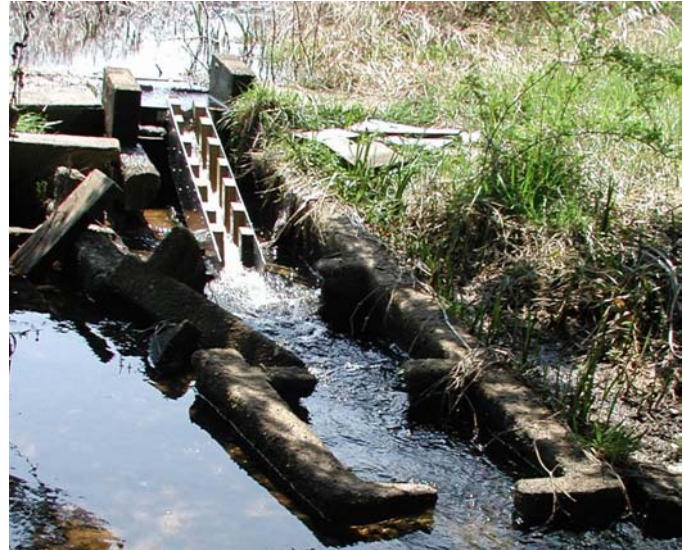
Stream Baffles below Stillwater Lake

Ladder at Stillwater Pond

Design	Material	Length (ft)	Inside W (ft)	Outside W (ft)	# of Baffles	Baffle H (ft)	Notch W (ft)	Pool L (ft)	Condition/Function
Stream baffle	Concrete	274 (stream width)	8.0	8.0	4	1.2	Varied (0.6 - 1.8)	Varied (48 - 100)	Fair Inefficient passage
Vertical slot	Aluminum, wood and concrete	11.0	Varied (0.5 and 1.3)	Varied (1.9)	10	Varied (0.6)	-	-	Good Inefficient passage

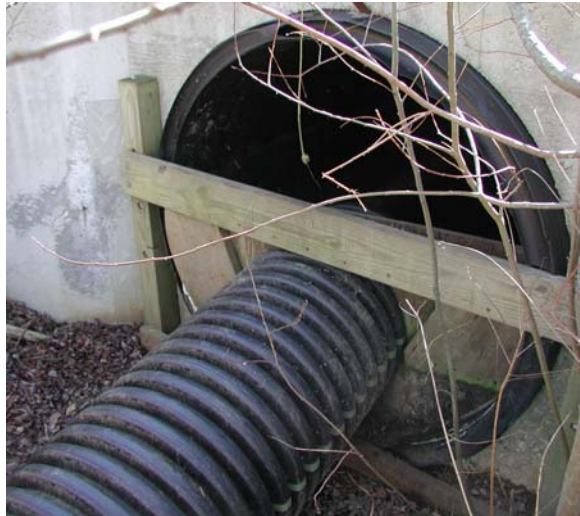
Lovers Lake Culvert

Design	Material	Length (ft)	Inside W (ft)	Outside W (ft)	# of Baffles	Baffle H (ft)	Notch W (ft)	Pool L (ft)	Condition/Function
Notched weir-pool	Corrugated plastic with wooden baffles	60.0	1.4	2.0	6	0.3	0.7	6.0	Good Passable

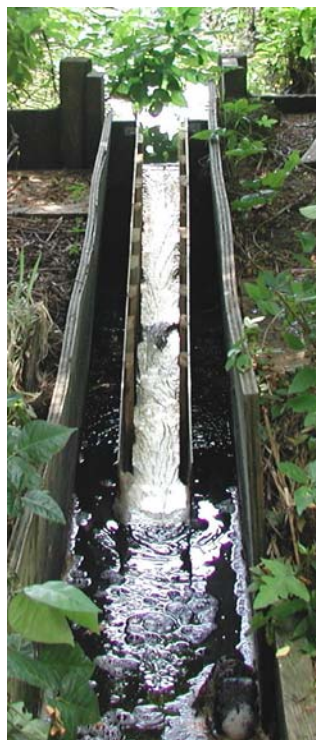
Fishway at Lovers Lake Outlet

<b>Design</b>	<b>Material</b>	<b>Length (ft)</b>	<b>Inside W (ft)</b>	<b>Outside W (ft)</b>	<b># of Baffles</b>	<b>Baffle H (ft)</b>	<b>Notch W (ft)</b>	<b>Pool L (ft)</b>	<b>Condition/Function</b>
Vertical slot	Wood and aluminum	4.6	0.5	0.5	9	0.5	0.3	0.5	Fair Passable

These ponds drain into Ryders Cove, Chatham by way of an unnamed stream. The first obstruction occurs at the head of the tide where a wooden vertical slot fishway allows herring to enter the stream over a wide range of tidal conditions. The second fishway overcomes an elevation change and control structure at Stillwater Pond. The unique design of this ladder, developed by the local herring warden, deserves mention. It consists of 147 feet of 2 foot diameter, corrugated plastic pipe which has been fitted internally with wooden notched baffles. This appears to function adequately for passage over low gradient elevation changes. A 60 foot length of this type of fishway allows fish to enter the third obstruction, a culvert below Lovers Lake. A wooden vertical slot fishway enables fish to overcome the final obstruction, the outlet control structure at Lovers Lake. The 55 acres of habitat in these ponds should support a productive fishery providing the fish passage facilities are well maintained.

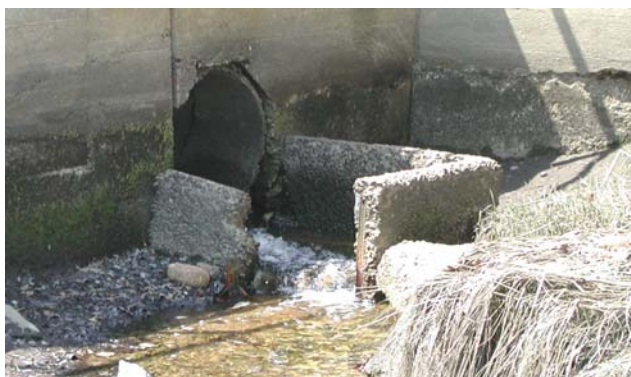
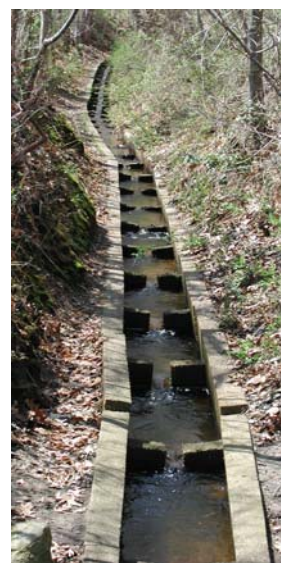
Entrance to Pilgrim Lake Ladder

Ladder below Pilgrim Lake

Design	Material	Length (ft)	Inside W (ft)	Outside W (ft)	# of Baffles	Baffle H (ft)	Notch W (ft)	Pool L (ft)	Condition/Function
Notched weir-pool	Concrete	415.0	1.7	2.5	55	1.2	0.4	7.0	Fair Inefficient passage

Two fishways provide passage to 39 acre Pilgrim Lake. The first, which overcomes an elevation change, is a concrete notched weir-pool structure which is functional but in a state of deterioration. The second, a concrete and wood weir-pool design is passable with proper flow regulation. In order to maintain this population the first ladder will require replacement in the near future.

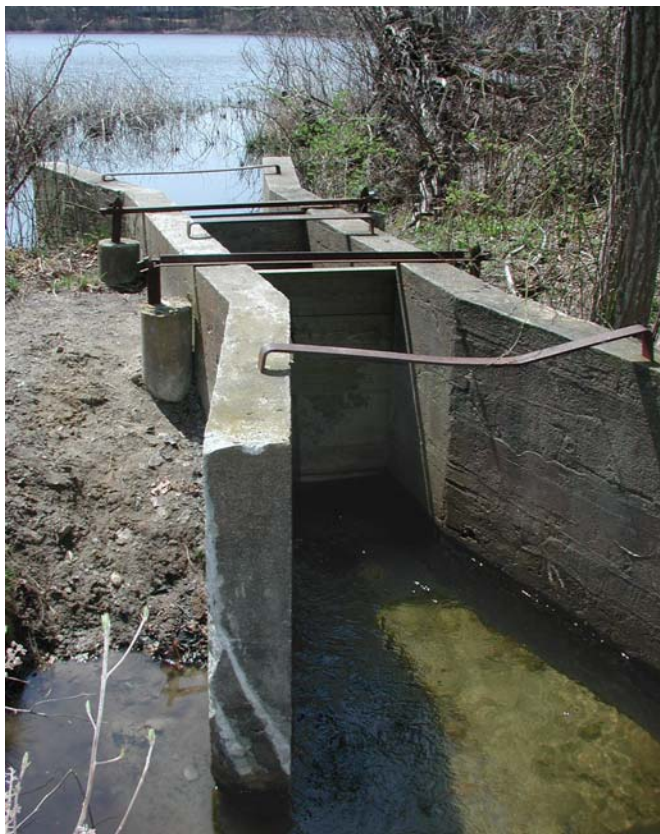
Pilgrim Lake Control Structure/Ladder

Design	Material	Length (ft)	Inside W (ft)	Outside W (ft)	# of Baffles	Baffle H (ft)	Notch W (ft)	Pool L (ft)	Condition/ Function
Notched weir-pool	Concrete with wooden baffles	4.0	1.9	3.3	2	0.7	0.6	4.0	Fair Inefficient passage

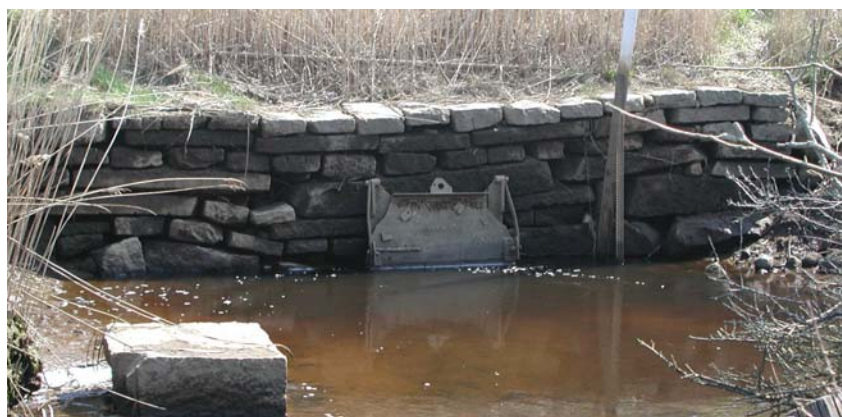
Tide Gate at Route 6A

This tidal stream nearly bisects the upper arm of Cape Cod. The salinity in its upper reaches is reduced by a tide gate. The fish passage problems caused by the tide gate and the lack of a significant amount of habitat above it make this stream a low priority for anadromous fish work.

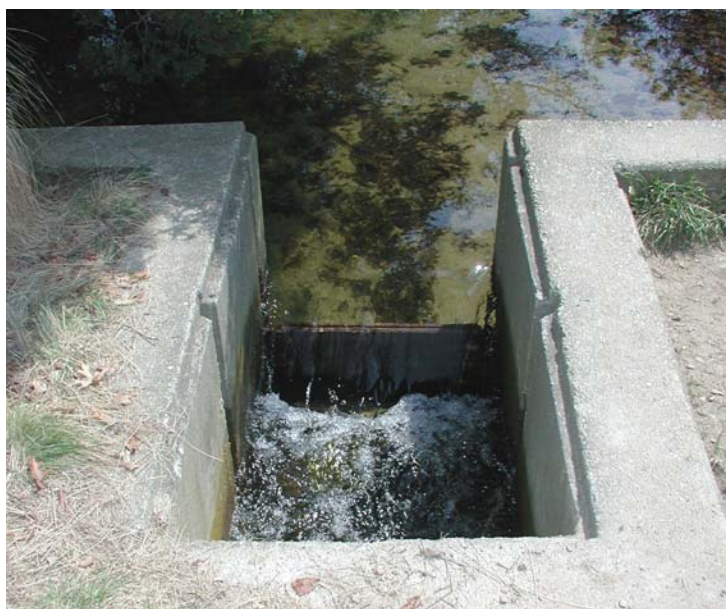
Herring Brook Road Control Structure/Ladder

Design	Material	Length (ft)	Inside W (ft)	Outside W (ft)	# of Baffles	Baffle H (ft)	Notch W (ft)	Pool L (ft)	Condition/Function
Weir-pool	Concrete with wooden baffles	5.4	2.9	4.6	1	2.2	-	-	Good Passable

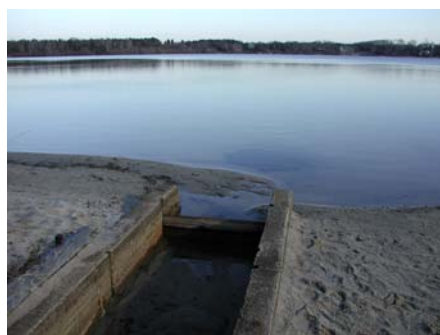
Herring Pond Control Structure

Design	Material	Length (ft)	Inside W (ft)	Outside W (ft)	# of Baffles	Baffle H (ft)	Notch W (ft)	Pool L (ft)	Condition/Function
Stream baffle	Wood	86.0	8.6	8.6	2	2.0	1.0	Varied (35.0 and 51.0)	Good Passable
Notched weir-pool	Concrete with wooden baffles	66.0	3.4	4.8	3	2.8	-	Varied (14.2-24.7)	Good Passable

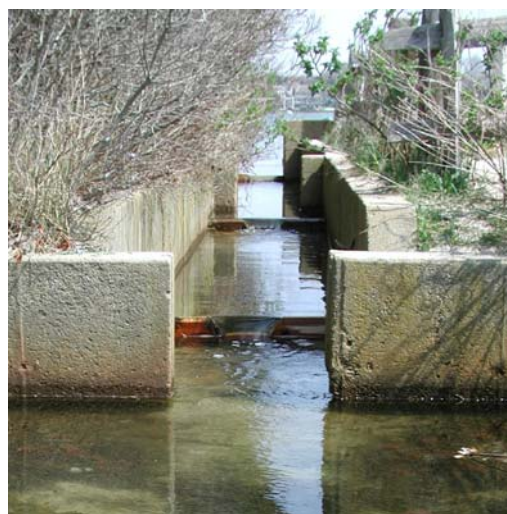
Notched Weir-pool at Herring Pond

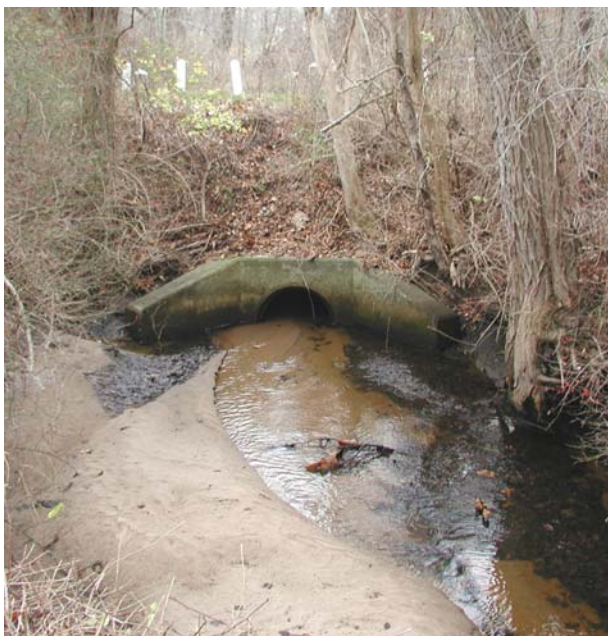
Rock Harbor Road Culvert

River Mile	Type	Material	Spillway W (ft)	Spillway H (ft)	Impoundment Acreage	Year Built	Owner	GPS
1.4	Culvert, circular	Concrete	3.0	0.0	0.0	-	-	41° 47' 50.100" N 69° 59' 29.700" W

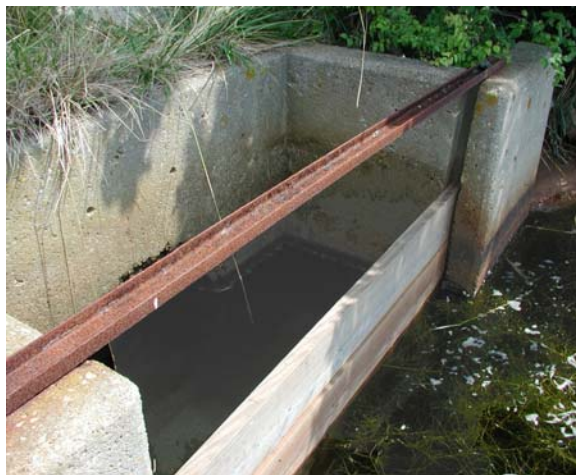
Cedar Pond Control Structure

River Mile	Type	Material	Spillway W (ft)	Spillway H (ft)	Impoundment Acreage	Year Built	Owner	GPS
1.5	Dam control structure	Concrete with wooden boards	5.0	3.3	17.0	-	-	41° 47' 46.749" N 69° 59' 29.533" W

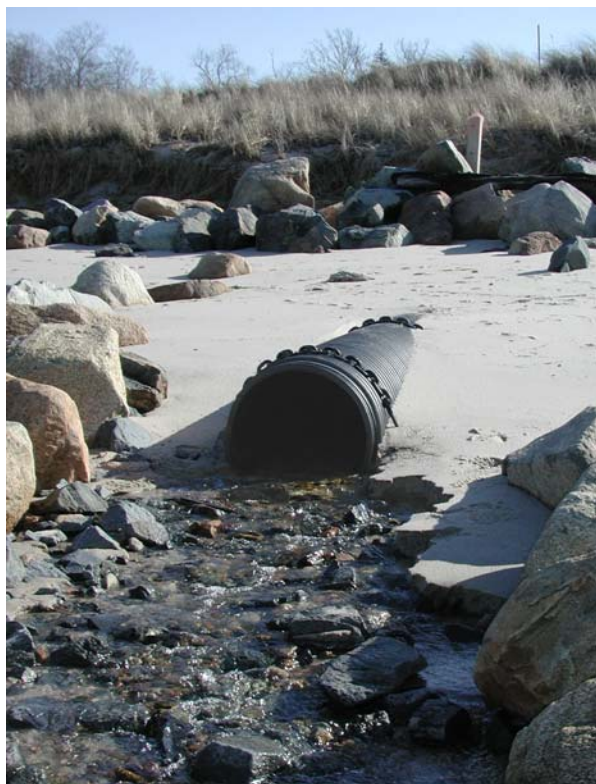
Cobbs Pond Culvert

River Mile	Type	Material	Spillway W (ft)	Spillway H (ft)	Impoundment Acreage	Year Built	Owner	GPS
0.0	Culvert, circular	Corrugated metal	3.0	0.0	21.0	-	-	41° 46' 06.881" N 70° 05' 04.489" W

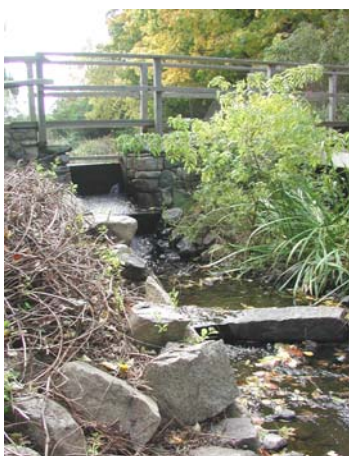
Lower Mill Pond Dam

River Mile	Type	Material	Spillway W (ft)	Spillway H (ft)	Impoundment Acreage	Year Built	Owner	GPS
1.8	Dam and elevation change	Concrete with wooden boards	1.5	8.8	40.0	1920	Town of Brewster	41° 44' 40.473" N 70° 06' 45.011" W

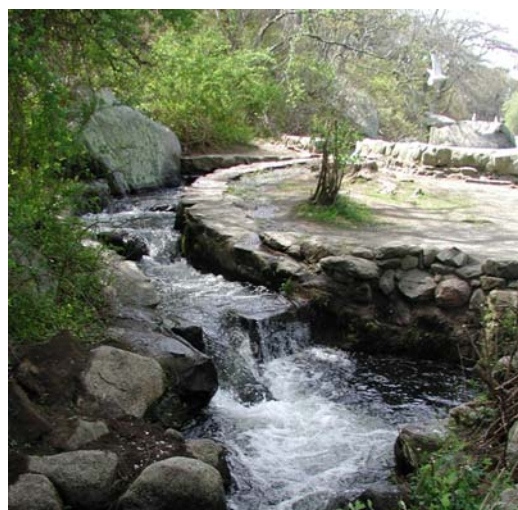
Lower Mill Pond Ladder (upstream side of Stony Brook Road)

Design	Material	Length (ft)	Inside W (ft)	Outside W (ft)	# of Baffles	Baffle H (ft)	Notch W (ft)	Pool L (ft)	Condition/Function
Notched weir-pool	Concrete and stone	490.0	Varied (3 - 4)	Varied (3 - 4)	27	Varied (0.4 - 1.2)	Varied (1)	Varied (8 - 25)	Good Passable

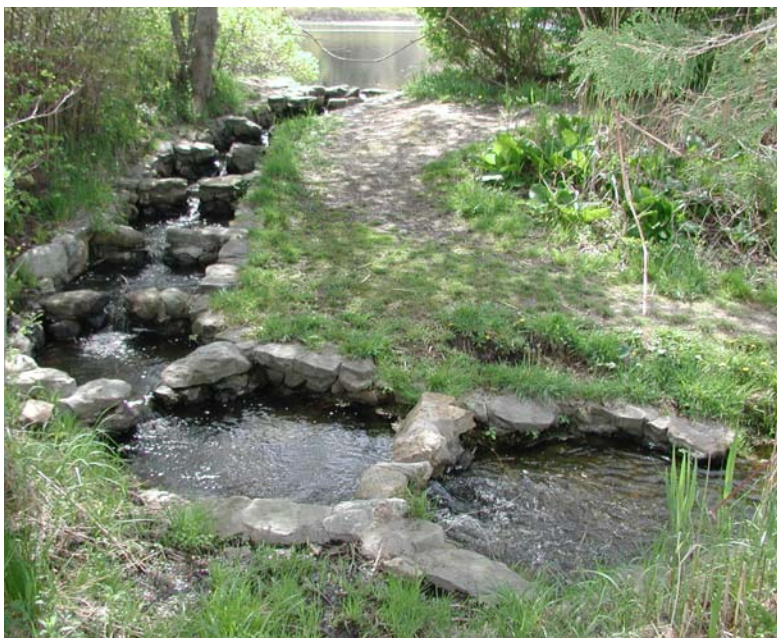
Airline Road Fishway

Design	Material	Length (ft)	Inside W (ft)	Outside W (ft)	# of Baffles	Baffle H (ft)	Notch W (ft)	Pool L (ft)	Condition/Function
Notched weir-pool	Stone	55.0	3.3	4.0	11	2.3	0.5	Varied (4 – 15)	Good Passable

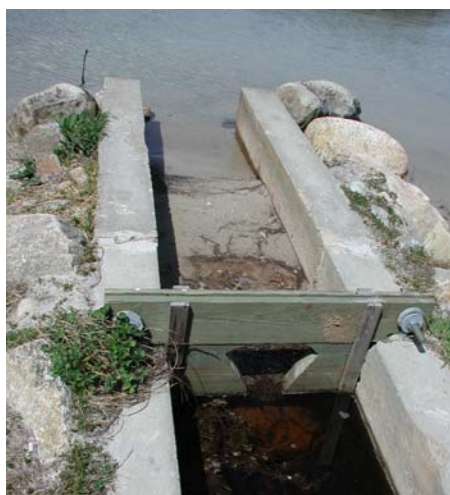
Scargo Lake Outlet

Design	Material	Length (ft)	Inside W (ft)	Outside W (ft)	# of Baffles	Baffle H (ft)	Notch W (ft)	Pool L (ft)	Condition/Function
Notched weir-pool	Concrete with wooden baffles	45.0	2.6	4.0	3	Varied (1.2-1.6)	0.3	Varied (7 – 15)	Poor Inefficient passage

This stream flows from 53 acre Scargo Lake to Cape Cod Bay. The system's most pressing fish passage problem is the shoaling of the pond's outlet. The town has attempted to overcome this with the installation of a concrete outlet retention structure which has provided a measure of relief. In addition, the culvert under Route 6A is deteriorating and may cause a blockage to migration. Additional shoaling of the creek and road culverts may impact this run through periodic blockages. Efforts should be made to deepen and stabilize the channel and improve passage through the street culverts.

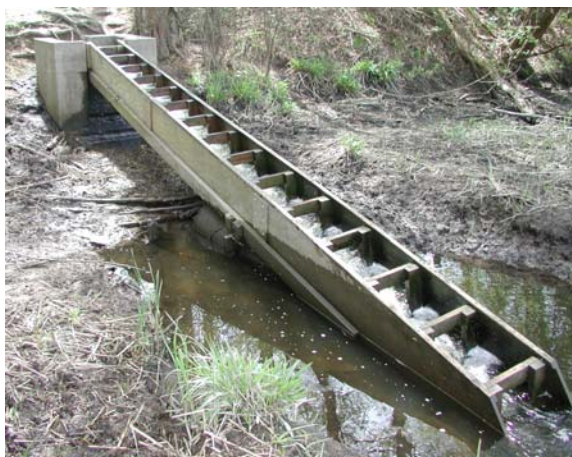
Ladder at Matthews Pond Outlet

Design	Material	Length (ft)	Inside W (ft)	Outside W (ft)	# of Baffles	Baffle H (ft)	Notch W (ft)	Pool L (ft)	Condition/Function
Denil	Wood	24.0	1.3	1.4	15	1.5	-	-	Good Passable

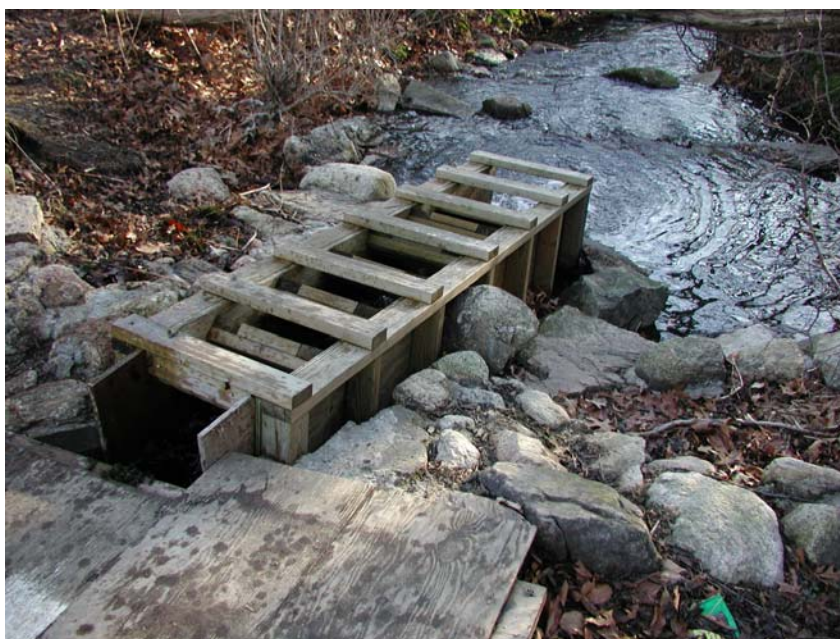
Mill Pond Dam and Ladder

Design	Material	Length (ft)	Inside W (ft)	Outside W (ft)	# of Baffles	Baffle H (ft)	Notch W (ft)	Pool L (ft)	Condition/Function
Denil	Wood	8.0	1.3	2.0	8	Varied (2.0-2.5)	-	-	Excellent Passable

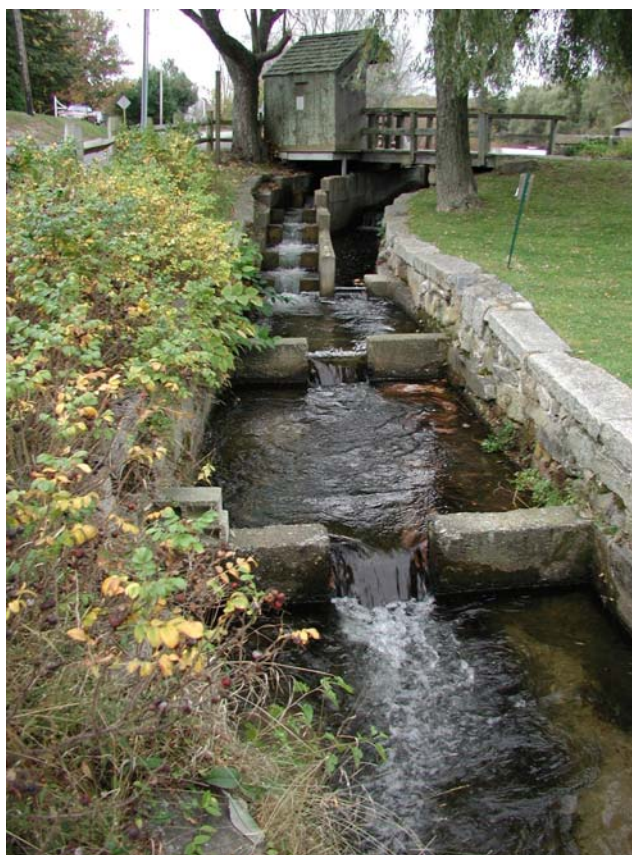
Sandwich Grist Mill Dam and Ladder

Design	Material	Length (ft)	Inside W (ft)	Outside W (ft)	# of Baffles	Baffle H (ft)	Notch W (ft)	Pool L (ft)	Condition/Function
Notched weir-pool	Concrete	40.8	3.0	4.2	10	Varied (1.8-4.7)	1.3	Varied (4.9-12.2)	Good Passable

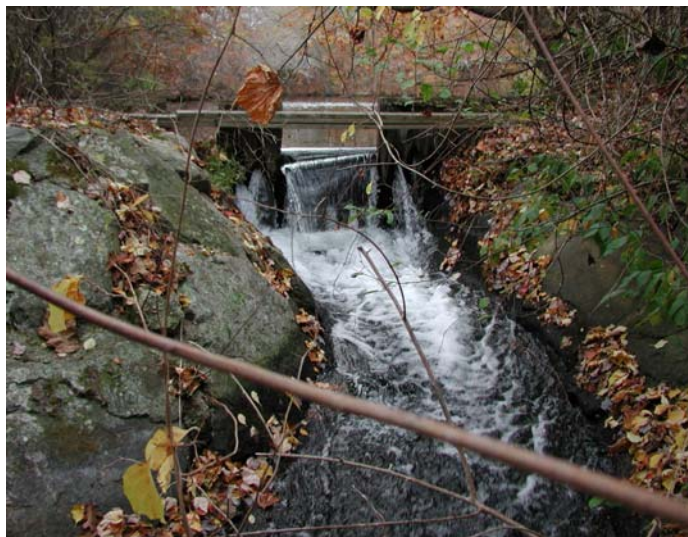
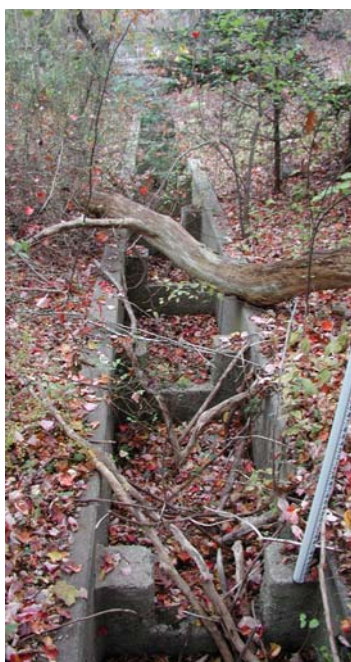
Upper Shawme Fishway

Design	Material	Length (ft)	Inside W (ft)	Outside W (ft)	# of Baffles	Baffle H (ft)	Notch W (ft)	Pool L (ft)	Condition/ Function
Notched weir-pool	Concrete	71.9	3.0	4.3	11	1.1	1.6	7.0	Poor Not passable

Mill Creek is largely a tidal stream that drains Upper and Lower Shawme Ponds. A fishway leading into 24.1 acre Lower Shawme Pond was reconstructed by DMF in 1993 and currently provides adequate passage. A fishway that formerly connected the two ponds has been bypassed and the upper pond is inaccessible. The dam at Upper Shawme Pond has been designated unsafe and is being considered for replacement. A functional fishway should be incorporated into a design for a new dam. This stream has historically supported a small American shad run in its lower reaches.
