**Massachusetts Division of Marine Fisheries  
Technical Report TR-16**

## **A Survey of Anadromous Fish Passage in Coastal Massachusetts**

### **Part 2. Cape Cod and the Islands**

May 2004

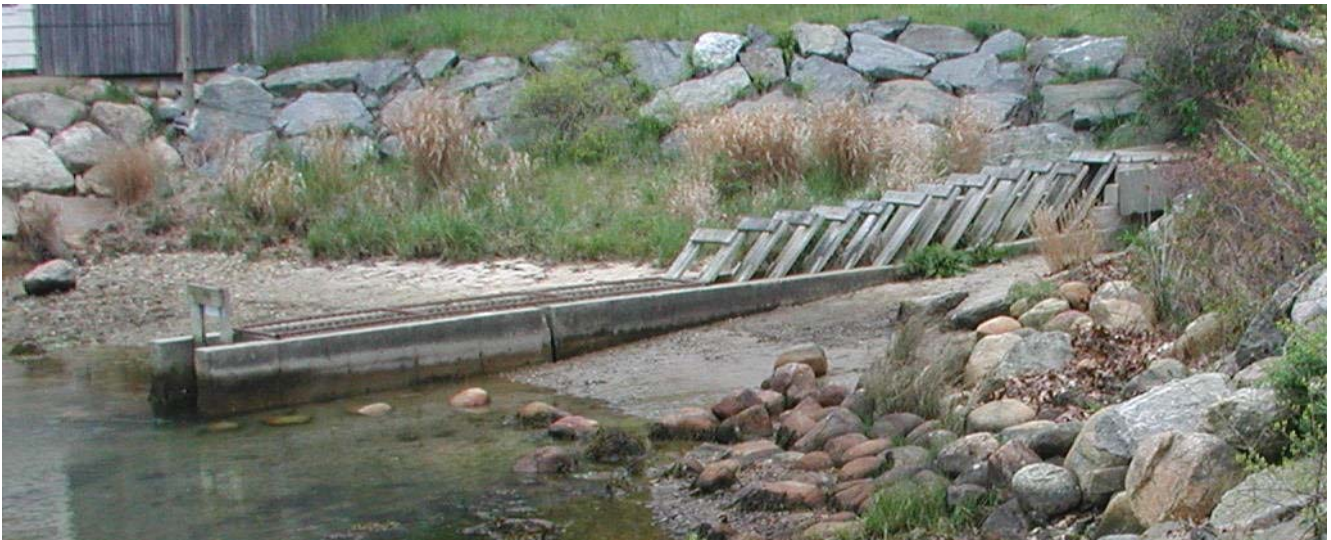
Richard Madieras Ladder

Design	Material	Length (ft)	Inside W (ft)	Outside W (ft)	# of Baffles	Baffle H (ft)	Notch W (ft)	Pool L (ft)	Condition/ Function
Denil & notched weir Pool	Concrete with wooden baffles	75.3	2.1	3.5	14	3.3	1.1	13.0	Good Passable

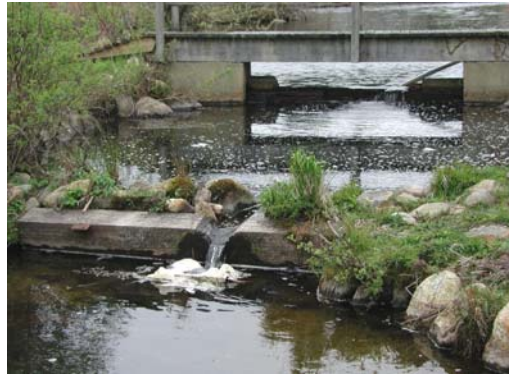
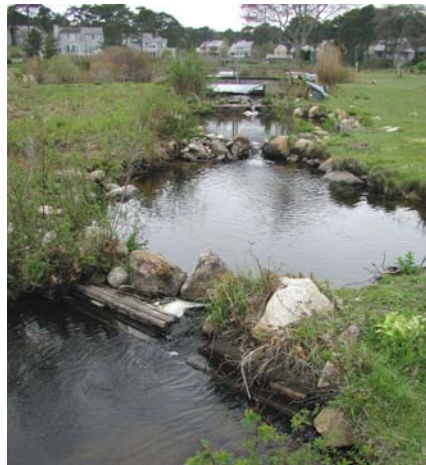
Fishway at Sengekontacket Development

Design	Material	Length (ft)	Inside W (ft)	Outside W (ft)	# of Baffles	Baffle H (ft)	Notch W (ft)	Pool L (ft)	Condition/Function
Stream baffle	Stones and wood	120	Varied (3-10)	Stream walls	6	Varied (0.5-1.3)	Varied (0.3-4)	Varied (8 – 35)	Good Inefficient passage

A small impoundment has recently been created on a stream that drains into Sengekontacket Pond. Baffles have been incorporated into this short stream making access to the potential spawning grounds possible and there has been local interest in developing a fishery. It will probably be necessary to stock the impoundment with adult herring to insure a stock that is imprinted on the site. Because of the small size of the pond and lack of public access, it is not recommended that DMF commit its resources to this project.

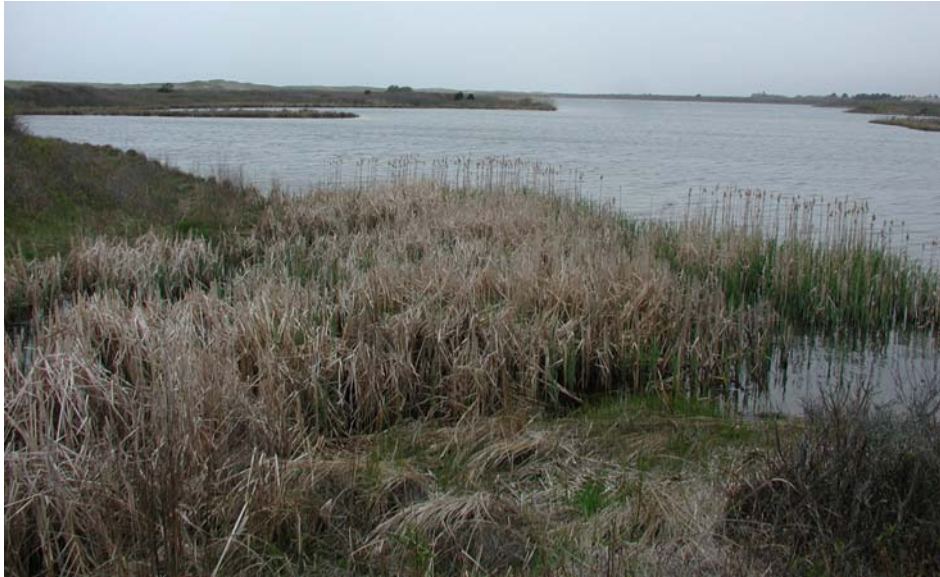
Mattakeset Herring Creek

This long artificial ditch, excavated in 1889, connected Edgartown Great Pond, an 1157 acre salt pond, to Katama Bay by way of Crackatuxet Cove. This access to the Great Pond enabled the establishment of a productive, private alewife fishery. In more recent years the connection between Crackatuxet Cove and Edgartown Great Pond has filled in and, with no passage available and little flow down the creek, the run no longer exists.

The Town of Edgartown with the cooperation of state and Federal agencies and NGOs has proposed to reestablish the connection with a control structure that will allow regulation of salinities within Crackatuxet Cove and provide restored spawning habitat in this 38 acre pond. This in combination with the extended opening of Edgartown Great Pond and dredging of the approach from Katama Bay should allow a new population to become established providing salinities in pond can be kept within an acceptable range for spawning and survival.

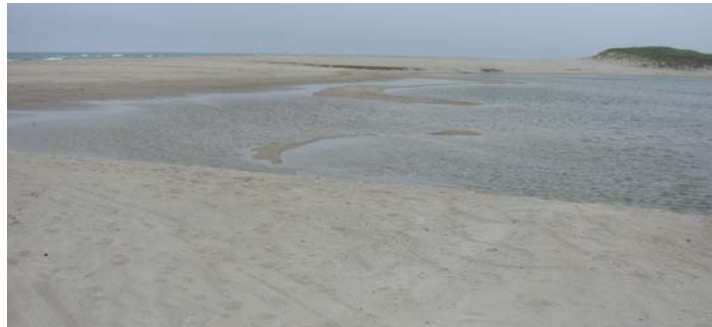
Barrier Beach at Edgartown Great Pond

This large salt pond is opened to the sea annually in order to maintain salinity for shellfish propagation. Salinities are low enough to allow some river herring reproduction. How the proposed extended opening of the outlet to the sea for the purpose of improved shellfish production will affect this population is unknown. A restored population in Crackatuxet Cove, however, should offset any reduction in size brought on by increased salinities in the Great Pond.

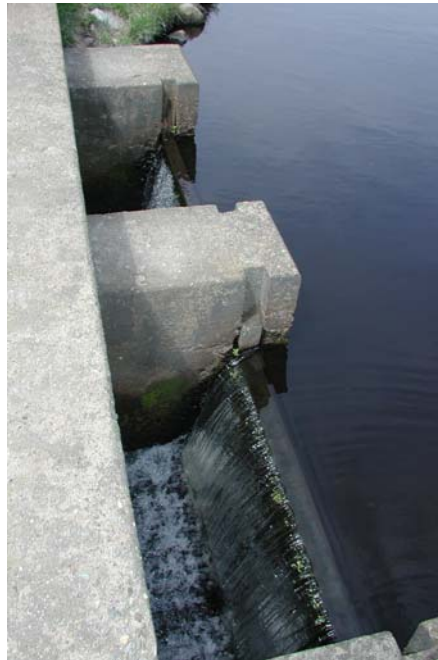
Spillway at Old Millpond Dam

<b>River Mile</b>	<b>Type</b>	<b>Material</b>	<b>Spillway W (ft)</b>	<b>Spillway H (ft)</b>	<b>Impoundment Acreage</b>	<b>Year Built</b>	<b>Owner</b>	<b>GPS</b>
0.4	Dam	Concrete with wooden boards	10.0	2.0	2.0	1890	Town of West Tisbury	41° 22' 58.109" N 70° 40' 17.500" W

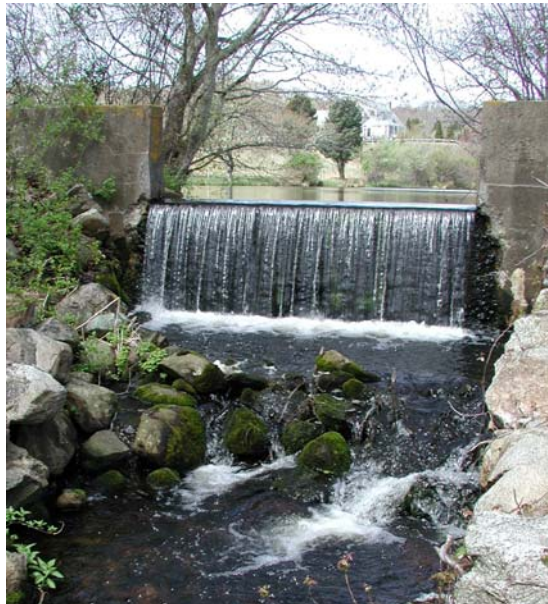
Looks Pond Dam

<b>River Mile</b>	<b>Type</b>	<b>Material</b>	<b>Spillway W (ft)</b>	<b>Spillway H (ft)</b>	<b>Impoundment Acreage</b>	<b>Year Built</b>	<b>Owner</b>	<b>GPS</b>
0.6	Dam	Concrete and stone	10.0	5.6	4.6	-	Private	41° 22' 40.814" N 70° 40' 44.601" W

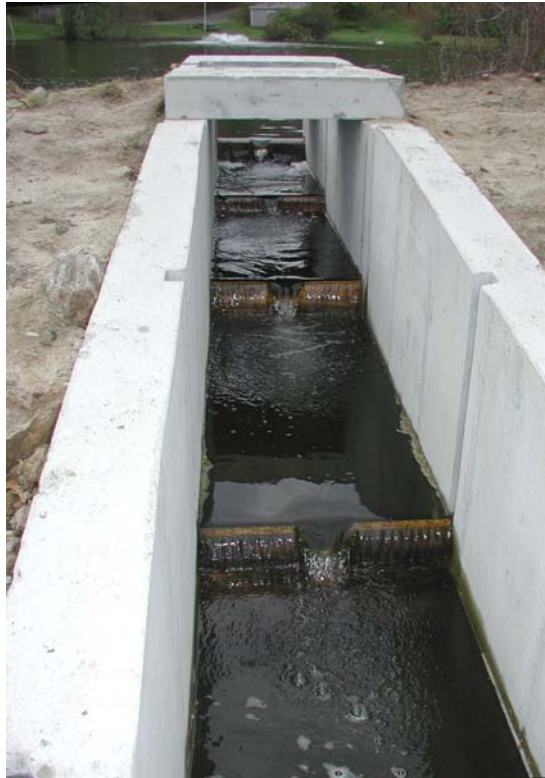
Lake Tashmoo Control Structure/Ladder

Design	Material	Length (ft)	Inside W (ft)	Outside W (ft)	# of Baffles	Baffle H (ft)	Notch W (ft)	Pool L (ft)	Condition/Function
Notched weir-pool	Concrete with wooden baffles	49.4	2.5	2.8	7	Varied (3.8)	0.6	6	Excellent Passable

Lake Tashmoo is a large salt pond which has a 1.3 acre freshwater impoundment at its head. In 2001, a fishway was designed by DMF and installed by the Town of Tisbury in order to provide passage to the impoundment. Since a small river herring spawning population already existed in the upper reaches of the salt pond, fish were observed using the new structure in the spring of 2002. It is not known if this new access to such a small spawning area will have any effect on the total population size of the system.
