## WATER TANK NOTES

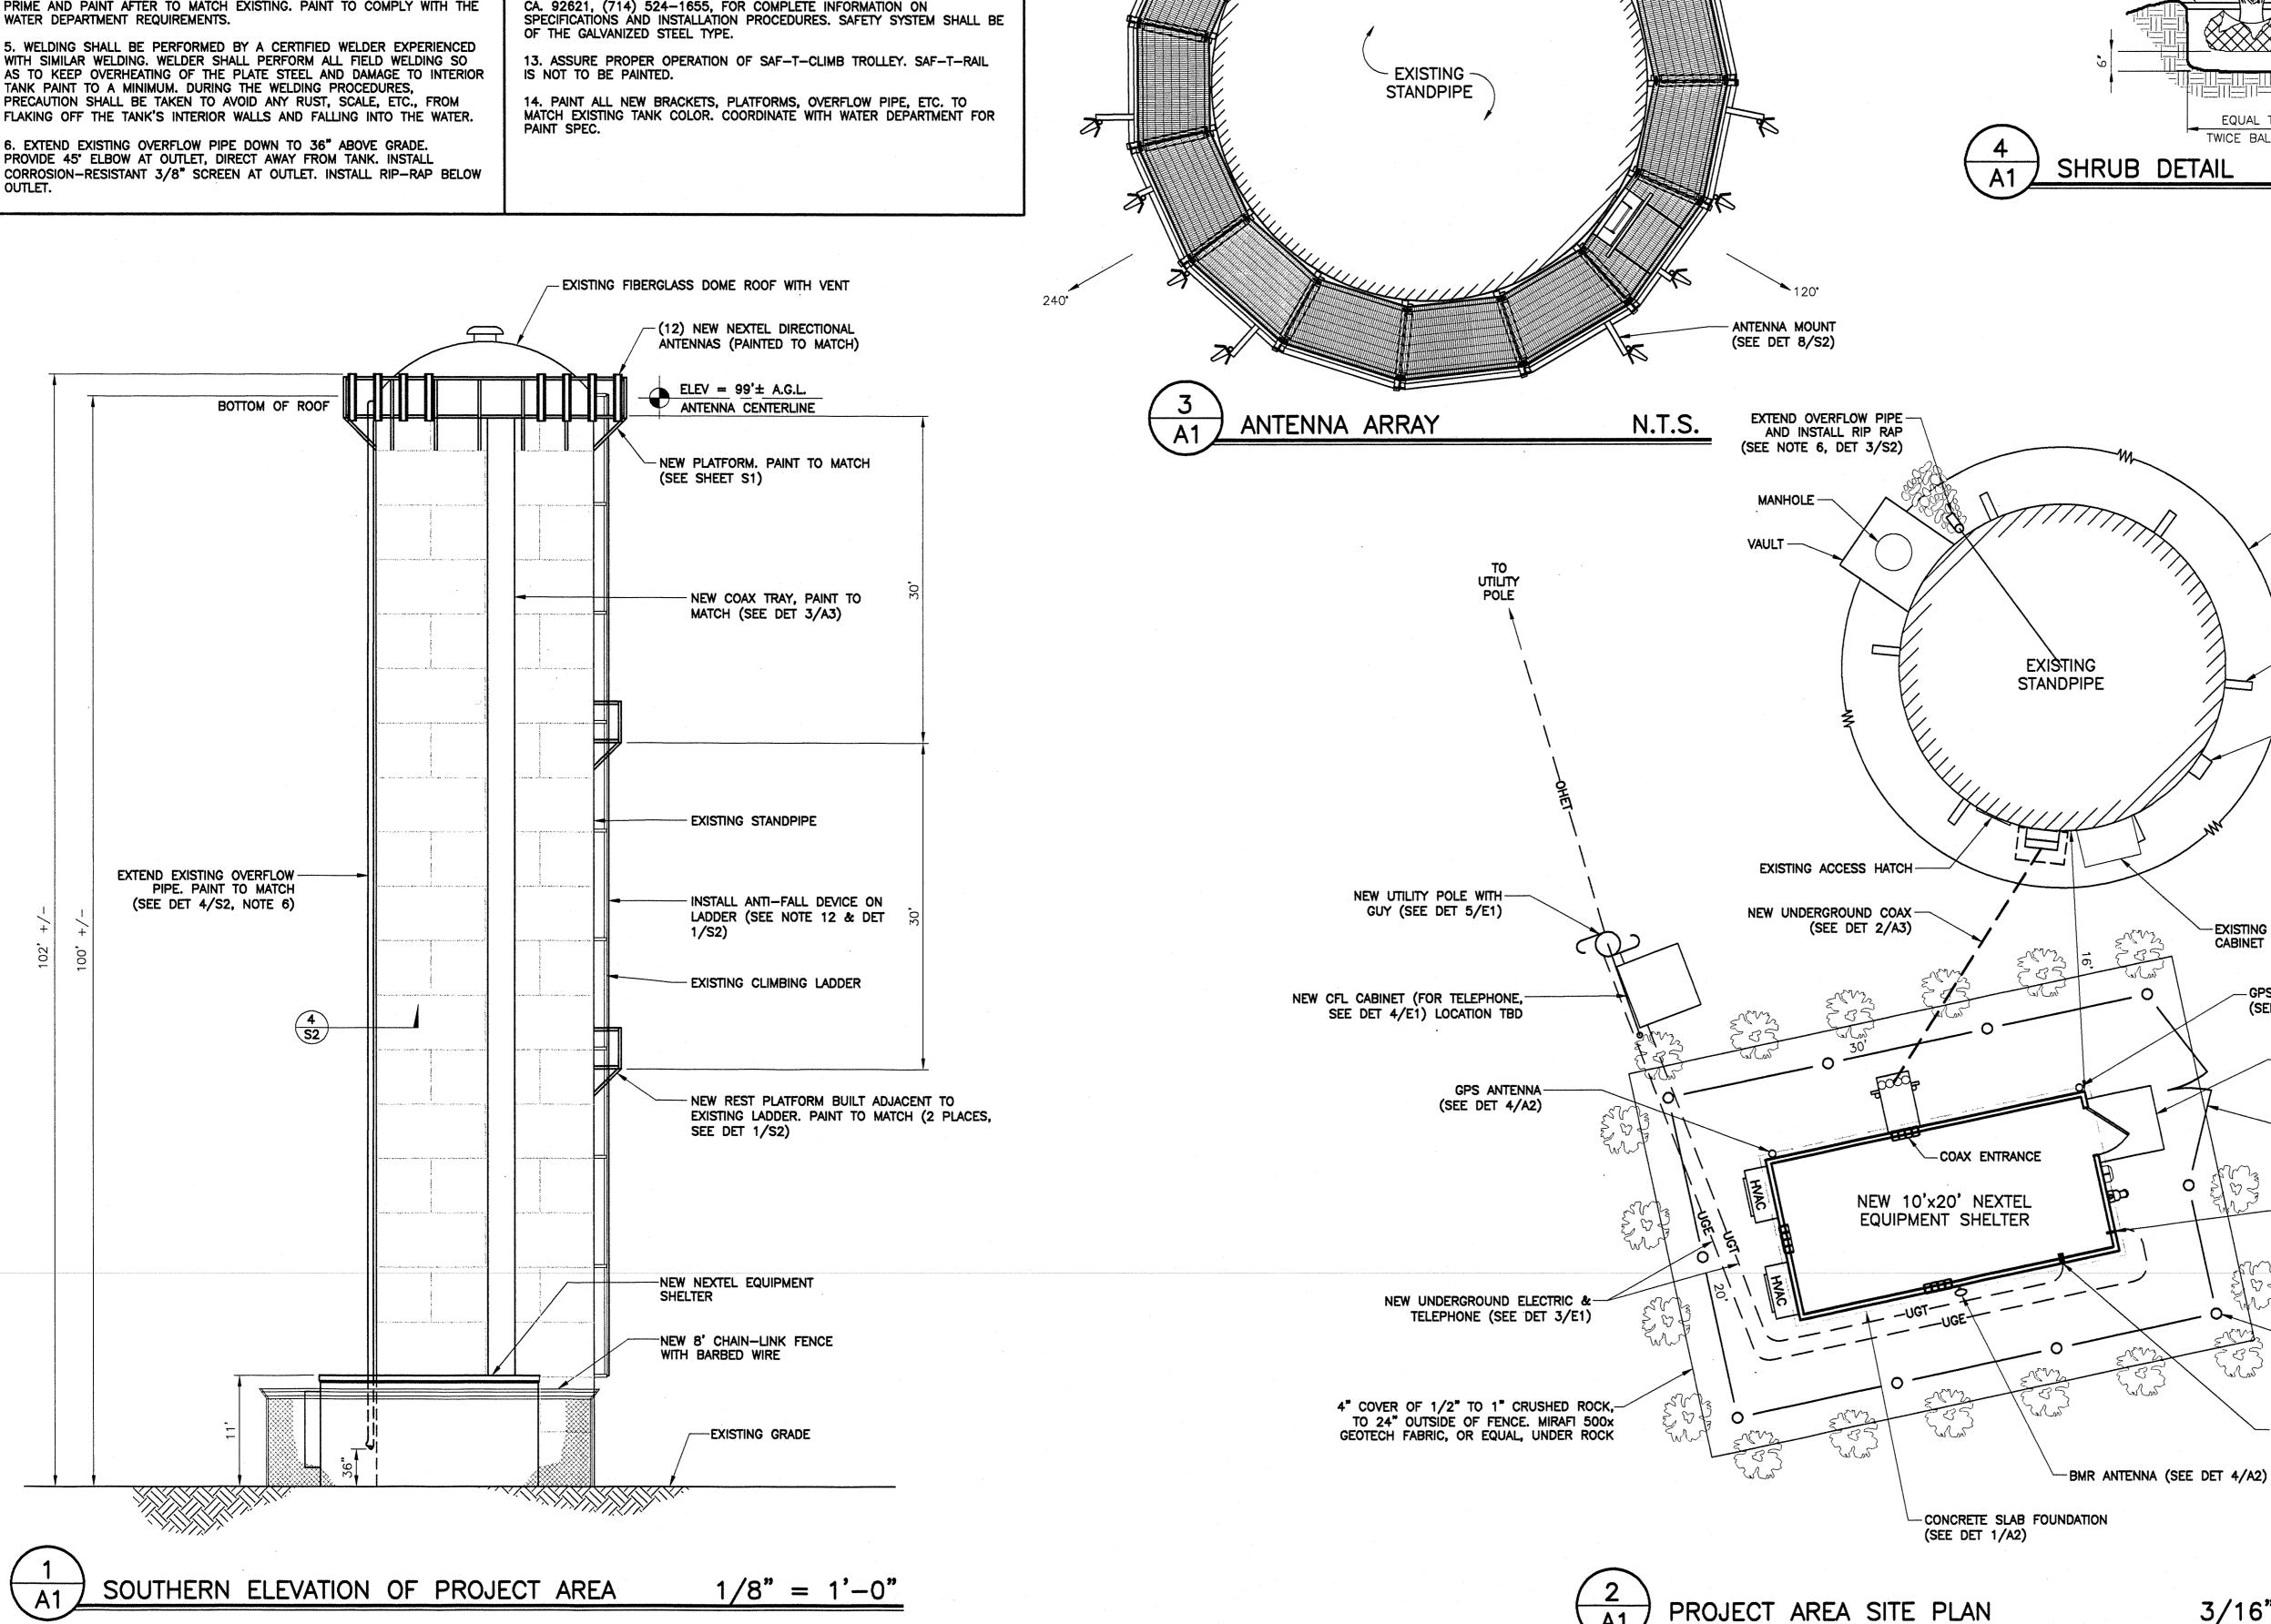
12'-0" TYP

NEW NEXTEL DIRECTIONAL-ANTENNA (12 PLACES)

TRUE

- NEW PLATFORM (SEE SHEET S1)

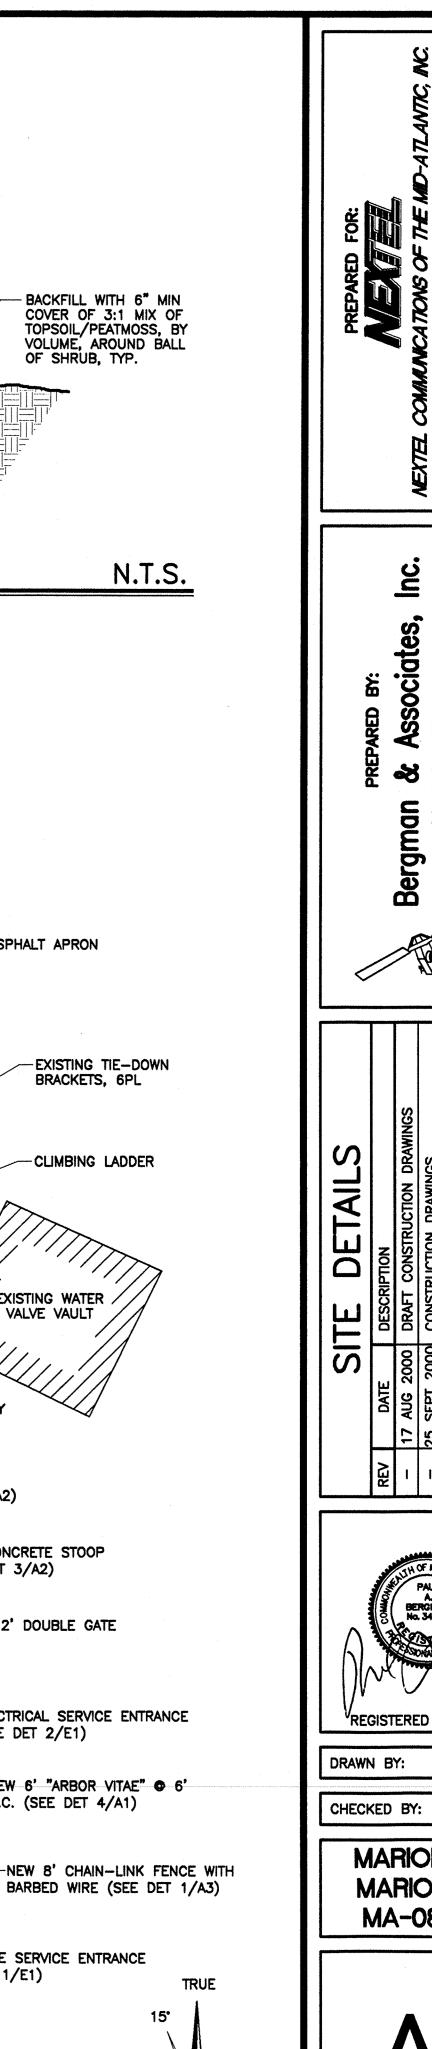
BACKFILL WITH 6" MIN

COVER OF 3:1 MIX OF

TOPSOIL/PEATMOSS, BY VOLUME, AROUND BALL

OF SHRUB, TYP.

ASPHALT APRON

EXISTING WATER VALVE VAULT

-4'x4' CONCRETE STOOP

-NEW 12' DOUBLE GATE

(SEE DET 2/E1)

- TELEPHONE SERVICE ENTRANCE

(SEE DET 1/E1)

-ELECTRICAL SERVICE ENTRANCE

NEW 6' "ARBOR VITAE" @ 6'
