Massachusetts Division of Marine Fisheries Technical Report TR-15

# A Survey of Anadromous Fish Passage in Coastal Massachusetts

# Part 1. Southeastern Massachusetts

May 2004

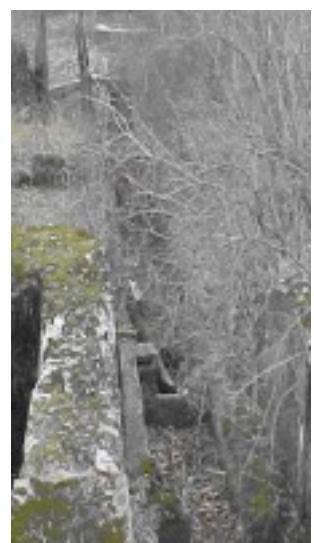
Fishway	Present								
Design	Material	Length (ft)	Inside W (ft)	Outside W (ft)	# of Baffles	Baffle H (ft)	Notch W (ft)	Pool L (ft)	Condition/ Function
Notched weir-pool	Concrete	122	3.5	6.0	12	-		-	Poor Not passable

Remnants of Plymouth Street Fishway

The Taunton River is formed by the confluence of Town River and the Matfield River in Bridgewater. The only obstruction on the main stem river is immediately downstream of this point. A partially breached dam at Plymouth Street creates an impediment to fish migration during low spring flows. Under most flow conditions, however, river herring are able to pass upstream. Complete removal or further breaching of the remaining dam would insure unencumbered passage to the upper river.

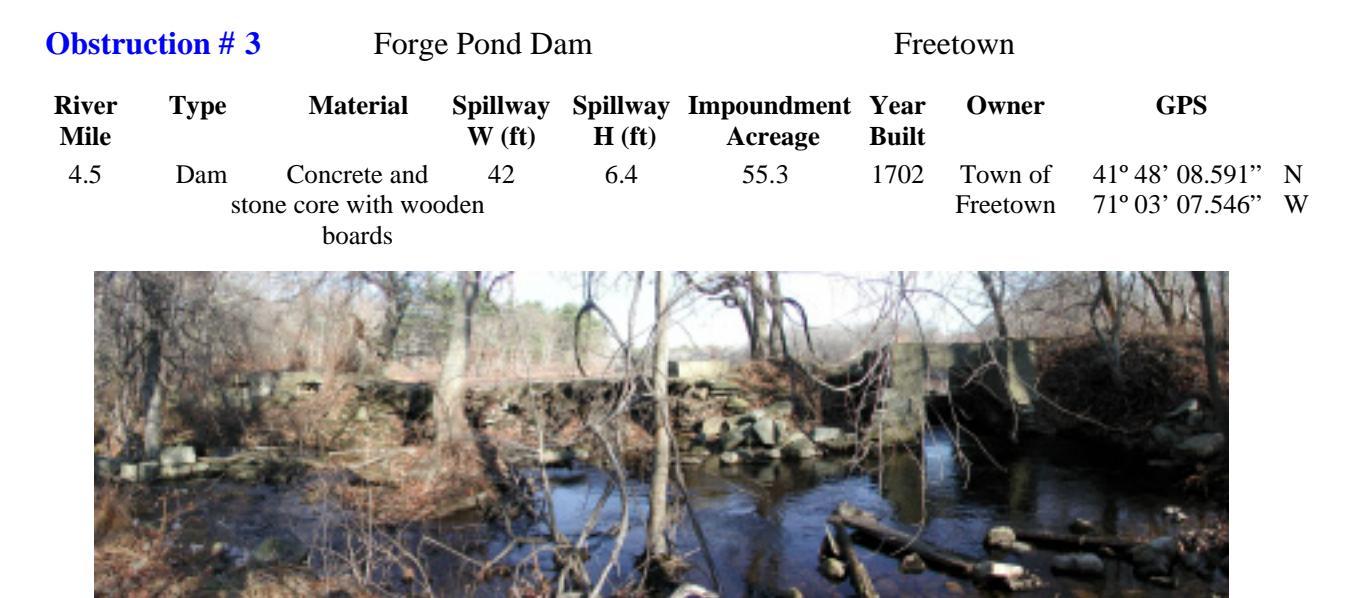
Forge Pond Dam

The Assonet River has 3 dams which obstruct fish passage. The first is at the head of the tide and the last forms the only significant potential spawning area, Forge Pond. The Forge Pond dam is in poor condition and leaks badly resulting in the loss of most of the impounded acreage. The cost of extensive repairs to the dams and fishway construction at all three sites gives this stream a low priority for development. River herring and smelt currently spawn immediately below the first dam and an active white perch fishery is carried on in the estuary. Consideration should be given to protection of existing spawning habitat and removal or breaching of the dams in order to create a free flowing stream habitat.

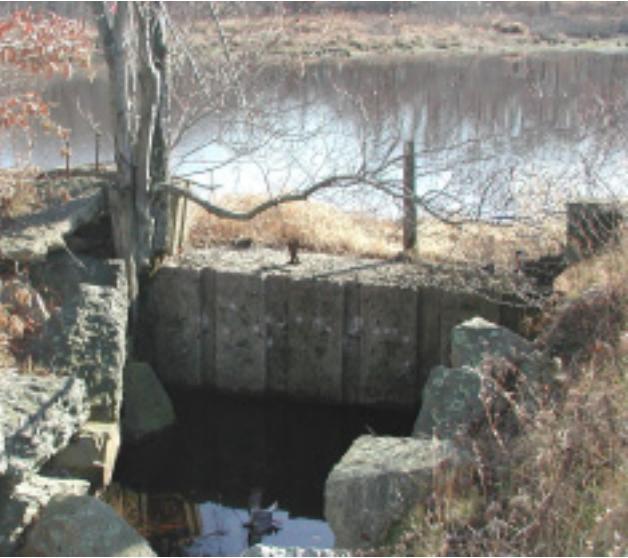
Bleachery Reservoir- Western Outlet

Rattlesnake Brook is a tributary to the Assonet River estuary. The stream is impounded at the Bleachery Reservoir. Although river herring and smelt have been observed just above the head of the tide, the impoundment's small size and the unusually low pH measured in the stream makes the brook a poor candidate for development. The existing spawning area below the reservoir should be protected and harvest of existing runs managed.

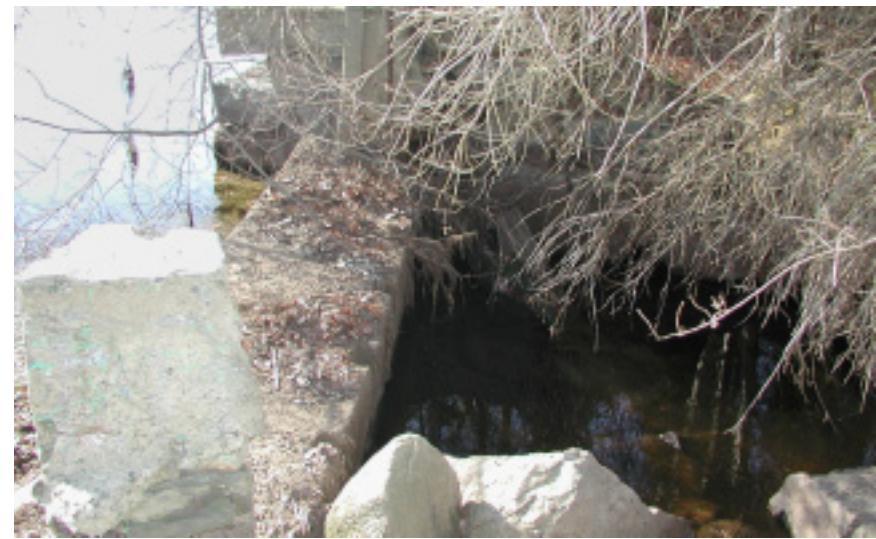
River Mile	Туре	Material	Spillway W (ft)	Spillway H (ft)	Impoundment Acreage	Year Built	Owner	GPS	
0.1	Dam and	Concrete and	12.3	Varied	3.9	1872	City of Fall	41° 46' 51.270"	Ν
	foundation wall	stone		(2.5-5.0)			River	71° 05' 09.356"	W

Bleachery Reservoir- Eastern Outlet

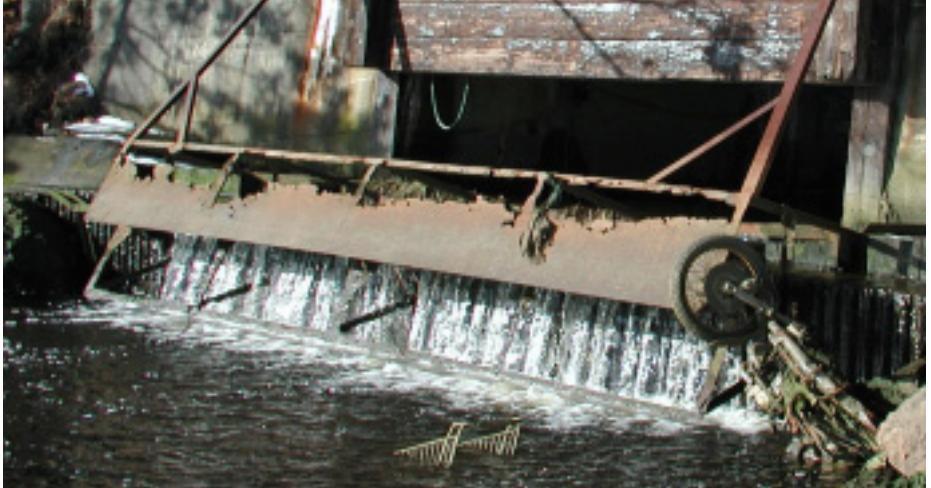
Gate under Railroad Tracks

Muddy Cove Brook is a small tributary to the main stem Taunton River in Dighton. Several obstructions exist, two of which are passable at some tidal stages. The first, a tide gate at the stream mouth has deteriorated and allows fish to get by at higher tidal stages. The second is a concrete dam which has had its wooden stop logs removed and is passable under current water levels. A 17 foot dam blocks fish passage to a 23 acre impoundment. River herring have been reported to ascend to the base of that dam. The habitat available in the impoundment and the fact that the owner has expressed interest in installing fish passage facilities makes this system a good candidate for development.

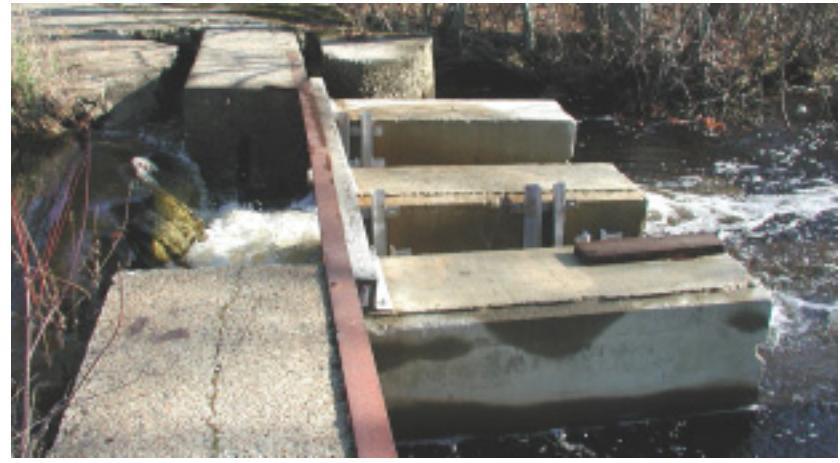
First unnamed dam and fishway on the Segreganset

Fishway	Present								
Design	Material	Length (ft)	Inside W (ft)	Outside W (ft)	# of Baffles	Baffle H (ft)	Notch W (ft)	Pool L (ft)	Condition/ Function
Weir-pool	Concrete	5.5	3.0	7.3	2	N/A	-	3.3	Excellent
•	with aluminu	n			(	(none in a	ıt		Passable
sl	lots and wood	en			tin	ne of surv	vey)		
	baffles

The Segreganset River has two obstructions to passage in its lower reaches. The first, a low head concrete and steel structure, was equipped with a steel plate weir-pool fishway which became badly deteriorated and was removed in 2000. A new ladder has been constructed by the Town of Dighton along with volunteer help and appears to be functional. Although this dam creates a spawning habitat of only 2.8 acres, a small population of river herring appears to be maintaining itself with some success. Also, smelt eggs have been observed in the stream below the dam in past years.

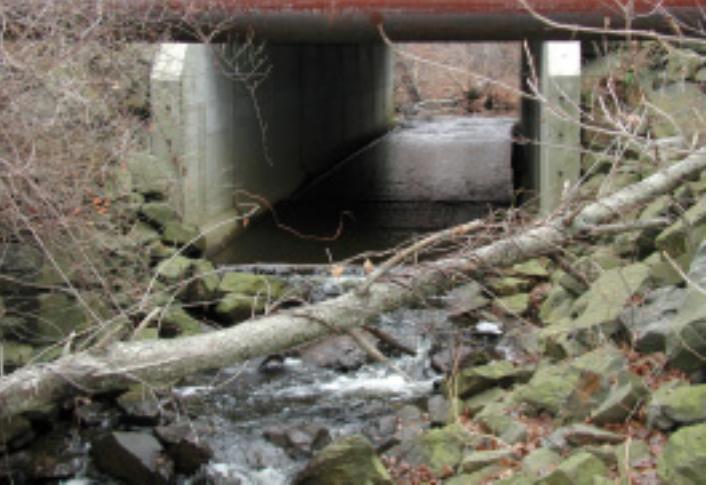
South Street Culvert

Dam Lot Brook is another small stream which enters the Taunton River in Raynham. It is obstructed first by a concrete culvert at South Street which has a depth of less the 0.2 feet of water due to its flat, wide floor. The second obstruction is a 4 foot dam at Orchard Street which creates an impoundment of less than 3 acres. This acreage does not justify the cost of providing fish passage.
Cotle	ey R	iver		Taun	ton, Berk	aley				
	Strea	m Length (mi	) Stream	Order p	H Anad	Anadromous Species Present				
	6.2		Firs	st 6	.9 Unkr	nown				
Ob	Obstruction # 1		Bars	stows Pond	d Dam		Tau	nton		
<b>River Type</b>		Material	Spillway W (ft)	Spillway H (ft)	Impoundment Acreage	Year Built	Owner	GPS		
0.	.4	Dam	Wood	30.0	5.0	15.1	1920	Private	41° 52' 56.524" 71° 02' 55.103"	N W

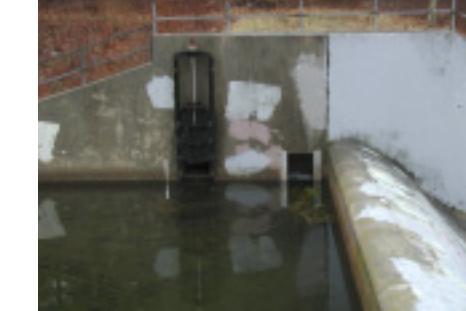
Design	Material	Length (ft)	Inside W (ft)	Outside W (ft)	# of Baffles	Baffle H (ft)	Notch W (ft)	Pool L (ft)	Condition/ Function
Weir-pool	Concrete	170.0	2.0	4.0	20	Varied	-	Varied (6 – 8)	Good Passable

Lake Rico Fishway

This stream flows for approximately one mile from Lake Rico to the Taunton River. The dam that creates Lake Rico was constructed by the Commonwealth's Department of Environmental Management in 1969. A fishway was installed at the time of construction but the inability to fill the impoundment to its design elevation caused the ladder to be nonfunctional. In 2000, DMF developed a design to retrofit the fishway with a new exit at the existing lake elevation. DEM funded the modifications and the fishway now passes river herring successfully. With proper maintenance and flow regulation, Lake Rico's 215 acres should support a sizeable population. Due to the low stream gradient, channel maintenance below the ladder and to the brook mouth is also an important priority.

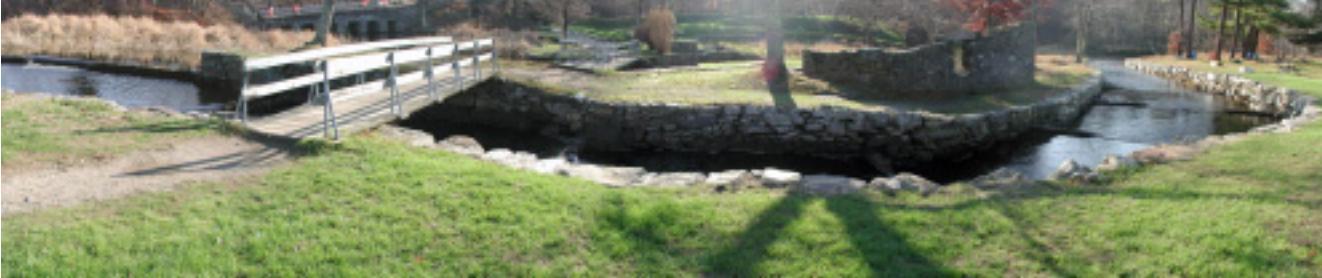
Fishway	Present								
Design	Material	Length (ft)	Inside W (ft)	Outside W (ft)	# of Baffles	Baffle H (ft)	Notch W (ft)	Pool L (ft)	Condition/ Function
Notched weir-pool	Stone and concrete	202.0	30-50	30-50	7	2.6	9	Varied (15-20)	Good Passable

Oliver Mills Fishway

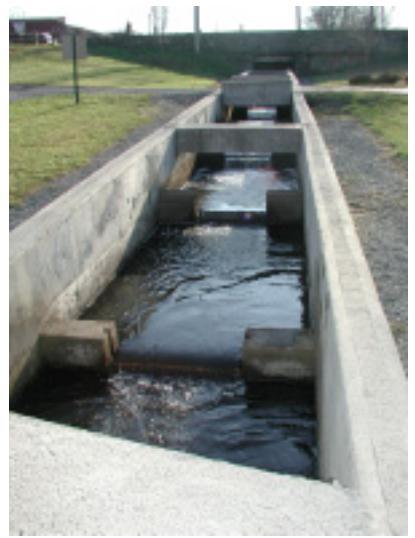
Fishway	Present								
Design	Material	Length (ft)	Inside W (ft)	Outside W (ft)	# of Baffles	Baffle H (ft)	Notch W (ft)	Pool L (ft)	Condition/ Function
Notched weir-pool	Concrete with wooden boards	189.0	6.0	7.5	18	4.1	3.0	11.0	Excellent Passable

Wareham Street Fishway

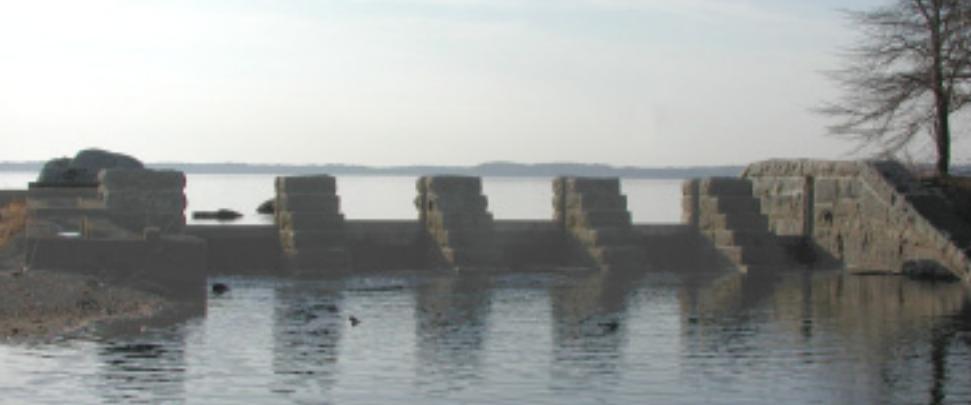
Assawompset Pond Dam (with Fishway along left edge of the dam)

Fishway	Present								
Design	Material	Length (ft)	Inside W (ft)	Outside W (ft)	# of Baffles	Baffle H (ft)	Notch W (ft)	Pool L (ft)	Condition/ Function
Denil	Concrete with wooden baffles	29.5	2.0	4.0	9	4.5	-	-	Good Inefficient passage

The dam at Assawompsett is, in fact, passable for most of the early spring flows since the tailwater pool level rises sufficiently to allow herring to swim over it. When the pool level drops, the migrating herring are able to utilize the fishway. This is an important point since the dam is in poor condition and may be replaced. A dam design that would not allow fish to ascend it could have a dramatic impact on the population because the small Denil ladder is incapable of passing such a large number of fish efficiently. Emergent aquatic vegetation in the impoundment above Wareham Street and other slow moving sections of the river has caused problems for migrating fish in the past and a channel should be maintained through this growth.

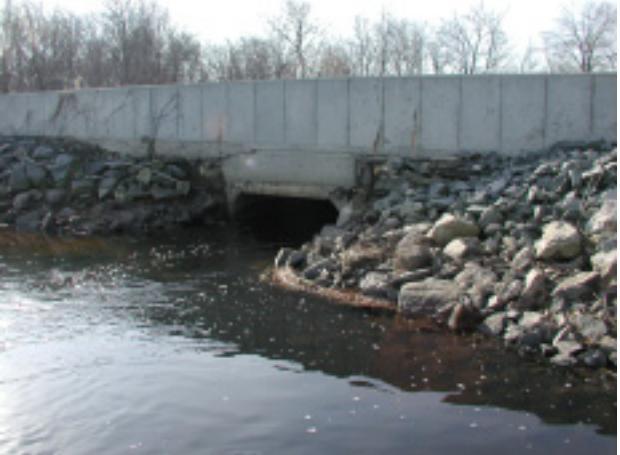
Larger culvert under Route 18

Two other potential obstructions to passage may be encountered once fish have entered the lake system. A culvert at Route 18 which accommodates the connector stream between Assawompsett and Long Pond was replaced in 1993. The invert elevation of the culvert was too high for downstream migration of juvenile herring and as a result a second smaller culvert was added at a lower elevation. The effectiveness of both these culverts in passing fish has never been assessed. Since Long Pond represents a substantial portion of the total spawning habitat, such an assessment should be conducted.

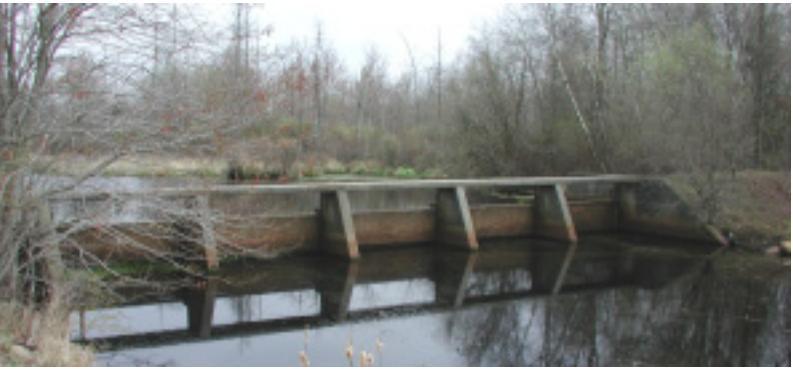
Stump Brook Dam

Fishway	Present								
Design	Material	Length (ft)	Inside W (ft)	Outside W (ft)	# of Baffles	Baffle H (ft)	Notch W (ft)	Pool L (ft)	Condition/ Function
Weir-pool	Concrete	19.5	2.0	4.2	6	Varied (0.6-3.0)	-	3.5	Good Passable
			Start of		A

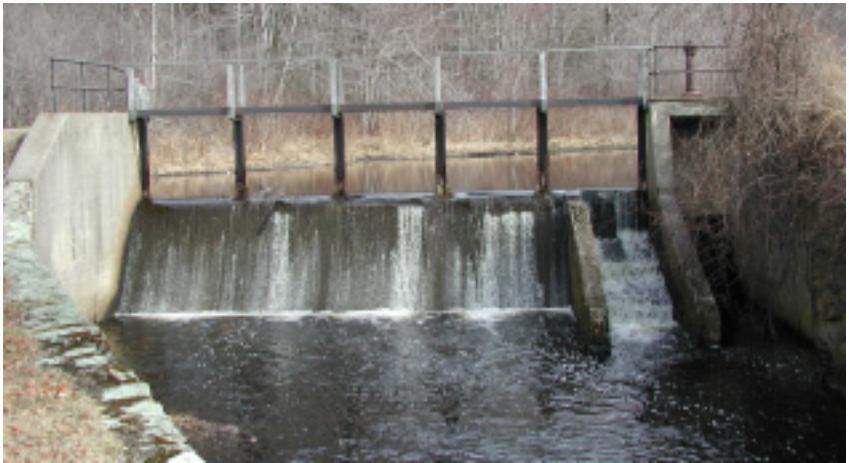
Forge Pond Dam, with fishway along right edge of the dam

Fishway	Present								
Design	Material	Length (ft)	Inside W (ft)	Outside W (ft)	# of Baffles	Baffle H (ft)	Notch W (ft)	Pool L (ft)	Condition/ Function
Weir-pool	Concrete with wood baffles	18.0	4.0	6.0	4 ti	N/A (none in a me of sur	- nt vey)	Varied (3-6)	Poor Not passable

Before it enters the Matfield River, this stream forms a 3 acre impoundment called Forge Pond. Immediately below the pond is a small dam at Willow Avenue. This 2 foot drop may be passable during spring flows with some adjustment to the notch in the crest. The dam at Forge Pond has a deteriorated fishway which is not currently functional. A population could be restored here if the ladder was repaired, although only a small spawning area would be gained.

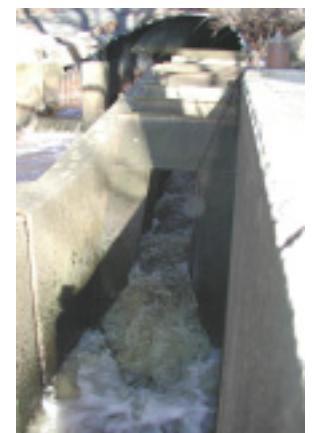
Design	Material	Length (ft)	Inside W (ft)	Outside W (ft)	# of Baffles	Baffle H (ft)	Notch W (ft)	Pool L (ft)	Condition/ Function
Denil	Concrete with fiberglass baffles	18.0	3.0	4.5	7	6.0	-	-	Good Inefficient passage
Weir-pool	Concrete	61.0	5.0	7.0	12	2.0	3	5.5	Good Passable

Russells Mills Pond Ladder, lower Denil section

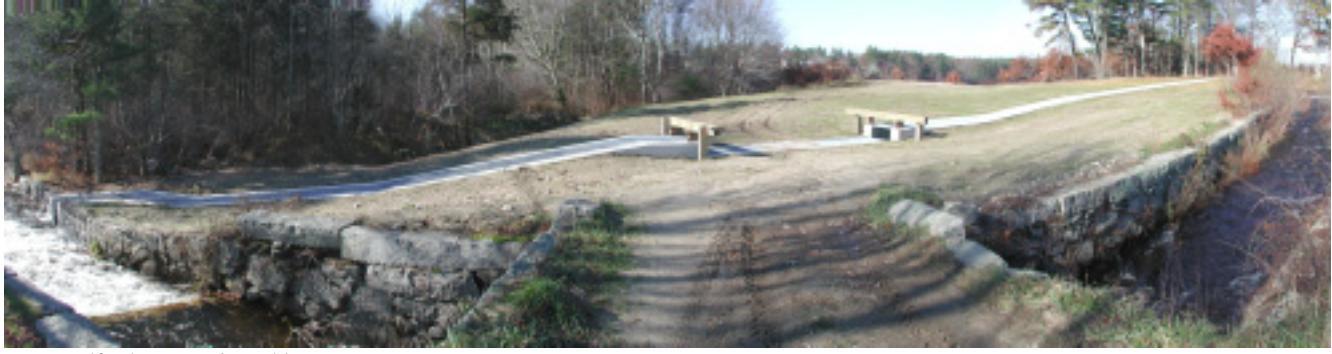
Fishway	Present								
Design	Material	Length (ft)	Inside W (ft)	Outside W (ft)	# of Baffles	Baffle H (ft)	Notch W (ft)	Pool L (ft)	Condition/ Function
Denil	Concrete with wooden baffles	264.0	3.0	5.0	26	5.0	-	-	Excellent Passable

New Bedford Reservoir Ladder

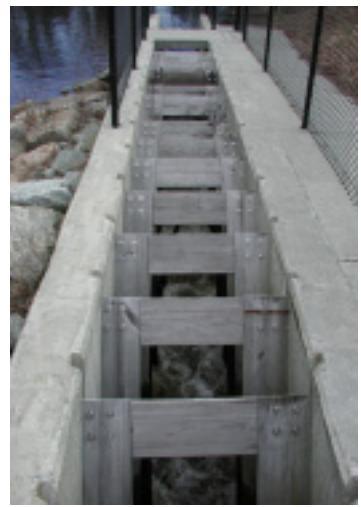
Fishway	Present								
Design	Material	Length (ft)	Inside W (ft)	Outside W (ft)	# of Baffles	Baffle H (ft)	Notch W (ft)	Pool L (ft)	Condition/ Function
Denil	Concrete with wooden baffles	58.0	3.0	5.0	16	8.6	-	-	Excellent Passable

Ladder at Route 6 Crossing

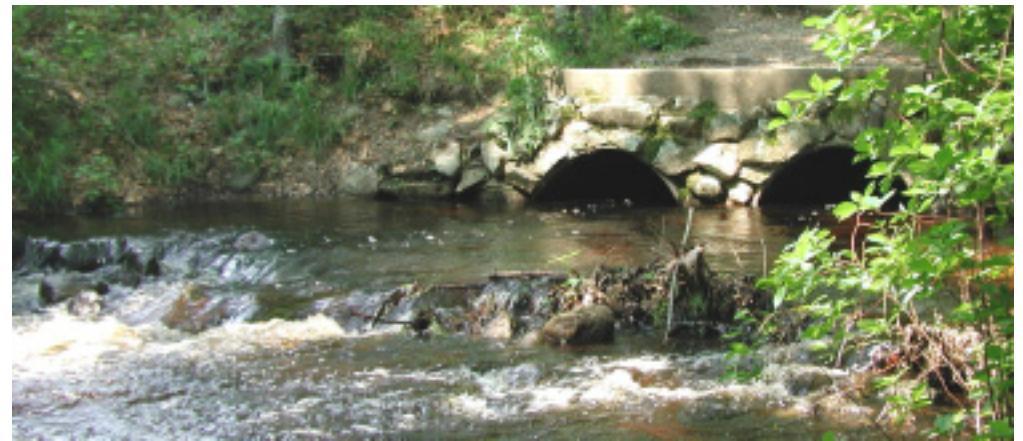
Fishway	Present								
Design	Material	Length (ft)	Inside W (ft)	Outside W (ft)	# of Baffles	Baffle H (ft)	Notch W (ft)	Pool L (ft)	Condition/ Function
Stream baffle	Stone	1790	10	10	15	Varied (0.5-1)	-	Varied (10-50)	Good Passable

Stream Baffles at Rochester Fish Hatchery

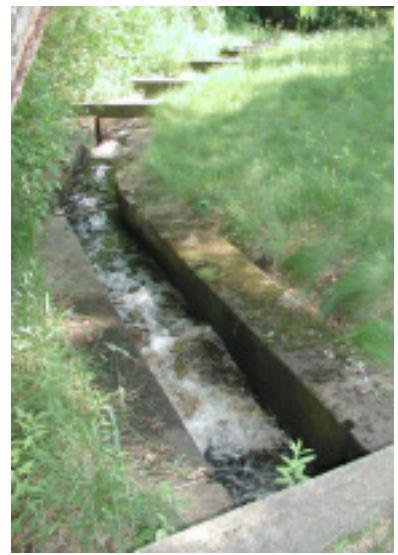
Fishway	Present								
Design	Material	Length (ft)	Inside W (ft)	Outside W (ft)	# of Baffles	Baffle H (ft)	Notch W (ft)	Pool L (ft)	Condition/ Function
Weir-pool	Concrete with wood baffles	85.0	2.0	4.8	8	Varied (2.6)	-	Varied (9.5-30.7)	Fair Inefficient passage

Hathaway Pond Ladder

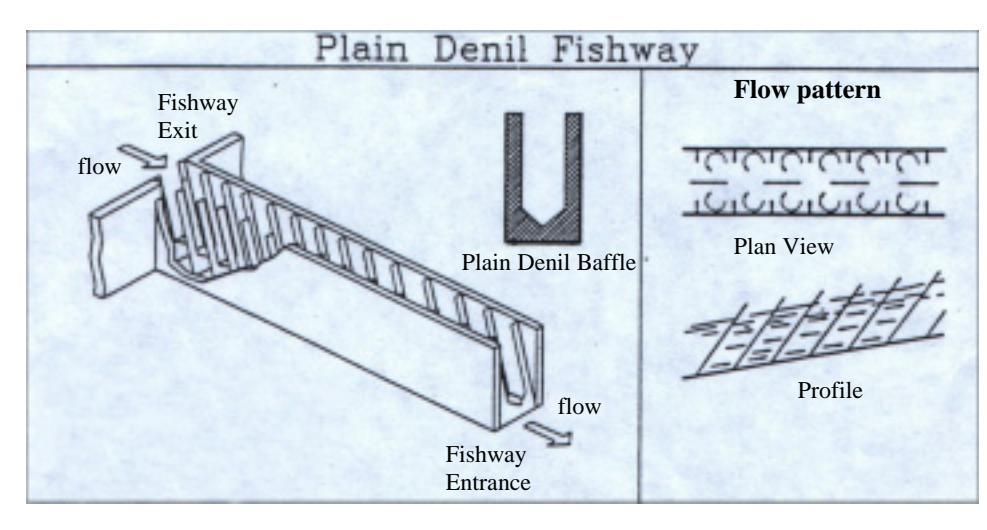
Denil Fishway

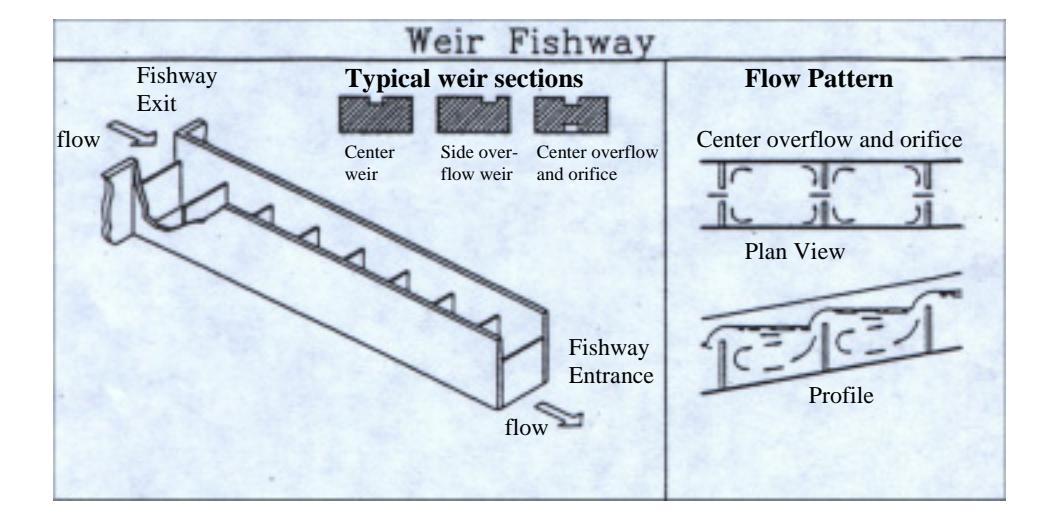
#### Weir Fishway

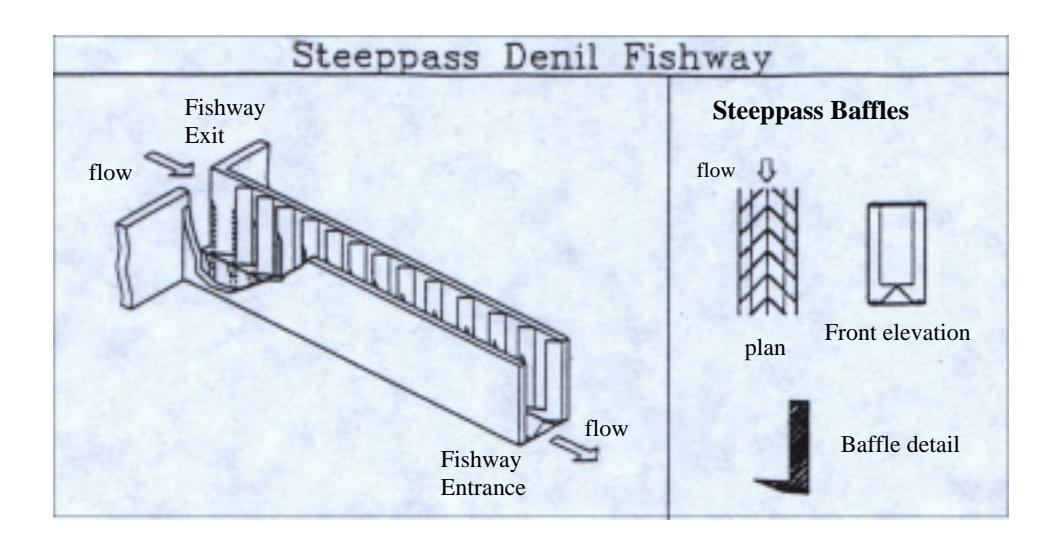
Steeppass Fishway

The first installation of a prefabricated, aluminum Alaskan steeppass fishway by DMF took place in 2000. Similar to the Denil in function, this style offered the benefit of reduced costs by eliminating the need for large, labor intensive construction projects. Also, impacts to streambeds, wetlands and adjacent uplands were minimized. In addition, the steeppass has been found to be useful in the modification of dilapidated, inefficient weirpool ladders. Its disadvantages are similar to those of the Denil type and its cost becomes a factor when many sections are required to overcome an obstruction.

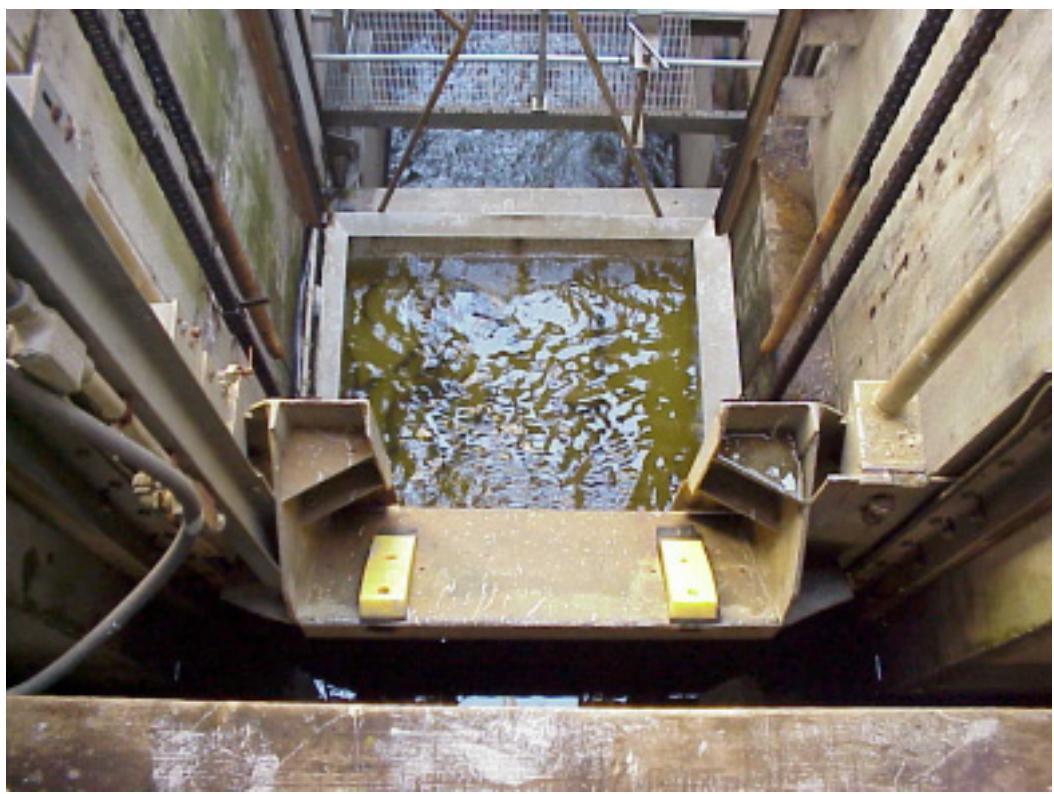
Fish lift - hopper rising with fish - Essex Dam, Lawrence

A mechanical fish lift is currently in operation on the Merrimack River. Operated by CHI Energy, the lift at the Essex Dam in Lawrence is primarily designed to pass Atlantic salmon and American shad although other species such as blueback herring utilize it in substantial numbers. Also, a vertical slot or Ice Harbor fishway in addition to a lift is utilized at the Pawtucket Dam in Lowell.
