Figure 3
Scraggy Neck
E1-11
Shoreline Segment Summary
Bouchard B No. 120 Oil Spill
Buzzards Bay, MA

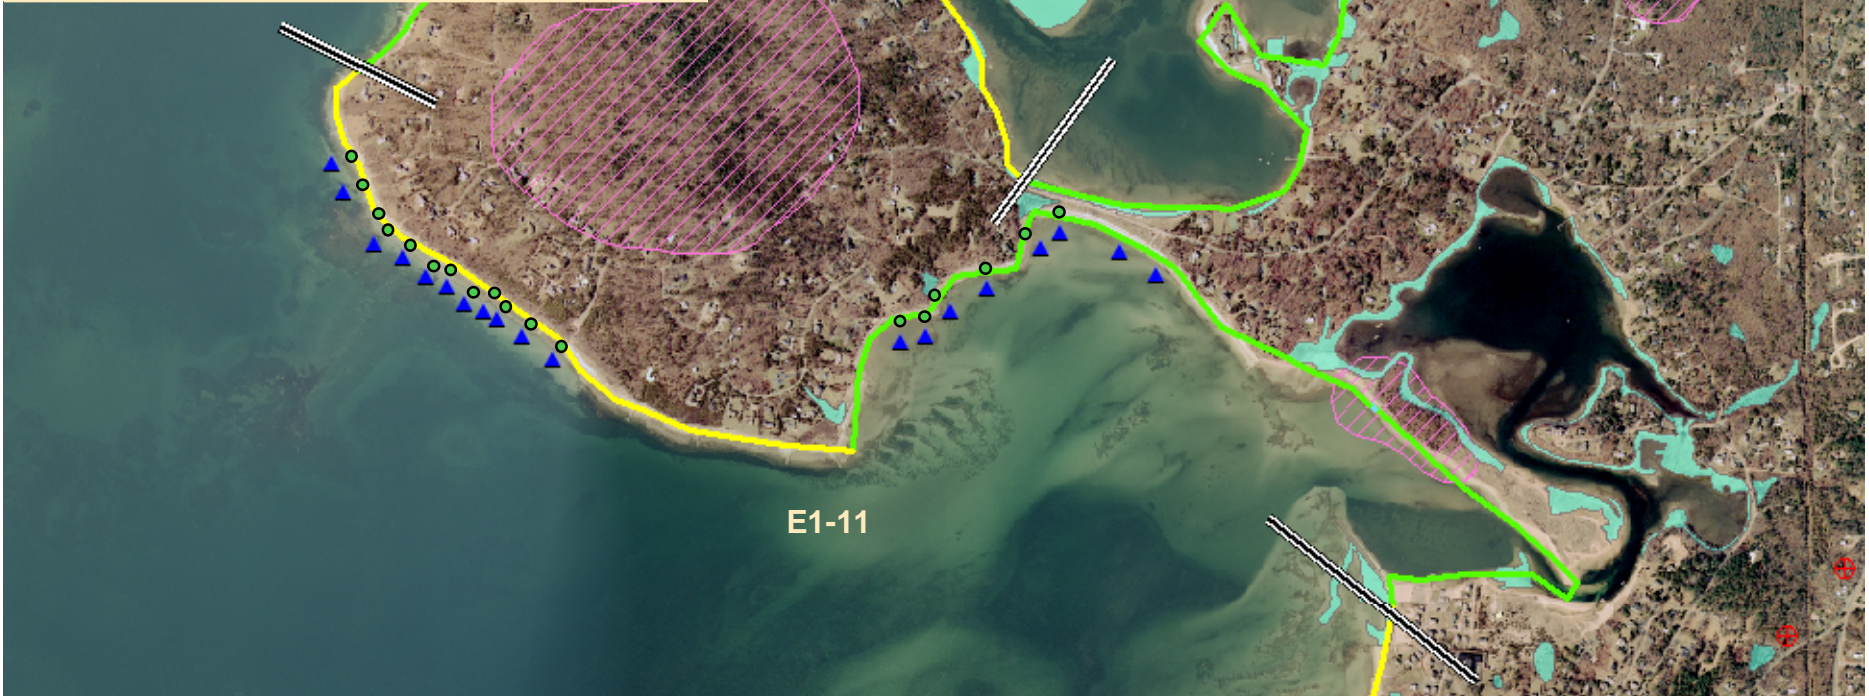
| <p>Trench Location</p> <ul style="list-style-type: none"> ● 10/27/2004 ● 9/27/2004 ● 9/22/2004 ● 9/10/2004 ● 9/9/2004 ● 8/10/2004 ● 7/29/2004 ● 7/28/2004 ● 7/27/2004 ● 7/26/2004 | <p>Subtidal Shellfish Sampling Location</p> <ul style="list-style-type: none"> ★ 9/27/2004 ★ 9/23/2004 ★ 9/8/2004 ★ 8/10/2004 ★ 7/29/2004 ★ 7/28/2004 ★ 7/27/2004 ★ 7/26/2004 | <ul style="list-style-type: none"> ○ Shallow Subtidal Sediment Sampling Location ○ Deep Subtidal Sediment Sampling Location ▲ Qualitative Shellfish Surveys ◆ Marsh Sampling Location ◆ Intertidal Sediment Sampling Location ⊕ Subtidal Sampling Location ○ Marsh Core Sampling Locations ● Water Sampling Locations ○ Wetlands → Chain drag Location ▨ NHESP 2003 Priority Habitats for State-Protected Rare Species | <ul style="list-style-type: none"> 🐣 Nests ⊕ Vernal Pool <p>OILING</p> <ul style="list-style-type: none"> — NO DATA — CLEAN — VERY LIGHT — LIGHT — MEDIUM — HEAVY |
