## Mattapoissett River

Mattapoissett, Rochester

Stream Length (mi)	Stream Order	pH	Anadromous Species Present
11.1	Fifth	6.0	Alewife, blueback, smelt

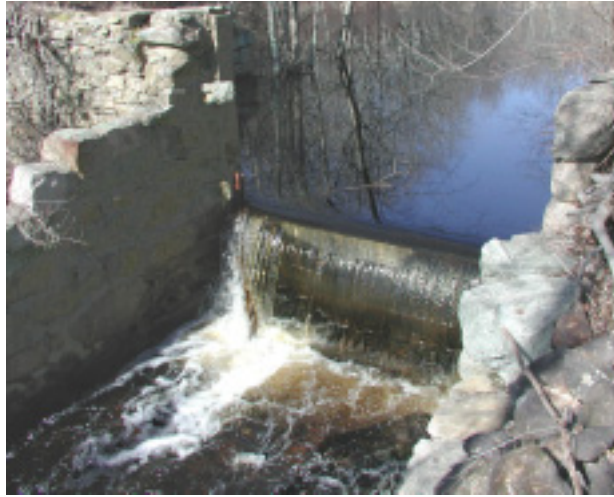
**Obstruction # 2**

River Mile	Type	Material	Spillway W (ft)	Spillway H (ft)	Impoundment Acreage	Year Built	Owner	GPS
8.7	Dam	Stone with wooden boards	11.0	4.0	0.0	-	-	41° 44' 10.582" N 70° 51' 45.888" W

Dam at Rounseville Road Crossing

The second obstruction is a concrete flume with wooden stoplogs at Route 105 (Rounseville Road). These boards are reportedly removed annually with the arrival of the herring. Another obstruction occurs at a fish hatchery owned by the Massachusetts Division of Fisheries and Wildlife. Fish avoid this dam by means of a bypass channel with stone stream baffles to overcome the elevation change. A third dam, at the outlet of 710 acre Snipatuit Pond, is surmounted by a concrete and wood weir-pool ladder incorporated into the dam structure.

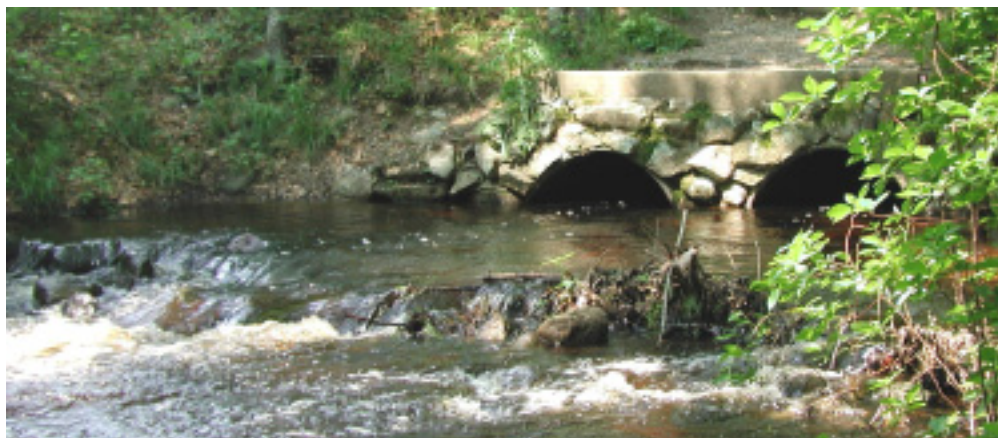
Design	Material	Length (ft)	Inside W (ft)	Outside W (ft)	# of Baffles	Baffle H (ft)	Notch W (ft)	Pool L (ft)	Condition/Function
Stream baffle	Stone	1790	10	10	15	Varied (0.5-1)	-	Varied (10-50)	Good Passable

Stream Baffles at Rochester Fish Hatchery

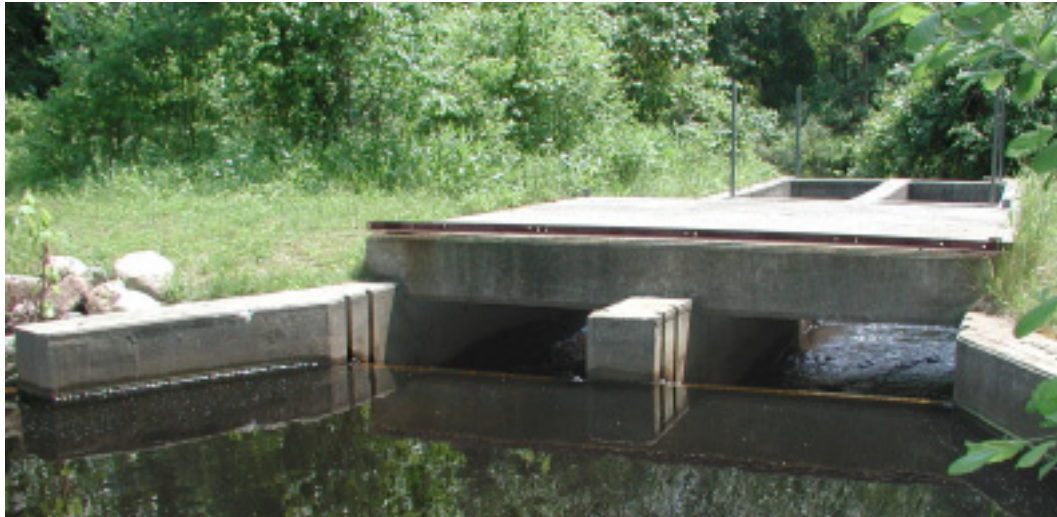
**Obstruction # 4**

River Mile	Type	Material	Spillway W (ft)	Spillway H (ft)	Impoundment Acreage	Year Built	Owner	GPS
11.1	Dam control structure	Concrete with wooden boards	4.0	2.4	710.0	1986	Private	41° 45' 45.877" N 70° 52' 09.022" W

Snipatuit Pond Dam and Ladder

Design	Material	Length (ft)	Inside W (ft)	Outside W (ft)	# of Baffles	Baffle H (ft)	Notch W (ft)	Pool L (ft)	Condition/Function
Weir-pool	Concrete with wooden baffles	44.0	4.0	5.3	6	Varied (2.4)	-	8.0	Excellent Passable

This fishery is controlled by a Tri-Town Herring Committee representing the towns of Mattapoissett, Marion and Rochester. In addition, a citizens group called Alewives Anonymous has assisted in the maintenance of this run. This organization has also installed an electronic fish counter at the outlet of Snipatuit Pond which has been in place for 14 years. A second counter has been added to the exit end of the first fishway. Estimates based on these counts have ranged from 40,000 to 130,000 fish annually.
