Wankinco River

Wareham, Carver, and Plymouth

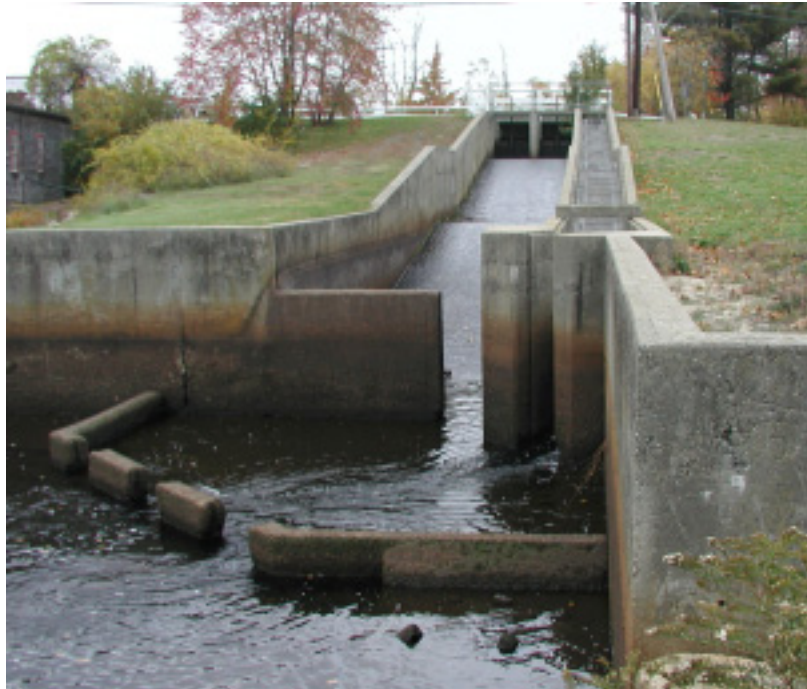
Parkers Mills Dam and Ladder

Design	Material	Length (ft)	Inside W (ft)	Outside W (ft)	# of Baffles	Baffle H (ft)	Notch W (ft)	Pool L (ft)	Condition/Function
Denil	Concrete with wooden baffles	123.7	3.0	4.5	42	4.8	-	-	Good Passable

The Wankinco is another southeastern Massachusetts stream which is highly manipulated by cranberry bog diversions. From its source in East Head Pond it flows through a long series of bogs forming several impoundments along its course. The first two, Parker Mills Pond and Tihonet Pond, provide spawning and nursery habitat for river herring. The dam at Parker Mills Pond is provided with a concrete and wood Denil ladder. This ladder functions well but entrance to the structure is difficult at low tidal stages. Also, care must be taken to insure maximum flow through the ladder for optimal attraction to the entrance.

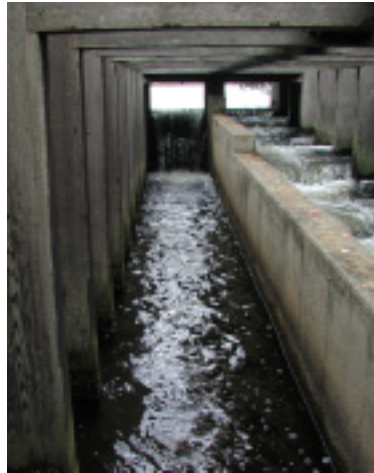
Tihonet Pond Dam

Design	Material	Length (ft)	Inside W (ft)	Outside W (ft)	# of Baffles	Baffle H (ft)	Notch W (ft)	Pool L (ft)	Condition/Function
Denil	Concrete with fiberglass and wooden baffles	86.0	2.0	3.8	37	8.0	-	-	Good Inefficient passage
Notched weir-pool	Concrete with wooden baffles	62.0	4.5	8.0	7	1.9	1.5	6.6	Good Inefficient passage

Tihonet Pond has two outlets, the eastern-most of which is equipped with a fishway. This combination weir-pool and Denil style ladder functions adequately with proper flow adjustment. The problem that occurs at this impoundment is the attraction flow from the west outlet which causes migrating herring to be diverted into a dead end channel. Careful adjustment of flows from the two outlets could increase the numbers of fish which reach the spawning area. Further development within this system is not justified due to numerous small obstructions and competing water usage by the cranberry growers.

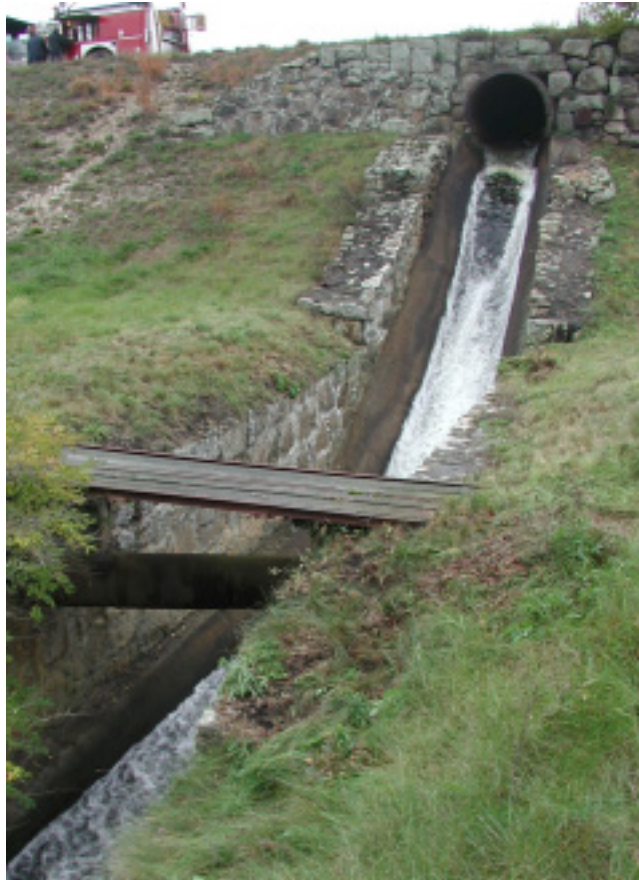
Tihonet Pond Outlet

Fishway None

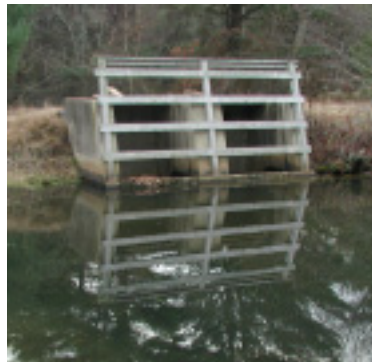
Bog Sluice at base of impoundment
Upstream of Tihonet Pond

Fishway None
