Appendix 5: Mattapoisett Potential Restoration Sites

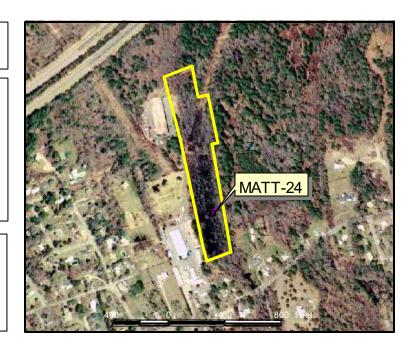
Disturbance Type: Abandoned Bog

**Disturbance Area:** 6.6 acres **Owner:** Linda Brownell **Assessors' Lot Number:** 17-3

**Comments:** The bog is within the Natural Heritage and Endangered Species Program's 2003 Priority Habitat for Rare Species.

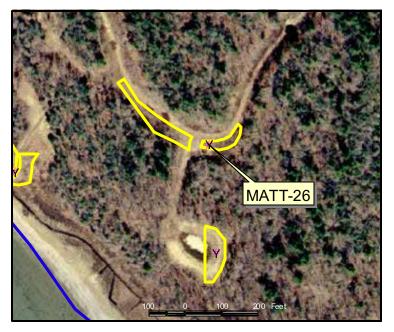
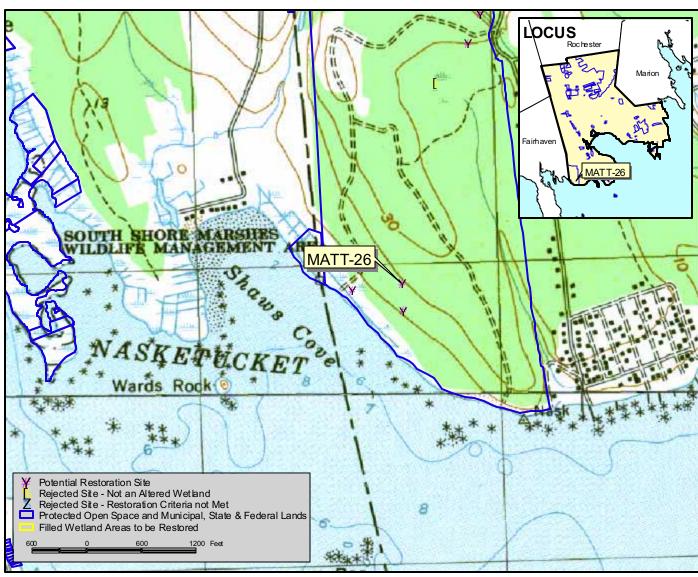
**Assessors' Lot Number: 14-2**

**Disturbance Type:** Fill **Disturbed Area:** 0.2 acre

Cubic Yards of Fill to be Removed: 370

**Comments:** This site was filled as part of a restoration project. There is easy access to the site and sufficient disposal sites nearby.
