Appendix 2: Dartmouth Potential Restoration Sites

Selected Inventory of Potential Wetland Restoration Sites in the Buzzards Bay Watershed – Phase I

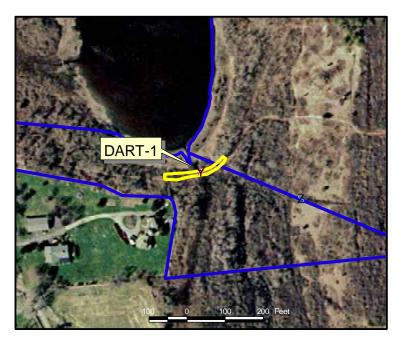
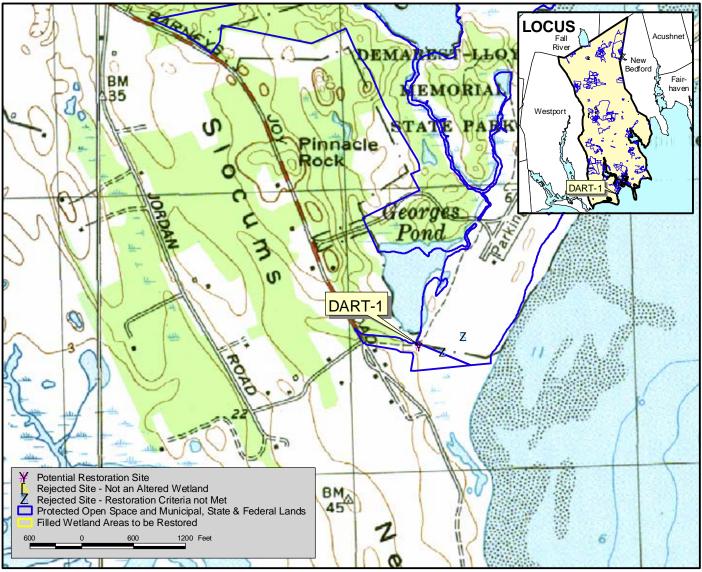
Disturbance Type: Fill **Disturbed Area:** 2,204, square feet **Owner:** Dartmouth Natural Resources Trust

Assessors' Lot Number: 6-10 Cubic Yards of Fill to be Removed: 245

Comments: This freshwater site is a path to the beach. The path can be narrowed to four feet in one section and removed and replaced with a raised walkway in another section.

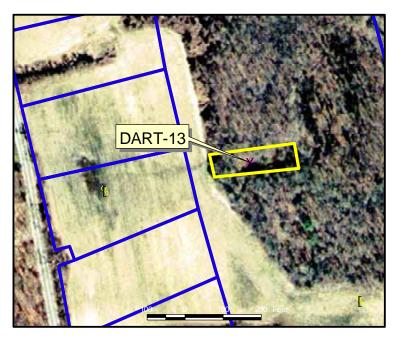
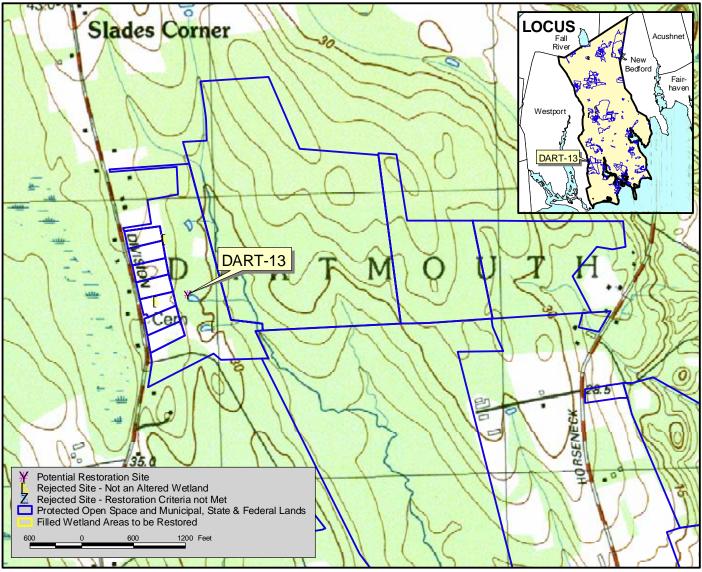
Town: Dartmouth Site: DART - 13

Disturbance Type: Fill **Disturbed Area:** 13,935 square feet **Owner:** Commonwealth of Massachusetts, Department of Fish & Game **Assessors' Lot Number:** 22-12 **Cubic Yards of Fill to be Removed:** 1,032

Comments: This freshwater site has been filled due to silt runoff from the farm field. The silt removal should coincide with an agricultural BMP to prevent further siltation.

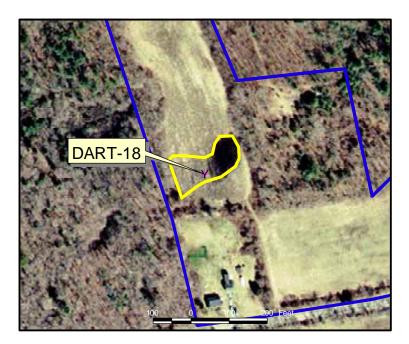
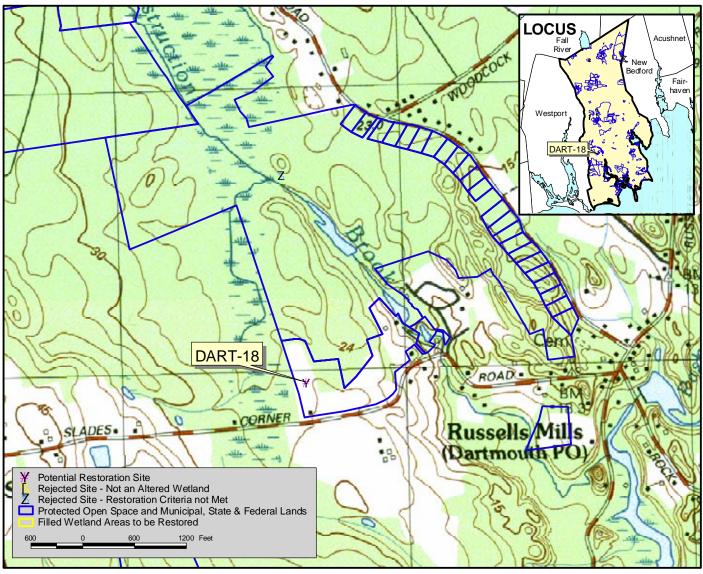
Town: Dartmouth Site: DART - 18

Disturbance Type: Cropping, hay, cranberry bog Disturbed Area: 14,559 square feet Owner: Dartmouth Natural Resource Trust (DNRT) Assessors' Lot Number: 28-5 Cubic Yards of Fill to be Removed: 0

Comments: Reduction of the hayed area may not fit the DNRT plan for this freshwater site. However, the wet conditions in this section of the field limit hay productivity.

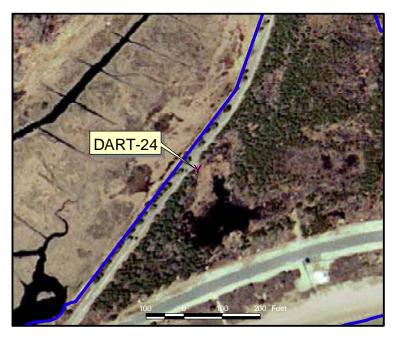
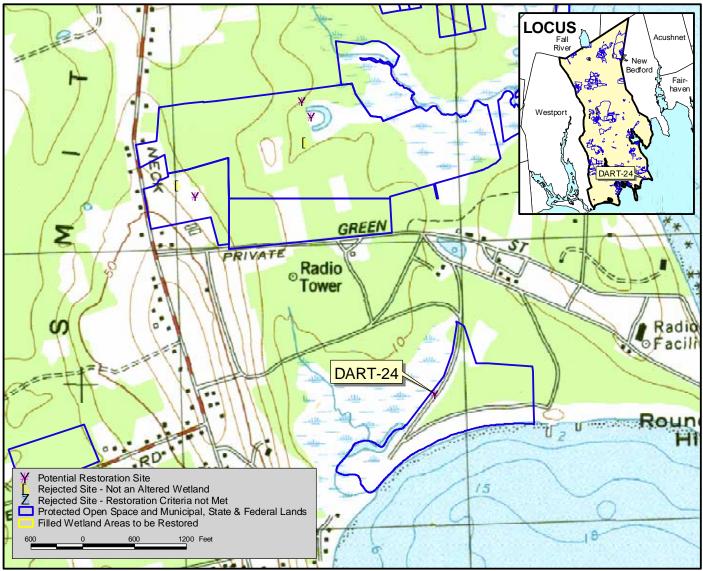
Town: Dartmouth **Site:** DART - 24

Disturbance Type: Fill **Disturbed Area:** 561,720 square feet **Owner:** Town of Dartmouth, Park Department **Assessors' Lot Number:** 90-10 **Cubic Yards of Fill to be Removed:** 62,413

Comments: This filled salt marsh is being investigated for restoration by local, state, and federal agencies. More information regarding this site is available in the "New Bedford Harbor Environment Wetlands Restoration Plan" as site MWRP 159.

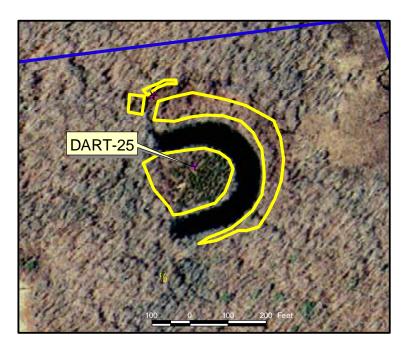
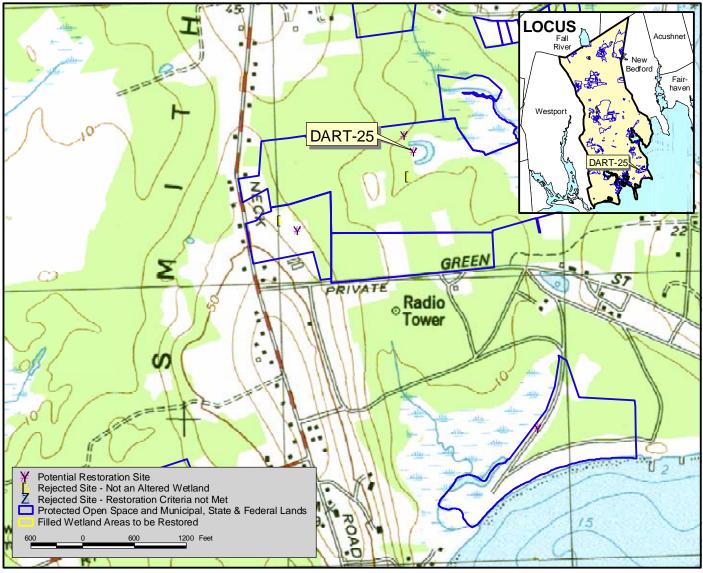
Disturbance Type: Fill **Disturbed Area:** 28,828 square feet **Owner:** Dartmouth Natural Resources Trust (DNRT) **Assessors' Lot Number:** 20-55 **Cubic Yards of Fill to be Removed:** 4,271

Comments: This freshwater site was filled with dredge material from the pond excavation. Access to the site with heavy trucks is limited to a dry time of year.

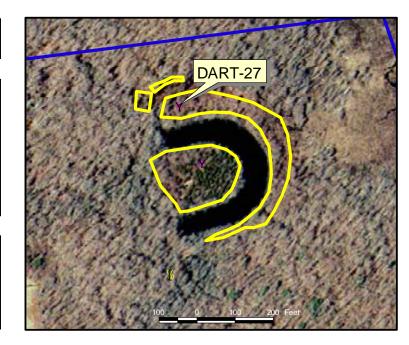
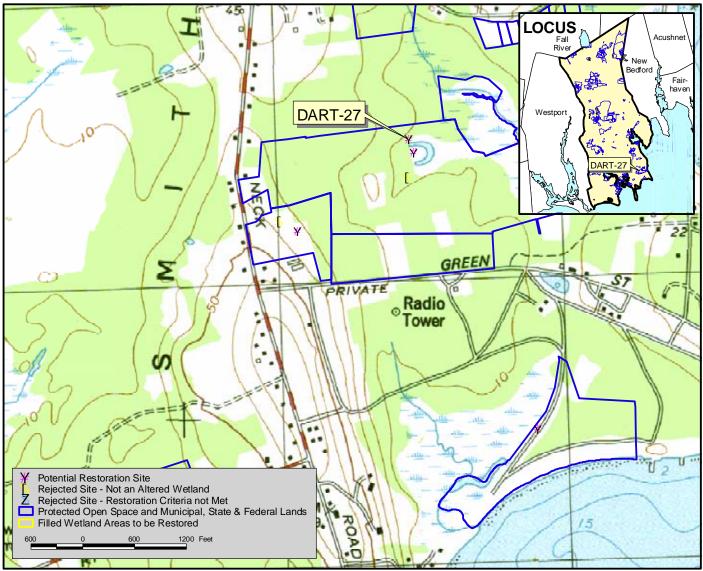
Disturbance Type: Fill **Disturbed Area:** 33,140 square feet **Owner:** Dartmouth Natural Resources Trust (DNRT) **Assessors' Lot Number:** 20-55 **Cubic Yards of Fill to be Removed:** 3.682

Comments: This freshwater site was filled with dredge material from the pond excavation. Access to the site with heavy trucks is limited to a dry time of year.

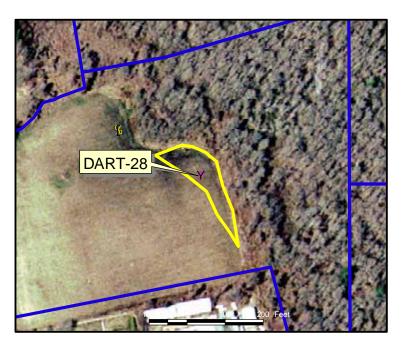
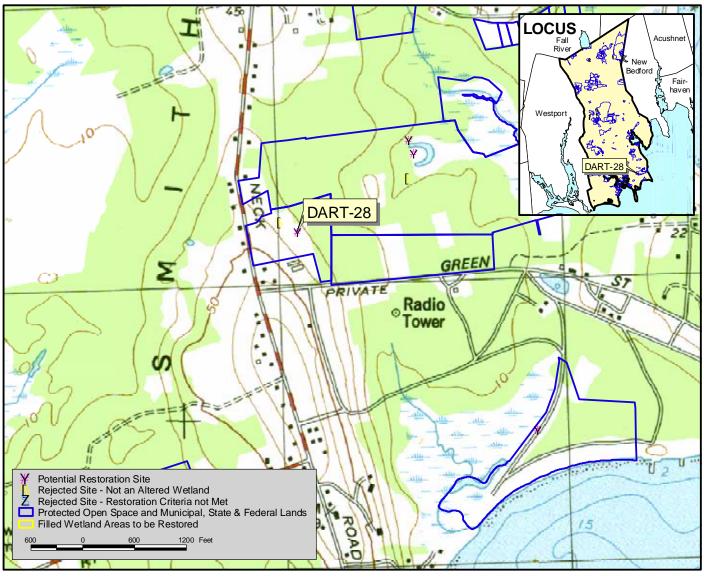
Disturbance Type: Cropping, hay Disturbed Area: 15,763 square feet Owner: Dartmouth Natural Resources Trust (DNRT) Assessors' Lot Number: 20-55-1 Cubic Yards of Fill to be Removed: 0

Comments: This freshwater site is a small wet area at the edge of the field that has low productivity for agricultural crops.

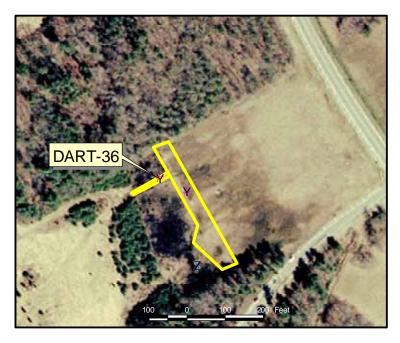
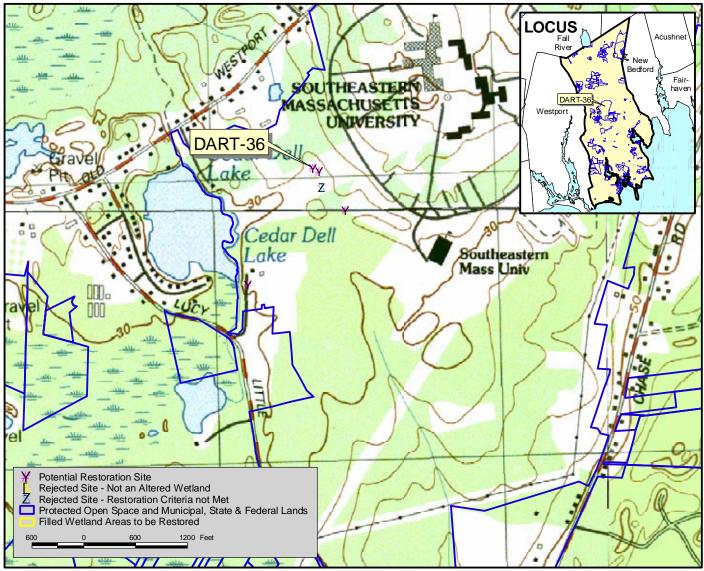
Disturbance Type: Fill Disturbed Area: 1,118 square feet Owner: Commonwealth of Massachusetts, UMASS Dartmouth Assessors' Lot Number: 49-19 Cubic Yards of Fill to be Removed: 41

Comments: This freshwater site is a footpath currently used as a shortcut. An elevated boardwalk would be fairly easy to construct at this site.

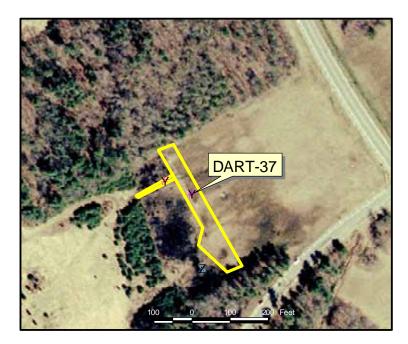
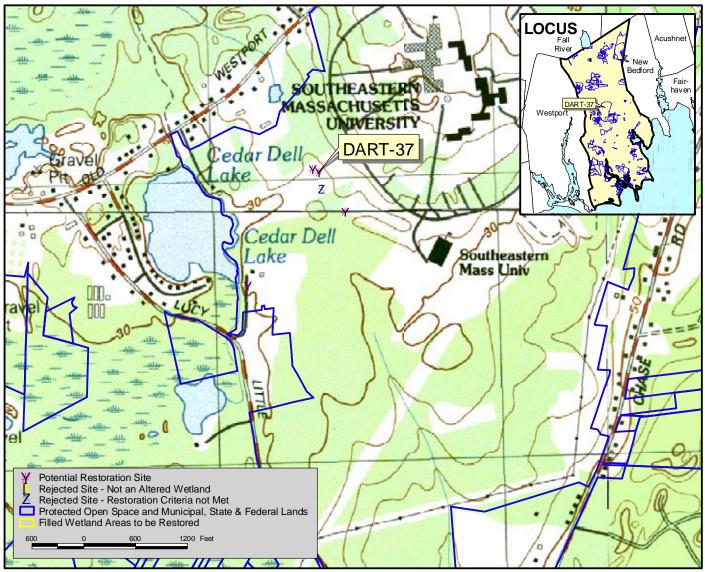
Disturbance Type: Cropping, mowed Disturbed Area: 17,097 square feet Owner: Commonwealth of Massachusetts, UMASS Dartmouth Assessors' Lot Number: 49-19 Cubic Yards of Fill to be Removed: 0

Comments: At this freshwater site the field could easily be left to grow back with no adverse effect upon University activities.

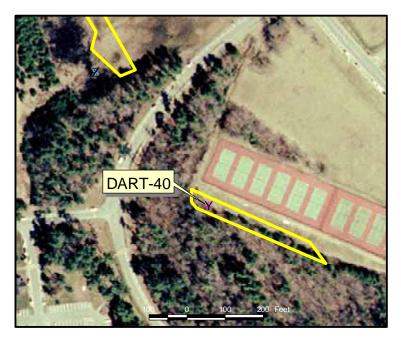
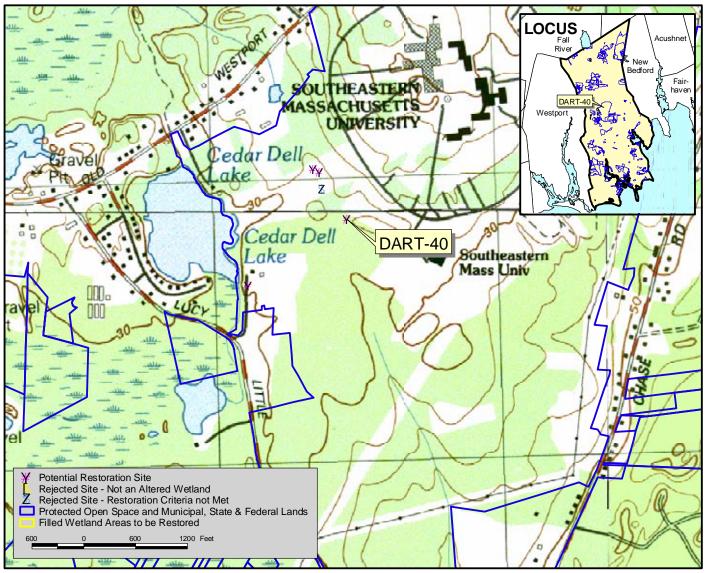
Disturbance Type: Fill **Disturbed Area:** 13,269 square feet **Owner:** Commonwealth of Massachusetts, UMASS Dartmouth **Assessors' Lot Number:** 49-19 **Cubic Yards of Fill to be Removed:** 1,966

Comments: This freshwater site consists of fill placed along the edge of the UMASS tennis courts for the court construction. A portion of the fill for the courts is not required for court use.

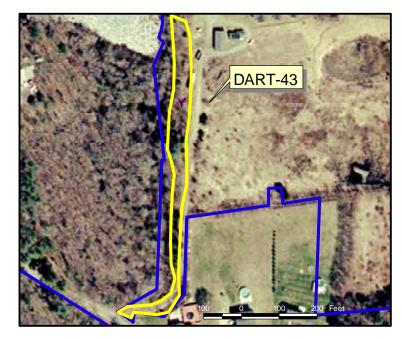
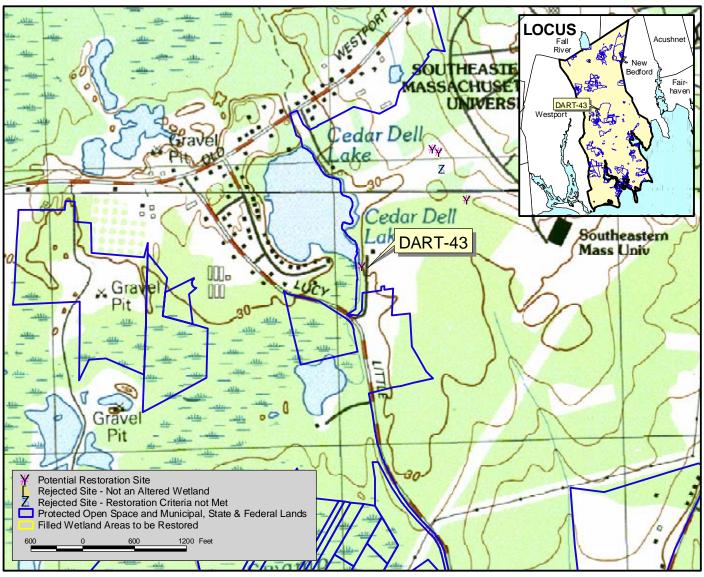
Disturbance Type: Fill **Disturbed Area:** 30,430 square feet **Owner:** Commonwealth of Massachusetts, UMASS Dartmouth **Assessors' Lot Number:** 49-19 **Cubic Yards of Fill to be Removed:** 4.508

Comments: This freshwater site is adjacent to the access road for the UMASS maintenance area.

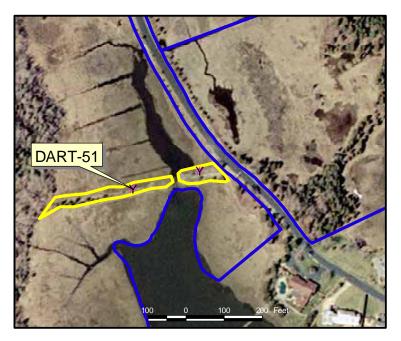
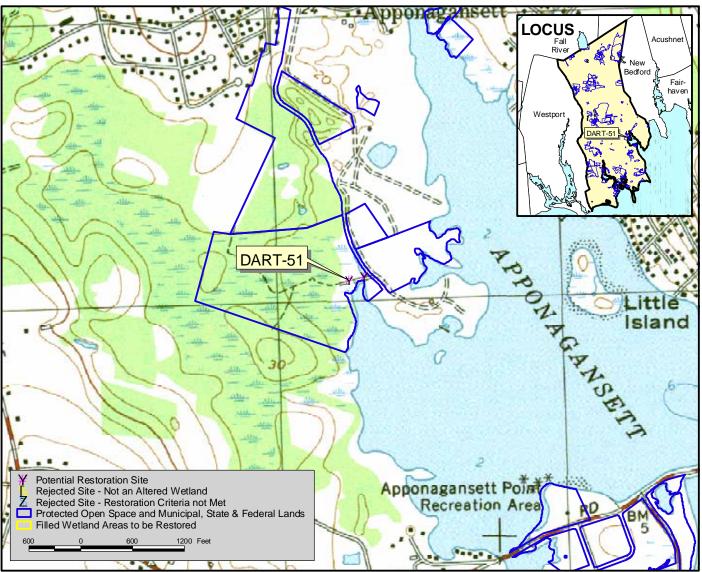
Disturbance Type: Fill **Disturbed Area:** 9,129 square feet **Owner:** Town of Dartmouth, Conservation Commission **Assessors' Lot Number:** 40-4 **Cubic Yards of Fill to be Removed:** 1.014

Comments: This filled salt marsh is part of a historic access way and an existing trail network with adjoining land trust property. Any removal of the trail would require replacement with an elevated walkway.

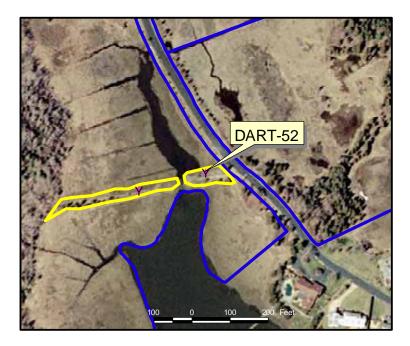
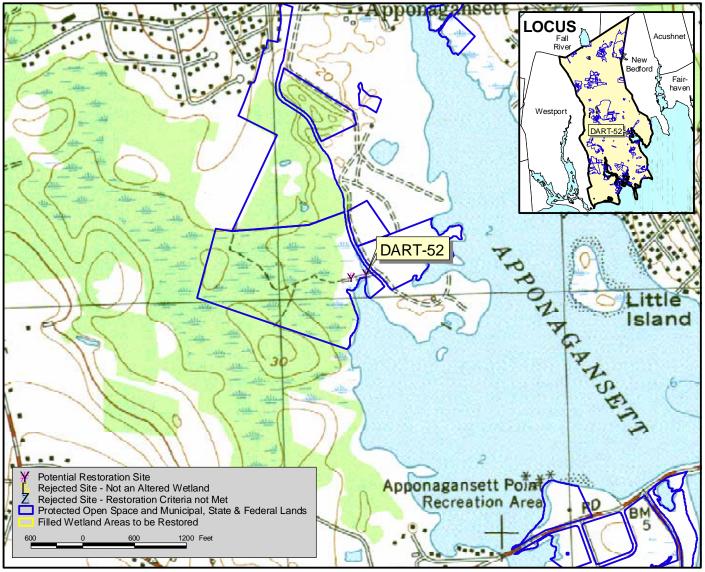
Disturbance Type: Fill **Disturbed Area:** 4,656 square feet **Owner:** Town of Dartmouth, Conservation Commission **Assessors' Lot Number:** 40-4 **Cubic Yards of Fill to be Removed:** 517

Comments: This filled salt marsh is part of a historic access way and an existing trail network with adjoining land trust property. Any removal of the trail would require replacement with an elevated

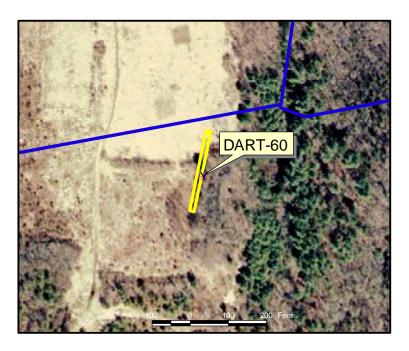
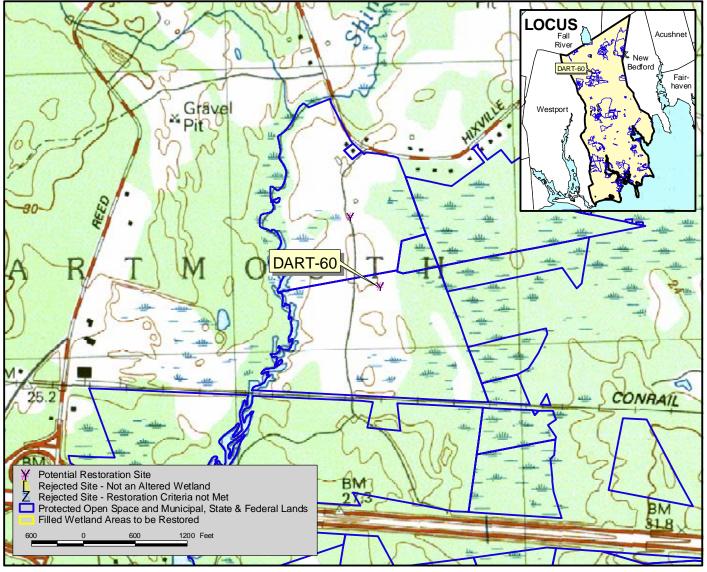
Disturbance Type: Fill Disturbed Area: 2,624 square feet Owner: Commonwealth of Massachusetts, Department of Fish & Game Assessors' Lot Number: 61-30 Cubic Yards of Fill to be Removed: 97

Comments: This small freshwater site appears to be a spoils pile created from the creation of the adjacent wetland.

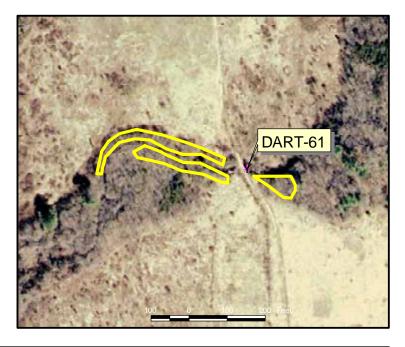
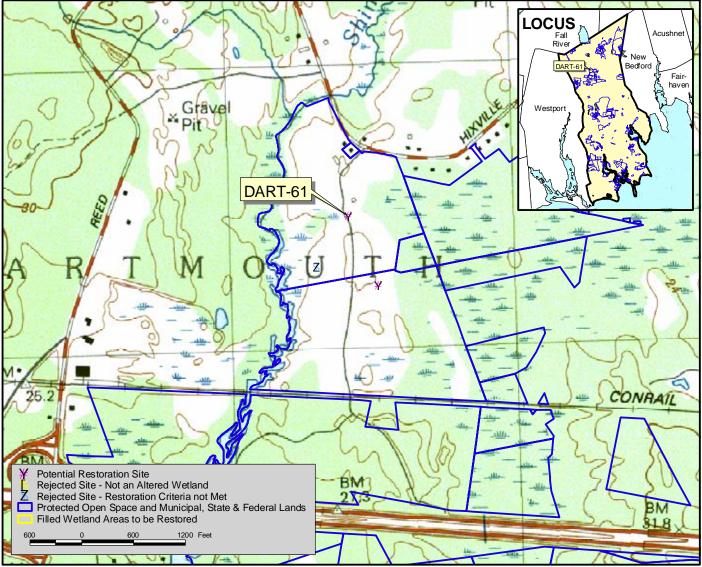
Disturbance Type: Fill **Disturbed Area:** 18,624 square feet **Owner:** Commonwealth of Massachusetts, Department of Fish & Game **Assessors' Lot Number:** 61-40 **Cubic Yards of Fill to be Removed:** 2,759

Comments: Rocks have been cleared from the farm field and pushed to the edge of the freshwater wetland. Closer investigation of the site may find more sites such as this at field edges.

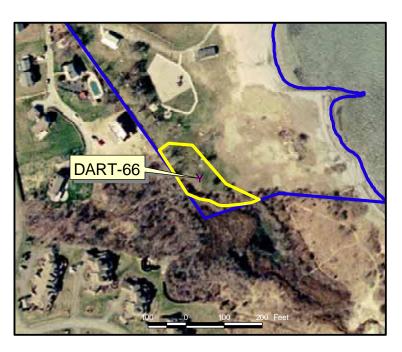
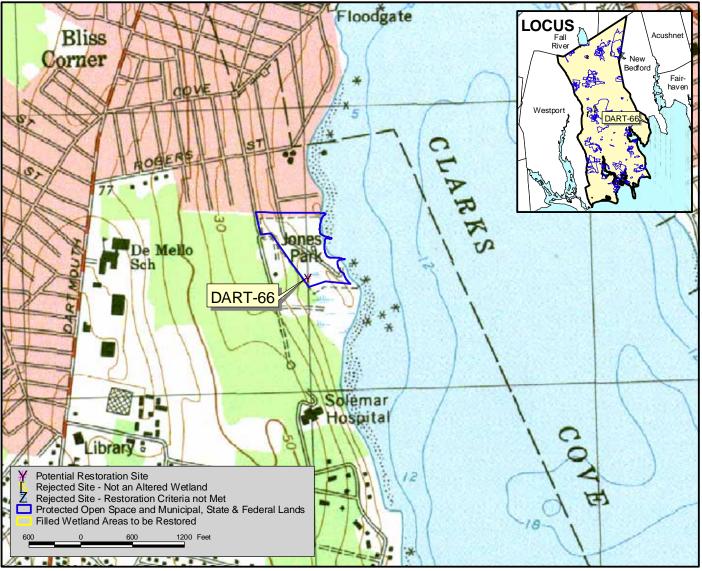
Disturbance Type: Fill Disturbed Area: 18,161 square feet Owner: Town of Dartmouth, Park Department Assessors' Lot Number: 134-41 Cubic Yards of Fill to be Removed: 1.345

Comments: This site is part of Jones Park. Some of the restoration activities may interfere with the use of the park.
